The Corporation of the Township of Brock  
Committee of the Whole Agenda

Monday, January 30, 2023, 10:00 a.m.  
Virtual Meeting

**Structural Condition Investigation, Report and Review for  
Rick MacLeish Memorial Community Centre  
91 Elliot Street, Cannington, ON  
The Corporation of the Township of Brock**

**Structural Condition Investigation, Report and Review for  
Sunderland Brock Memorial Arena  
20 Park Street, Sunderland, ON  
The Corporation of the Township of Brock**

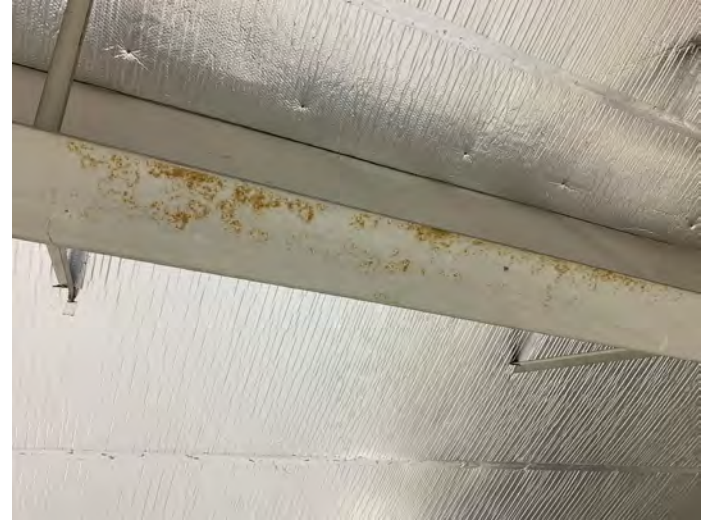
Photo 01 - Pre Engineered Frames

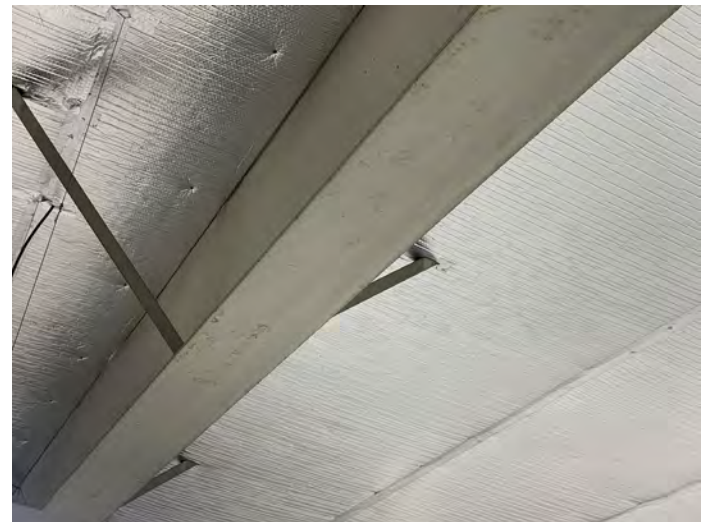
Photo 03 - Pre Engineered Frame Bottom Flange Corrosion

- Any corroded areas should be wire brushed to bare metal and epoxy painted to prevent further deterioration of the structural framing
  - Any peeled/flaked paint areas to be removed and repainted with a new coat of epoxy paint

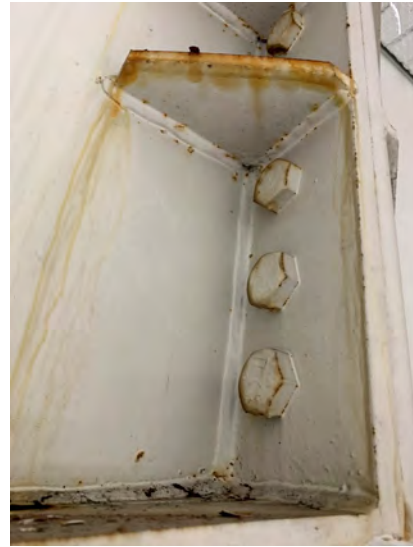
Photo 05 - Pre Engineered Frame Bolted Connection Corrosion

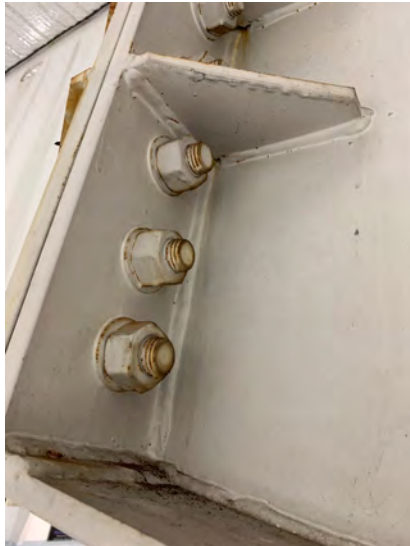
Photo 06 - Pre Engineered Frame Bolted Connection Corrosion

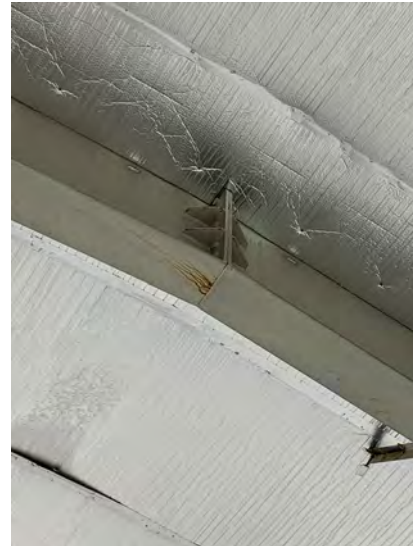
Photo 07 - Pre Engineered Frame Bolted Connection Corrosion

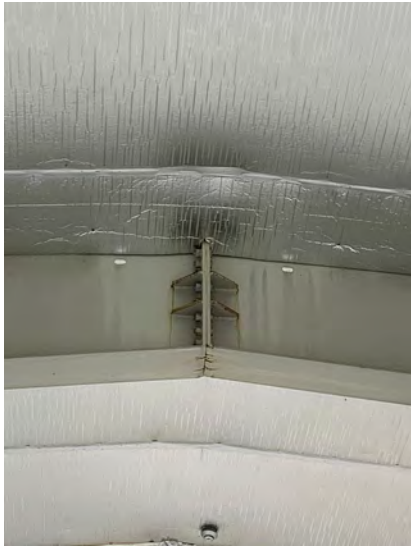
Photo 08 - Pre Engineered Frame Moisture Staining

- Any areas of moisture staining on structural framing should be cleaned and a protective coating should be applied
- Rick MacLeish Memorial Community Centre:

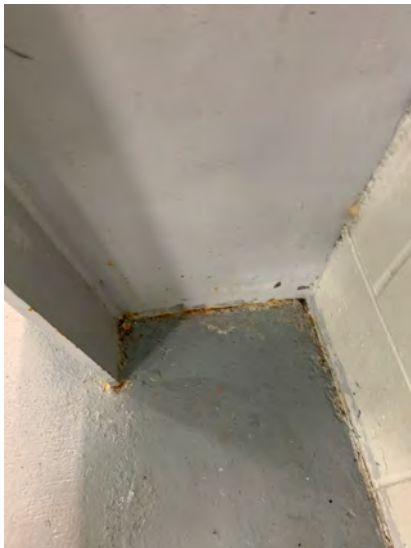
Photo 10 - Pre Engineered Frame Base Corrosion

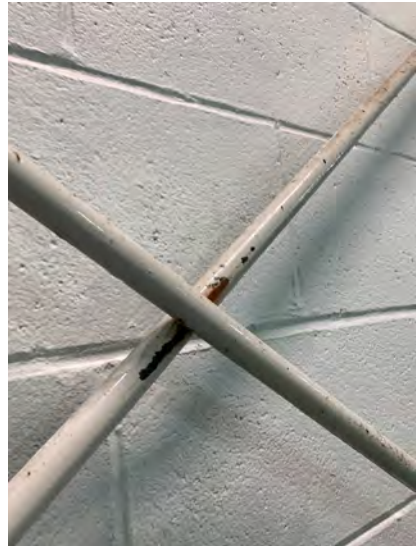
Photo 13 - Pre Engineered Frame Bracing Corrosion

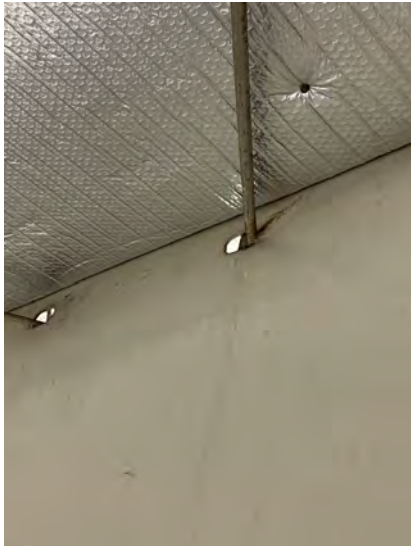
Photo 14 - Pre Engineered Frame Bracing Corrosion

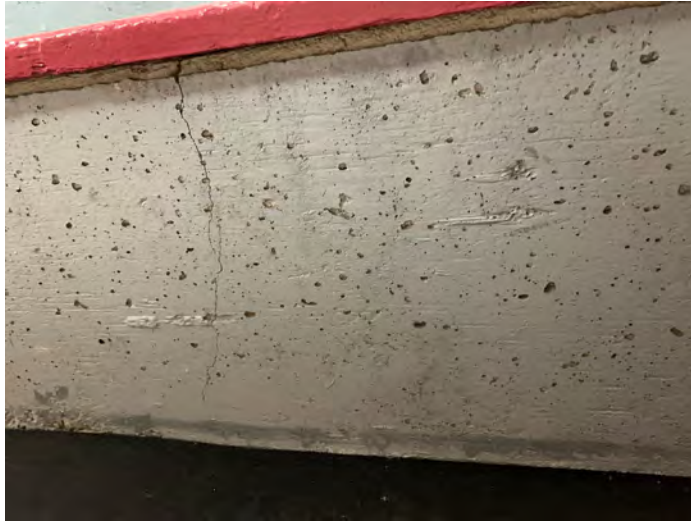
Photo 16 - Bleacher Seating Honeycombing

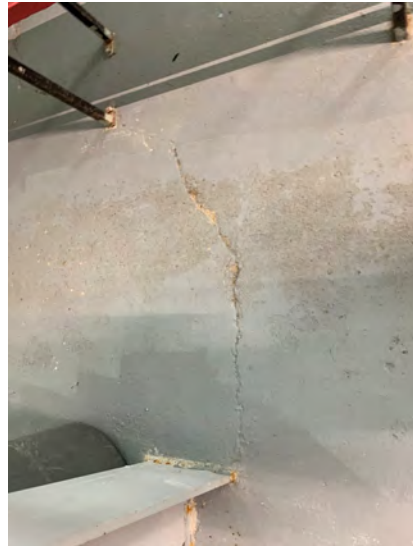
Photo 17 - Bleacher Seating Minor Cracking

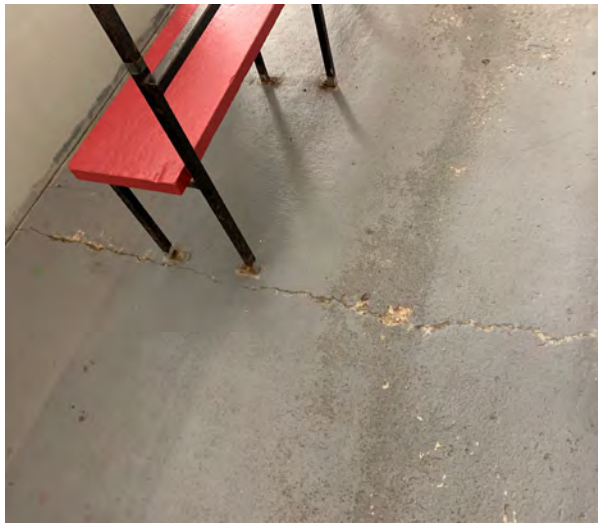
Photo 18 - Bleacher Seating Cracking

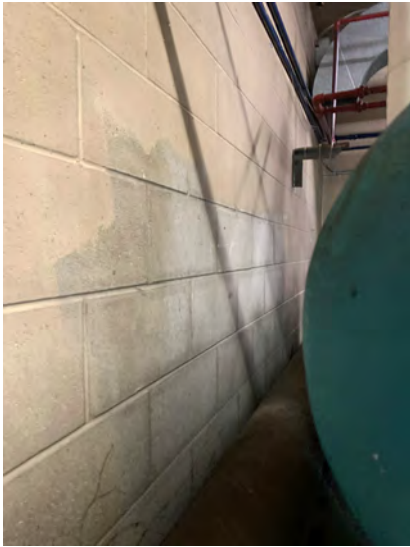
Photo 24 - Masonry Block Wall Efflorescence

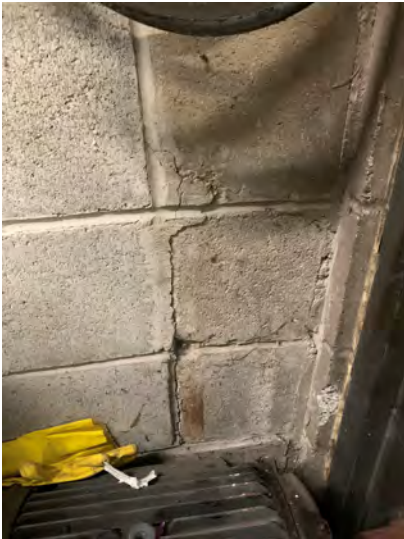
Photo 26 - Masonry Block Wall Staining

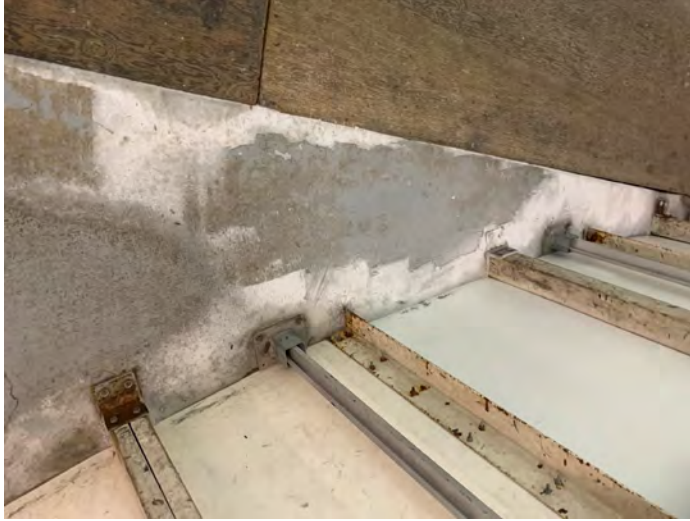
Photo 28 - Concrete Apron Slab Cracking

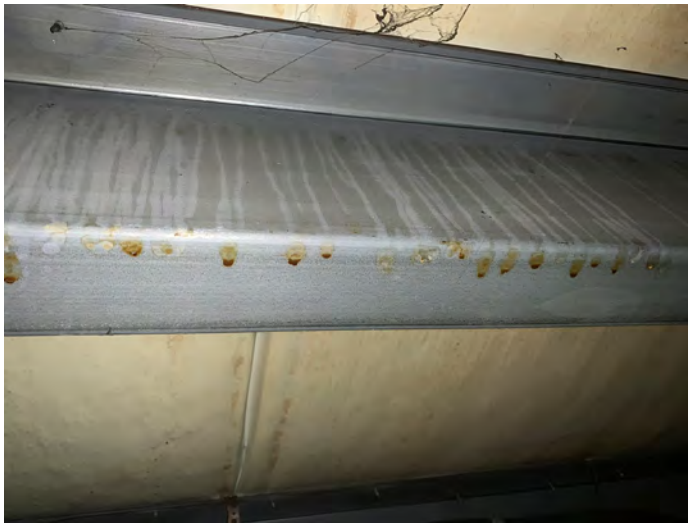
Photo 34 - Partial Second Floor Framing

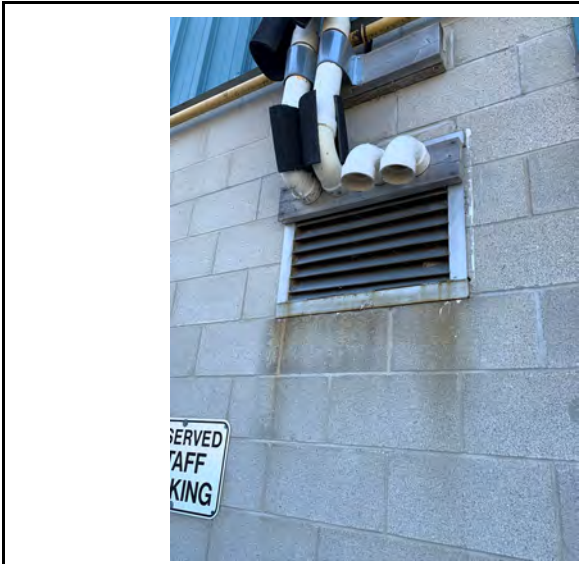
Photo 36 - South Elevation Opening

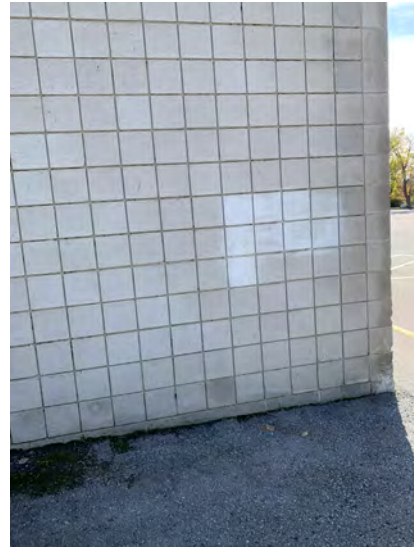
Photo 43 - East Elevation Corroded Cladding

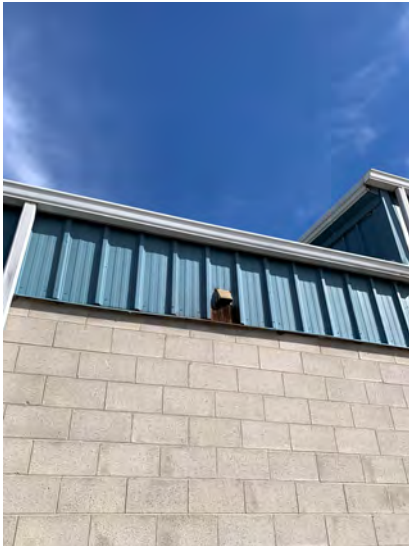
Photo 46 - North Elevation

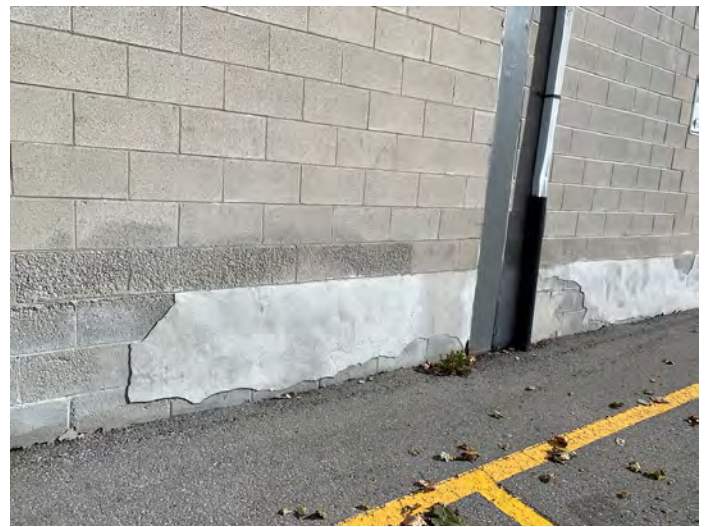
Photo 47 - North Elevation Corroded Cladding

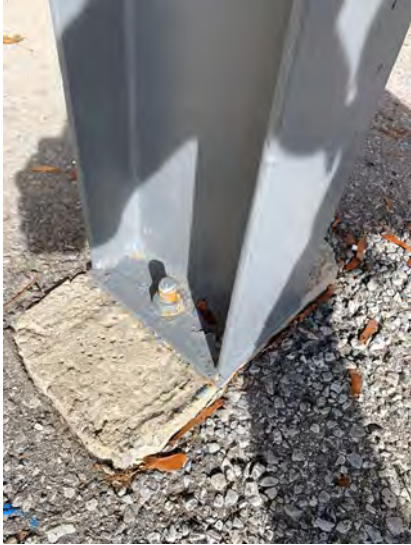
Photo 52 - North Elevation Deterioration 2

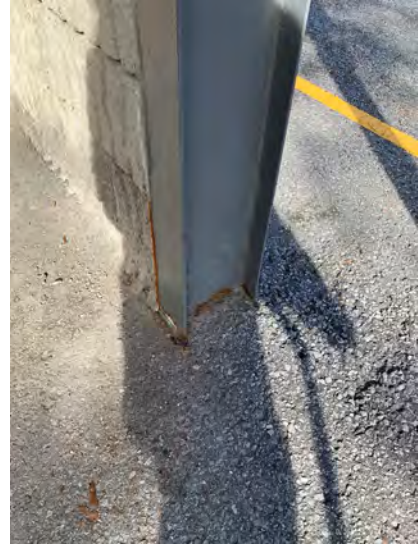
Photo 53 - West Elevation Exterior Column Bolted Connection Corrosion
