Structural Investigation and Report
BEAVERTON-THORAH COMMUNITY CENTRE

Township of Brock

BBA PROJECT NO. 17176
NOVEMBER 23, 2021

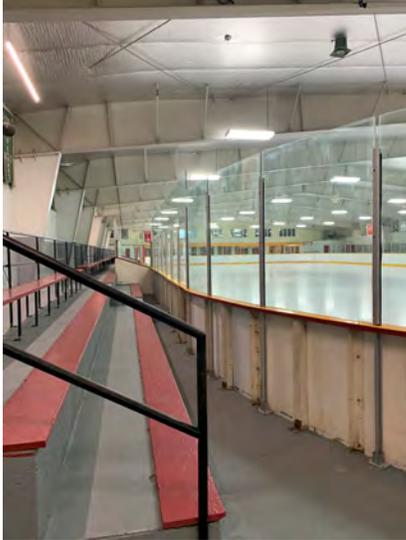
The main structure of the arena consists of a pre-engineered structural frame system with tapered steel girders supporting the steel purlins. The steel frames span approximately 100'-0" and are spaced at approximately 25'-0" centre to centre. We were unable to complete a detailed review of the entire extents of the tapered girders as this framing was enclosed by the existing insulation system (Photo 001). Our observations are as follows:

Photo 01 - Pre Engineered Frames

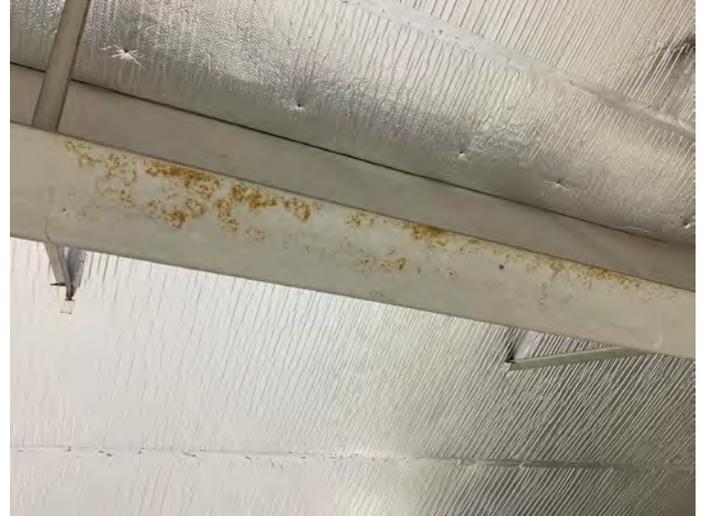
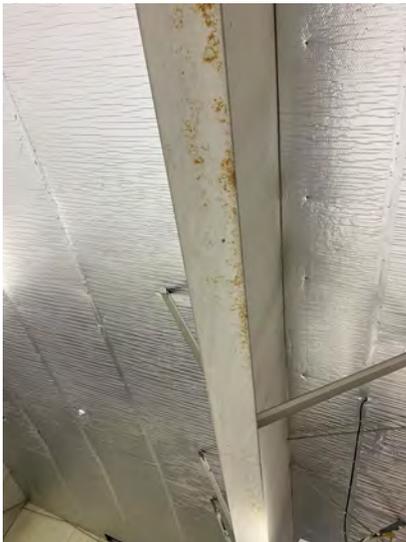
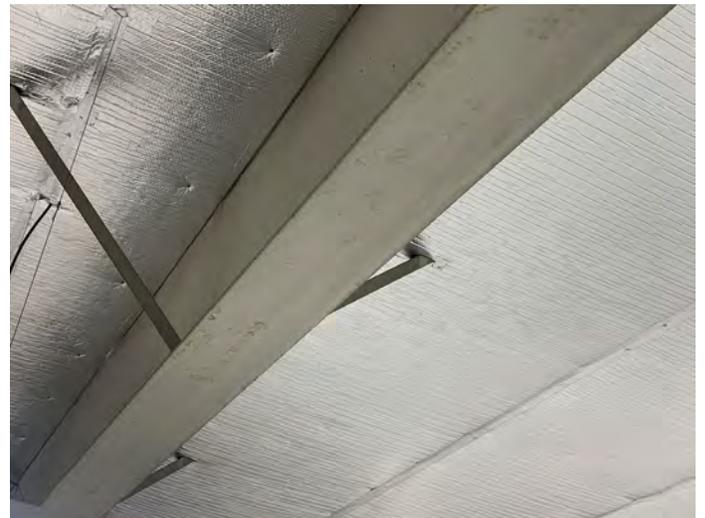
- Minor localized surface corrosion and peeled paint was observed on the bottom flange of the frames at several locations (Photos 002-004). This is likely due to condensation and high humidity during occupancy. We recommend for the corroded areas to be wire brushed clean to bare metal and an epoxy protective coating is applied.

Photo 02 - Pre Engineered Frame Bottom Flange Corrosion

Photo 03 - Pre Engineered Frame Bottom Flange Corrosion

Photo 04 - Pre Engineered Frame Bottom Flange Corrosion

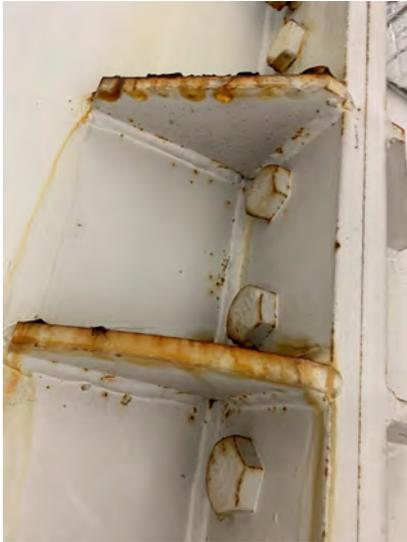
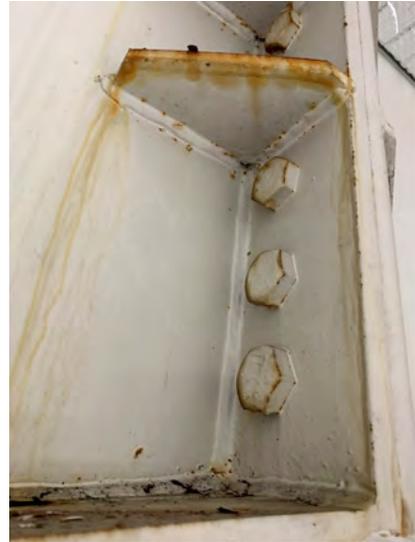
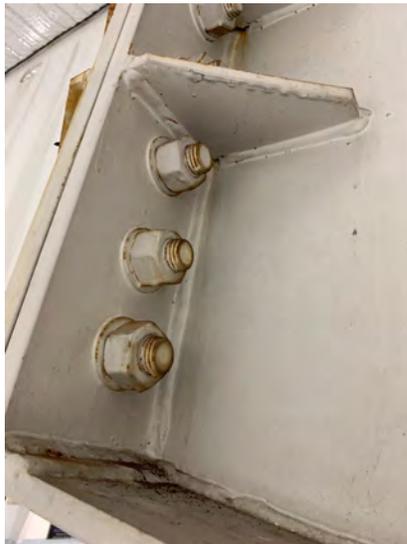
- The bolted connection of the pre-engineered frame web appeared to be experiencing localized minor corrosion (Photos 005-007). This is likely due to condensation and high humidity during occupancy. We recommend for the corroded areas to be wire brushed clean to bare metal and an epoxy protective coating is applied.

Photo 05 - Pre Engineered Frame Bolted Connection Corrosion

Photo 06 - Pre Engineered Frame Bolted Connection Corrosion

Photo 07 - Pre Engineered Frame Bolted Connection Corrosion

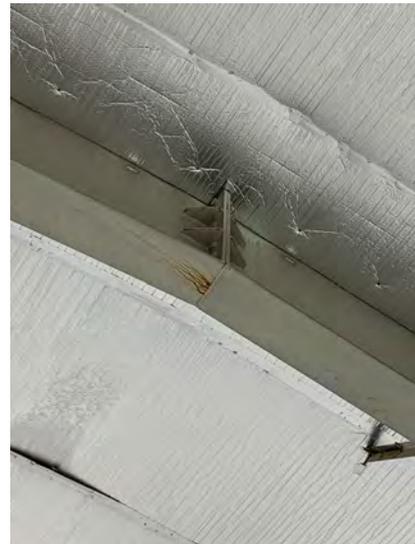
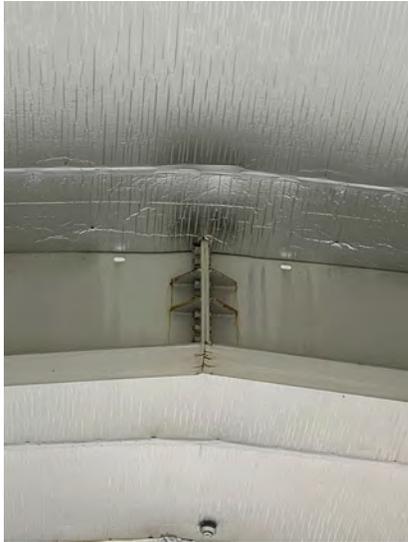
- The pre-engineered steel frame at the south wall elevation appeared to have moisture staining along the bottom flange (Photo 008 & 009). This is likely due to condensation and high humidity during occupancy. We recommend for the corroded areas to be wire brushed clean to bare metal and an epoxy protective coating is applied.

Photo 08 - Pre Engineered Frame Moisture Staining

Photo 09 - Pre Engineered Frame Moisture Staining

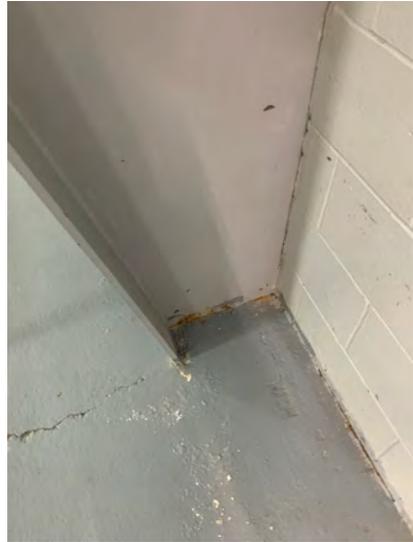
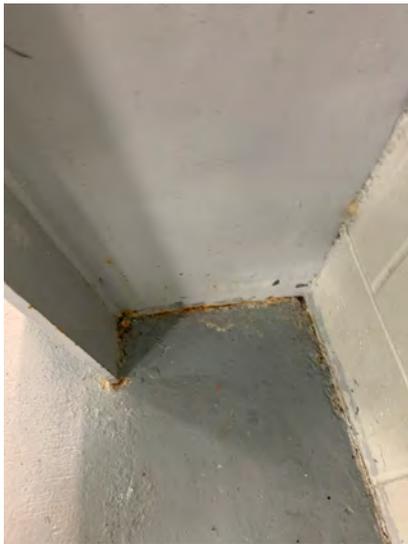
- The base of several frames appeared to not consist of a protective epoxy coating and appears to have experienced minor surface rusting (Photo 010 & 011). We recommend for the rusted areas to be wire brushed clean to bare metal and a protective coating is applied.

Photo 10 - Pre Engineered Frame Base Corrosion

Photo 11 - Pre Engineered Frame Base Corrosion

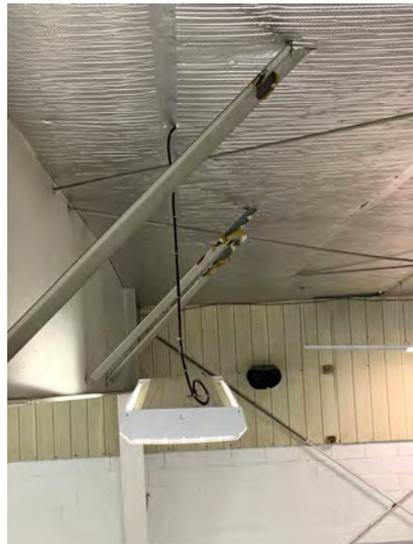
- The bridging of several pre-engineered frames appeared to be peeling (Photo 012). This is likely due to condensation and high humidity during occupancy. We recommend for the peeled paint areas to be removed and repainted with a suitable coating for the high humidity environment.

Photo 12 - Pre Engineered Frame Bridging Peeling

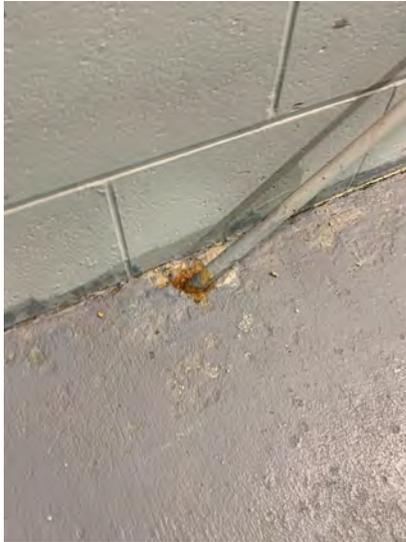
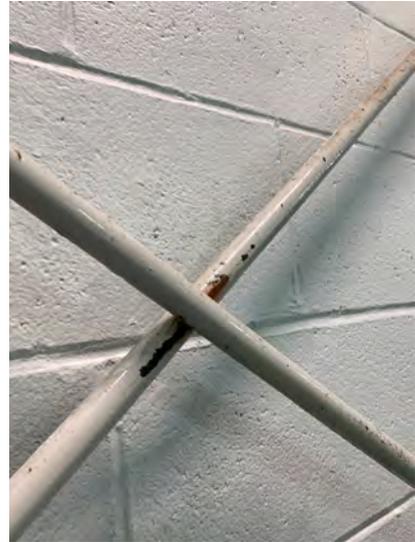
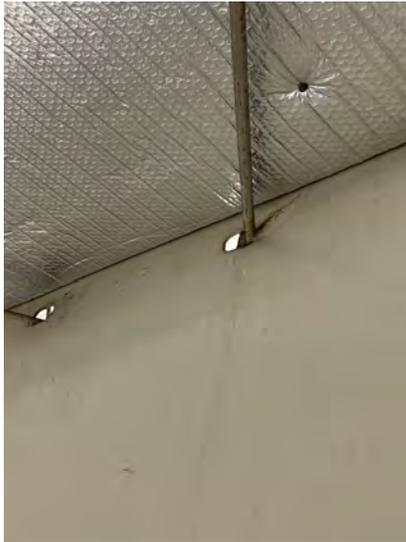
bracing at roof level appeared to be experiencing localized minor corrosion (Photo 013-015). We recommend for the corroded areas to be wire brushed clean to bare metal and an epoxy protective coating is applied.

Photo 13 - Pre Engineered Frame Bracing Corrosion

Photo 14 - Pre Engineered Frame Bracing Corrosion

Photo 15 - Pre Engineered Frame Bracing Corrosion

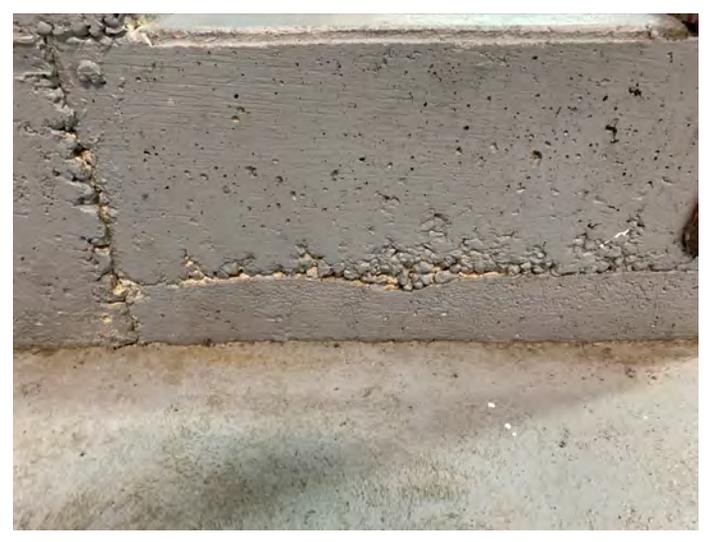
- There appeared to be localized honeycombing at the exposed sides of the bleacher seating (Photo 016). This appears to be an existing condition and is not a structural concern at this time.
- Minor cracking was observed on the vertical face of the bleachers (Photo 017). These cracks are not a structural concern at this time however we recommend that they be monitored over a five (5) year period for continued propagation.
- Minor cracking was observed at the base of the pre-engineered frames (Photo 018 & 019). These cracks are not a structural concern at this time however we recommend that they be monitored over a five (5) year period for continued propagation.
- Minor deterioration was observed along the bleacher seating (Photo 020). We recommend that this area be cleaned, and a non-slip industrial coating be applied.

Photo 16 - Bleacher Seating Honeycombing

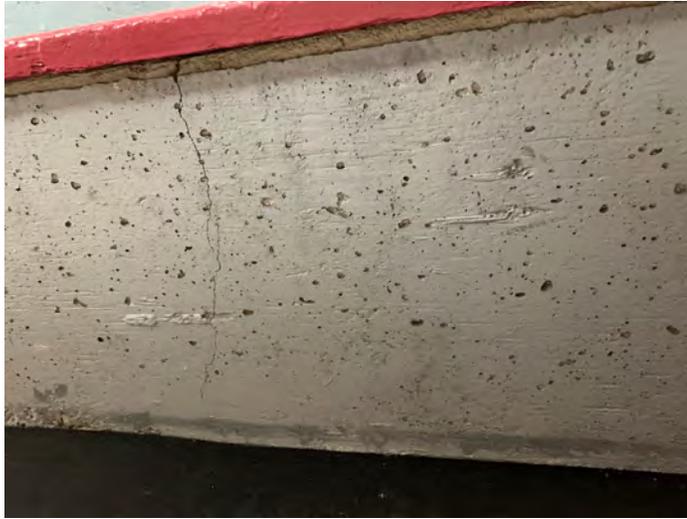
Photo 17 - Bleacher Seating Minor Cracking

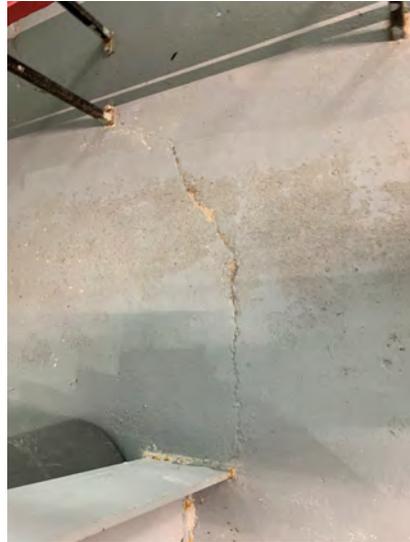
Photo 18 - Bleacher Seating Cracking

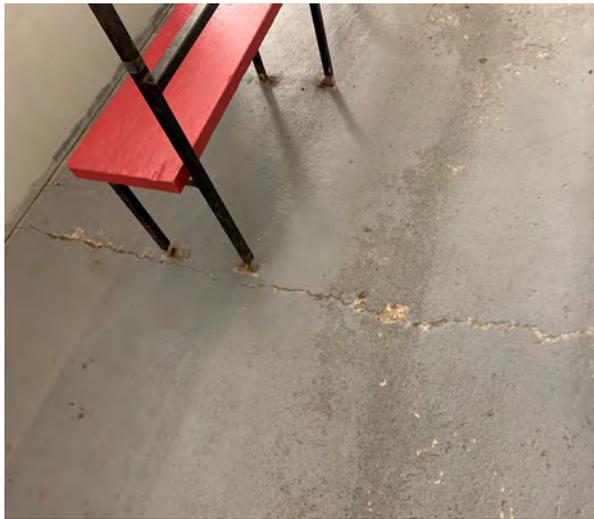
Photo 19 - Bleacher Seating Cracking

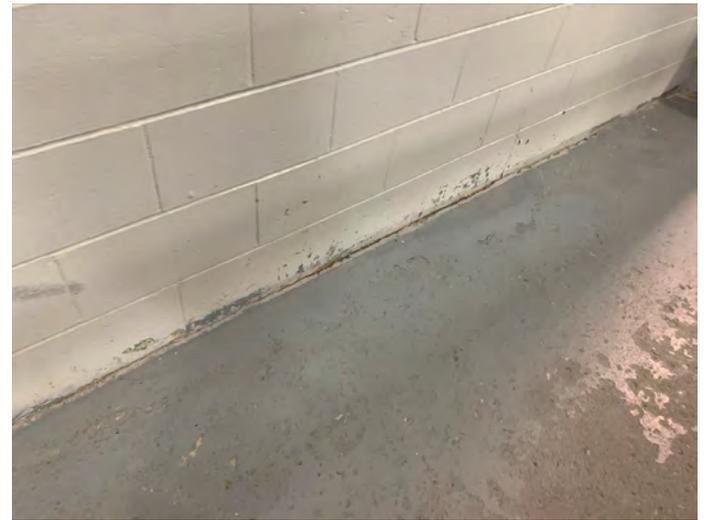
Photo 20 - Bleacher Seating Deterioration

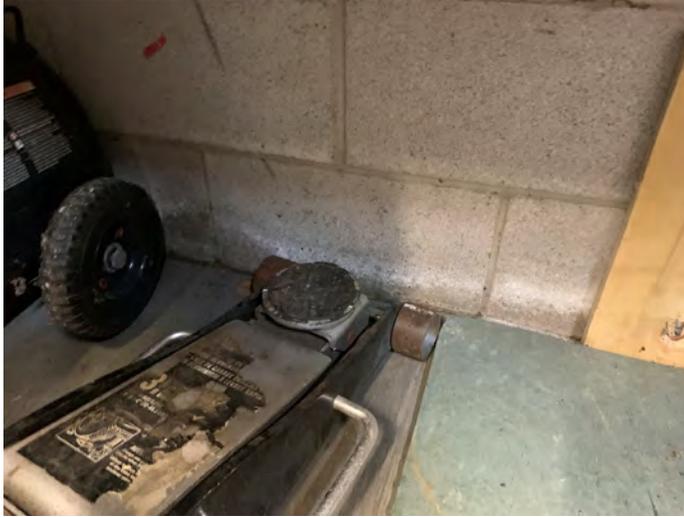
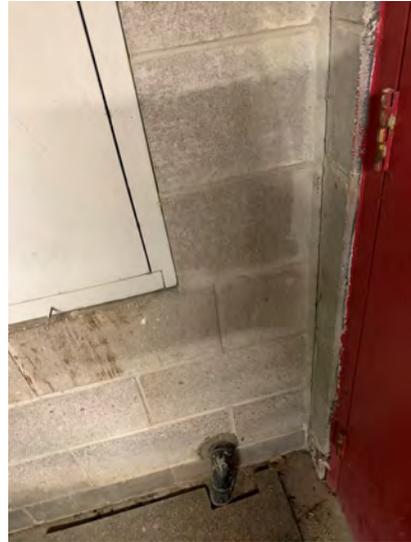
- Efflorescence accumulation was observed along the base of the concrete block walls in the Zamboni room (Photo 021 & 022). The efflorescence accumulation is likely due to moisture absorption through the wall system. We recommend for the area to be cleaned and coated with a protective coating.

Photo 21 - Masonry Block Wall Efflorescence

Photo 22 - Masonry Block Wall Efflorescence

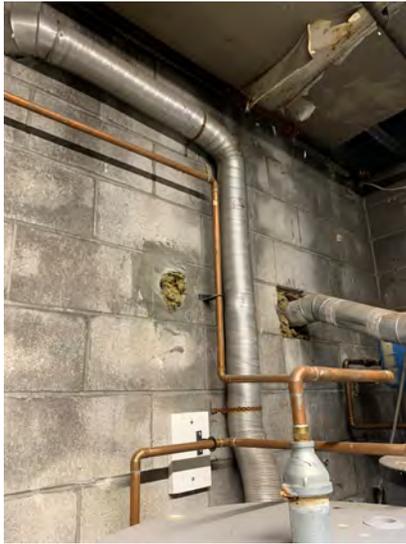
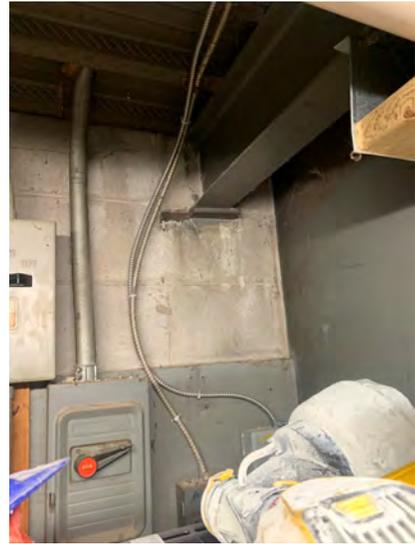
- Efflorescence accumulation was observed along the concrete block walls in the Ammonia room and Mechanical room (Photo 023 & 024). The efflorescence accumulation is likely due to high humidity in the room with poor ventilation. We recommend for the area to be cleaned and coated with a protective coating.

Photo 23 - Masonry Block Wall Efflorescence

Photo 24 - Masonry Block Wall Efflorescence

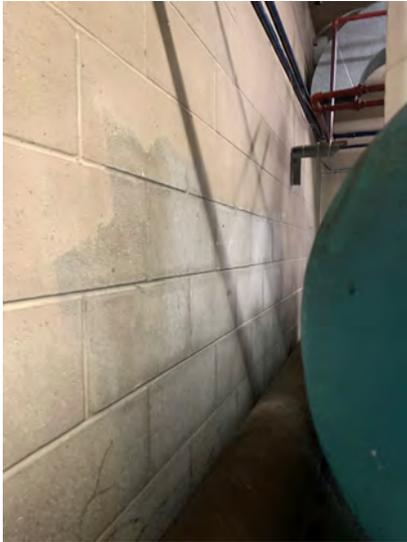
- Minor deterioration of the paint on the concrete masonry block wall was observed within the ammonia room (Photo 025). This is likely a result of condensation within the room due to the high humidity. We recommend for the peeled paint areas to be removed and repainted with a suitable coating for the high humidity environment.

Photo 25 - Masonry Block Wall Deterioration

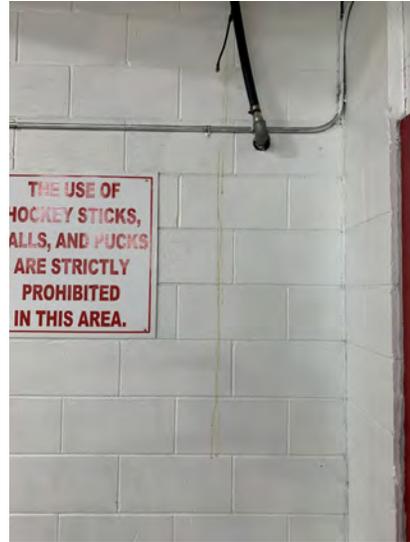
- Water staining on the masonry block walls was observed beneath the condensing unit in the northeast corner of the arena (Photo 026). This is likely a result of moisture from the condensing unit causing water staining on the walls. We recommend the walls be cleaned and a new protective coating applied.
- Minor localized cracking was observed in the mortar joints (Photo 027). We recommend this crack be repaired with a suitable repair mortar.

Photo 26 - Masonry Block Wall Staining

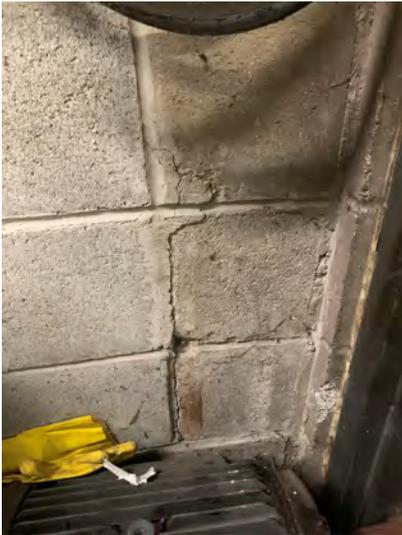
Photo 27 - Masonry Block Wall Cracking

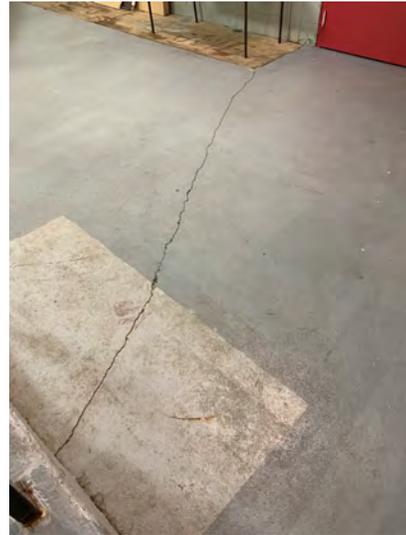
- Localized cracking at the apron slab surface was observed at the corner of the floor drain location extending towards the rink slab (Photo 028). The cracking is likely a result of concrete shrinkage and is not a structural concern.
- Efflorescence accumulation was observed at multiple areas on the exposed concrete apron slab (Photo 029 & 030). The efflorescence accumulation is likely due to high moisture content due to the nearby ice. We recommend for the area to be cleaned and coated with a protective coating.
- Larger cracking at the apron slab surface was observed in the southeast corner of the arena (Photo 031). This crack should be epoxy injected to try and extend the long-term serviceability of the pad.
- Surface deterioration was observed along the bleacher seating (Photo 032 & 033). We recommend that this area be cleaned, and a non-slip industrial coating be applied.

Photo 28 - Concrete Apron Slab Cracking

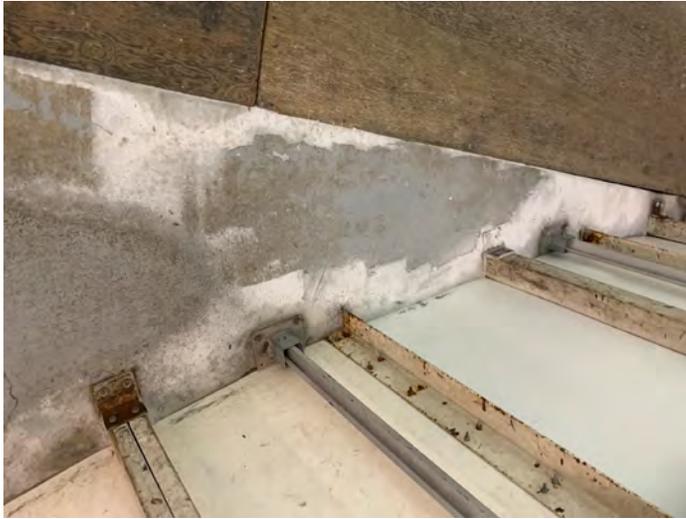
Photo 29 - Concrete Apron Slab Efflorescence

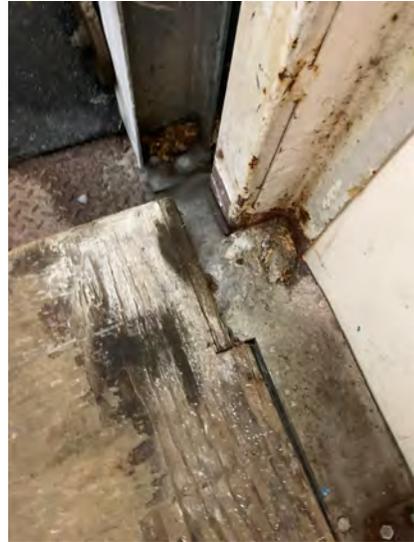
Photo 30 - Concrete Apron Slab Efflorescence

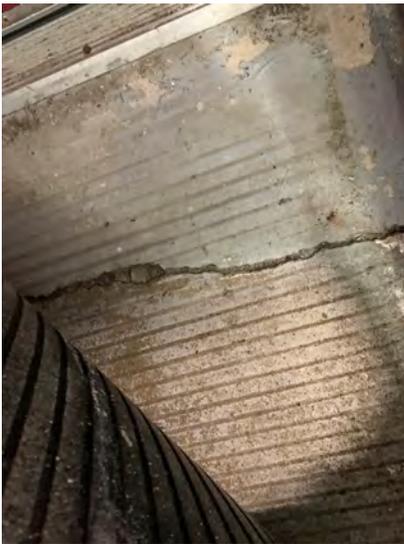
Photo 31 - Concrete Apron Slab Bigger Cracking

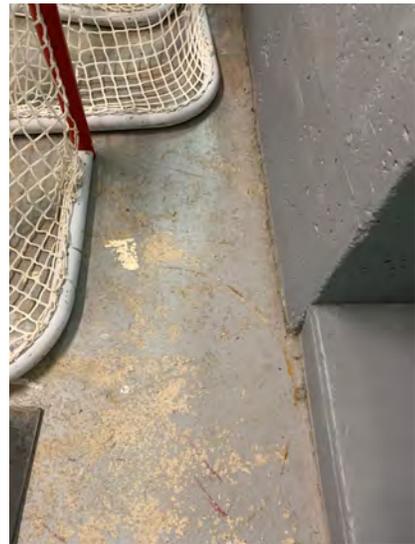
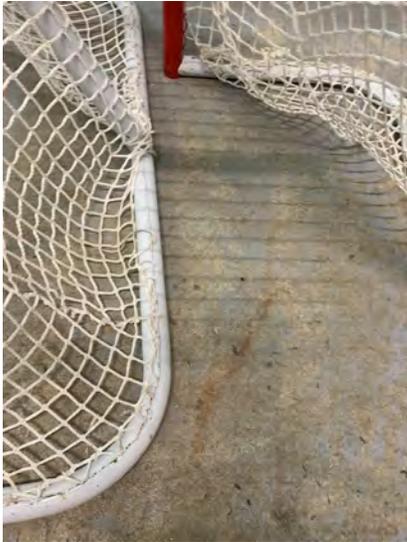
Photo 32 - Concrete Apron Slab Deterioration

Photo 33 - Concrete Apron Slab Deterioration

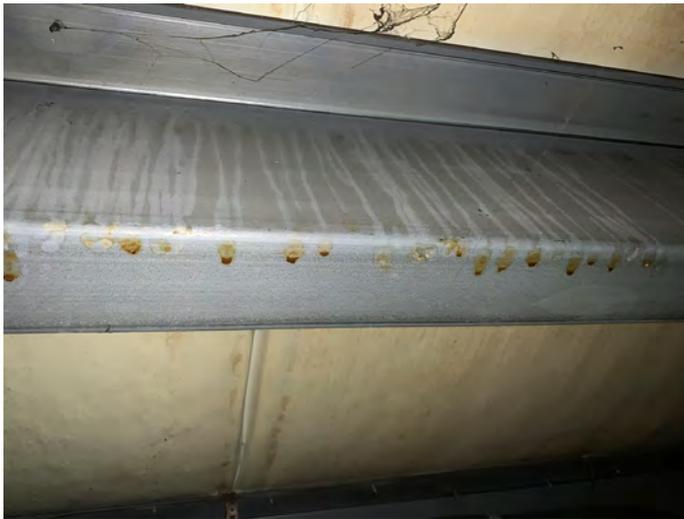
- There appeared to be some water staining on the underside of the Z girts (Photo 035). We recommend these stains be removed and a protective coating be applied.

Photo 35 - Partial Second Floor Z Girt Water Staining

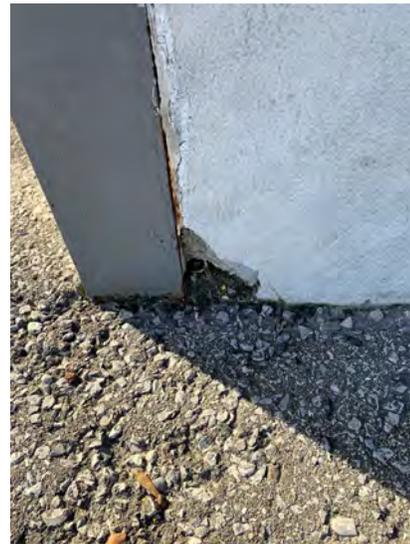
- There appears to be an opening beneath the metal cladding at ground level (Photo 036). This opening will allow moisture to enter the building and should be repaired by a suitable repair mortar the exposed portion.

Photo 36 - South Elevation Opening

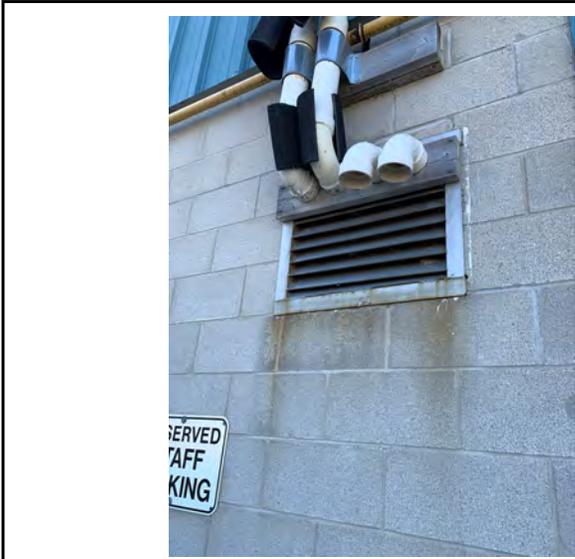
- The block wall was observed to be corroded around a mechanical unit (Photo 037). This is most likely due to leaks from the mechanical unit. We recommend for the corroded areas to be cleaned and an epoxy protective coating is applied.

Photo 37 - South Elevation Block Wall Corrosion

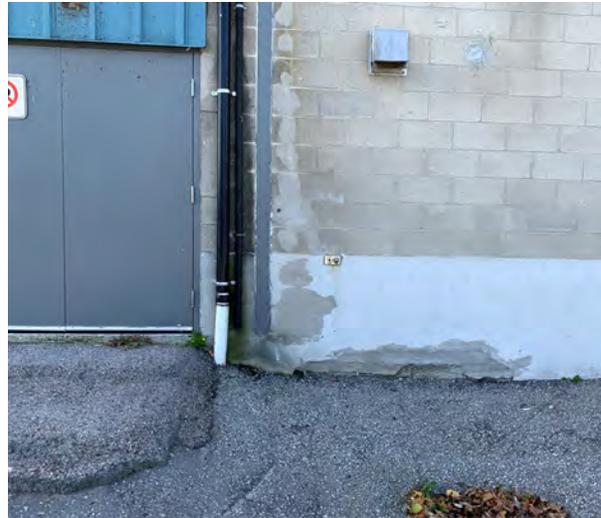
- Vegetation growth on the concrete masonry block wall was observed behind a gutter (Photo 038). This is likely due to the moisture from gutter. We recommend this area be cleaned and a protective coating be applied.

Photo 38 - South Elevation Block Wall Vegetation

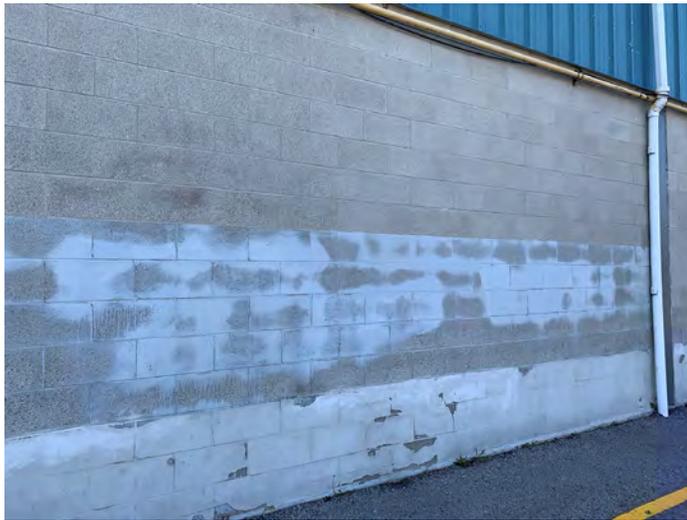
- Efflorescence accumulation was observed along the block wall (Photo 039). We recommend for the area to be cleaned and coated with a protective coating.

Photo 39 - South Elevation Block Wall Efflorescence

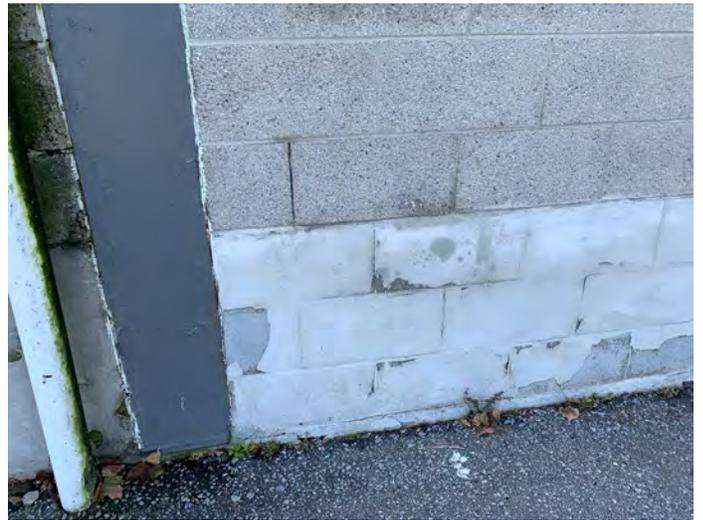
- Parging at the base of the block wall appeared to be deteriorating (Photo 040). This is likely due to de-icing salts and snow accumulation against the wall. We recommend a protective coating be applied and this area be re-parged to prevent further deterioration.

Photo 040 - South Elevation Block Wall Parging

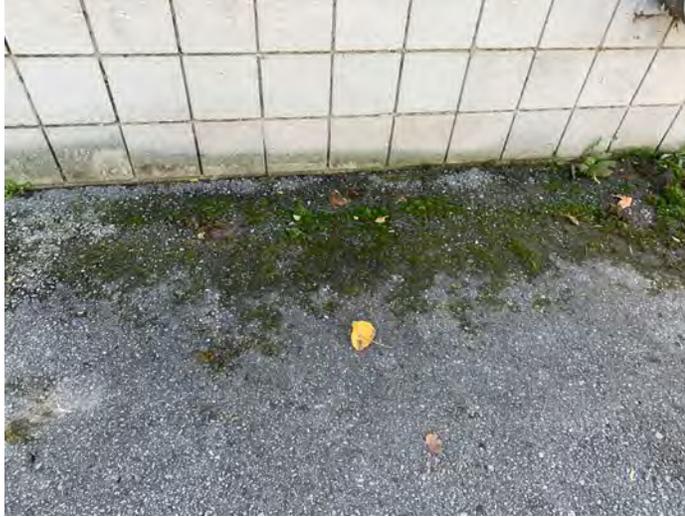
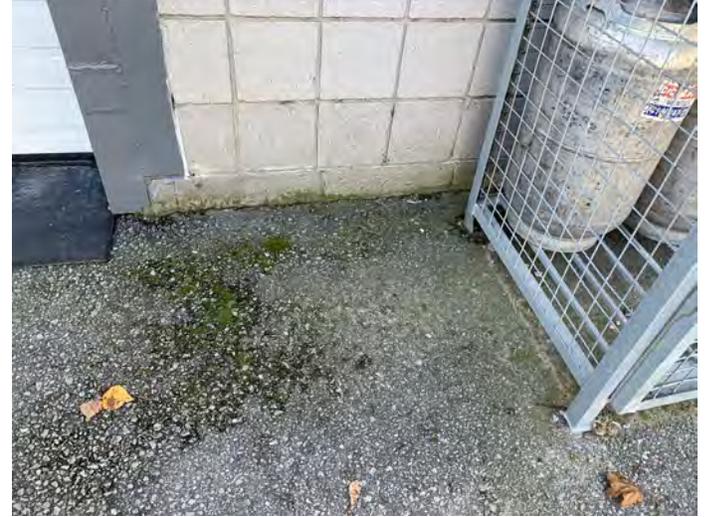
- Vegetation growth on the concrete masonry block wall was observed at the base of the wall (Photos 041 & 042). The walls should be cleaned and coated with a suitable protective coating.
- The metal cladding was observed to be corroded around a mechanical unit (Photo 043). This is most likely due to leaks from the mechanical unit. We recommend for the corroded areas to be wire brushed clean to bare metal and an epoxy protective coating is applied.
- Efflorescence accumulation was observed along the block wall (Photo 044). We recommend for the area to be cleaned and coated with a protective coating.

Photo 41 - East Elevation Vegetation

Photo 42 - East Elevation Vegetation 2

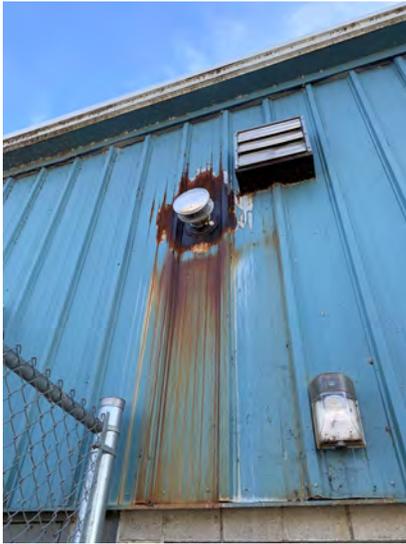
Photo 43 - East Elevation Corroded Cladding

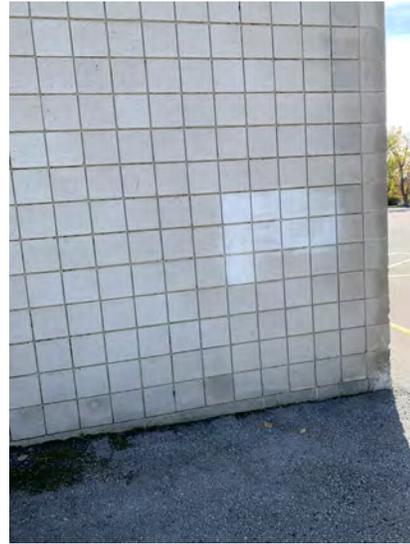
Photo 44 - East Elevation Block Wall Efflorescence

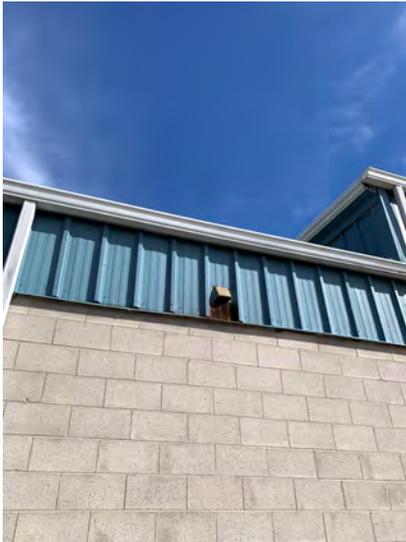
- The metal cladding was observed to be corroded around a mechanical unit (Photo 047). This is most likely due to leaks from the mechanical unit. We recommend for the corroded areas to be wire brushed clean to bare metal and an epoxy protective coating is applied.

Photo 47 - North Elevation Corroded Cladding

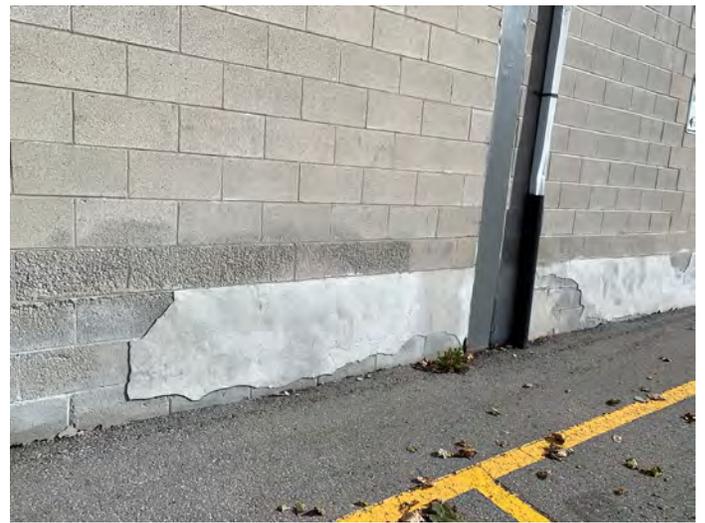
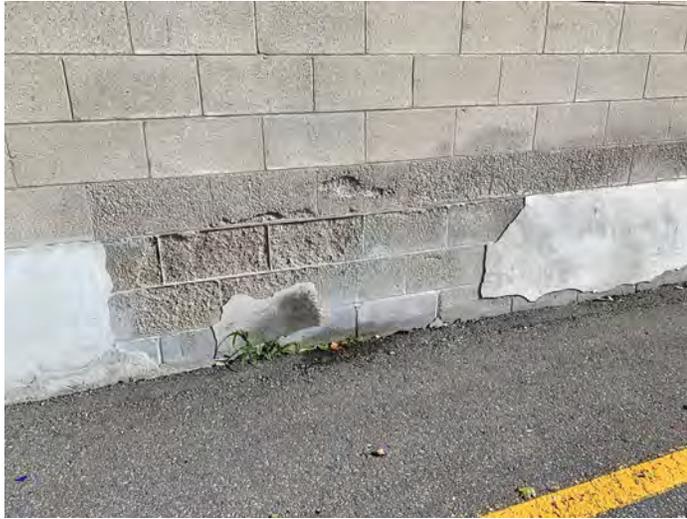
- Parging at the base of the block wall appeared to be deteriorating and in return the block wall was observed to be deteriorating (Photo 048 & 049). This is likely due to de-icing salts and snow accumulation against the wall. We recommend a protective coating be applied and this area be re-parged to prevent further deterioration.

Photo 48 - North Elevation Parging

Photo 49 - North Elevation Parging2

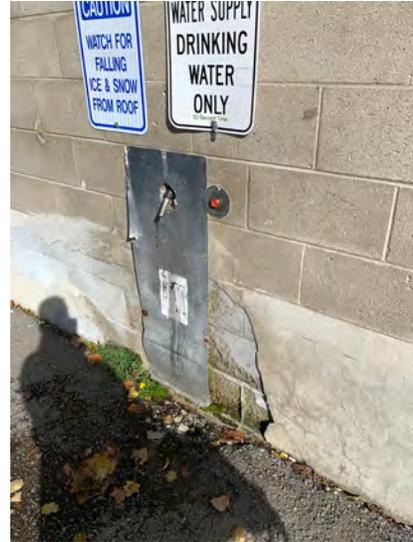
- Vegetation growth on the concrete masonry block wall was observed at the base of the wall below a water supply (Photos 050). This is likely due to the moisture from the water supply. We recommend this area be cleaned, a protective coating be applied and this area be re-parged to prevent further deterioration.

Photo 50 - North Elevation Vegetation and Deteriorated Parging

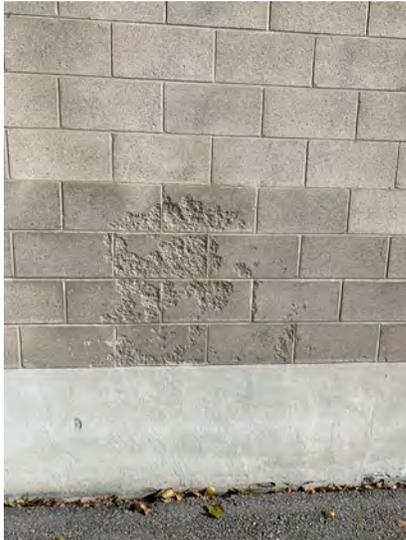
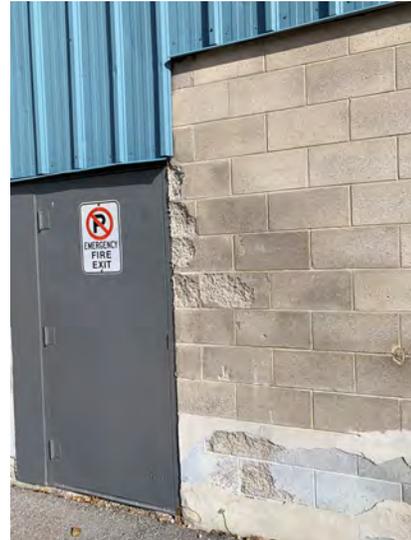
- Localized deterioration of the block was observed (Photo 051 & 052). We recommend for the deteriorated concrete to be repaired with a suitable repair mortar and protective coating to prevent further deterioration of the exterior wall.

Photo 51 - North Elevation Deterioration

Photo 52 - North Elevation Deterioration 2

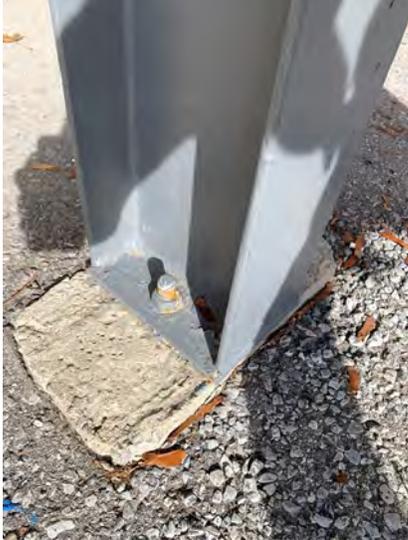
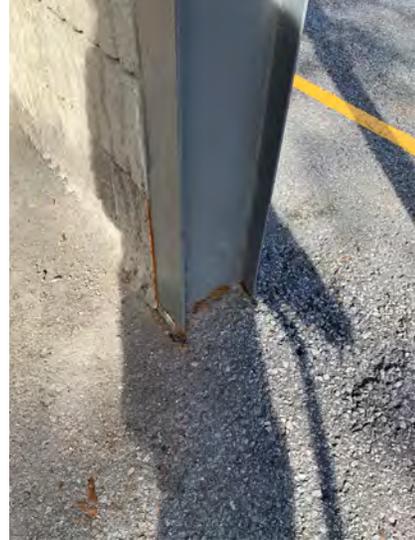
- The base of the exterior column supporting the partial second floor appeared to be experiencing localized minor corrosion (Photos 053 & 054). This is likely due to condensation and high humidity during occupancy. We recommend for the corroded areas to be wire brushed clean to bare metal and an epoxy protective coating is applied.
- Vegetation growth and efflorescence on the concrete foundation wall was observed at the base of the wall (Photos 055 & 056). We recommend this area be cleaned and a protective coating be applied.
- Minor cracking was observed on the concrete foundation wall (Photo 057). We recommend the wall be repaired with a suitable repair mortar.

Photo 53 - West Elevation Exterior Column Bolted Connection Corrosion

Photo 54 - West Elevation Exterior Column Base Corrosion

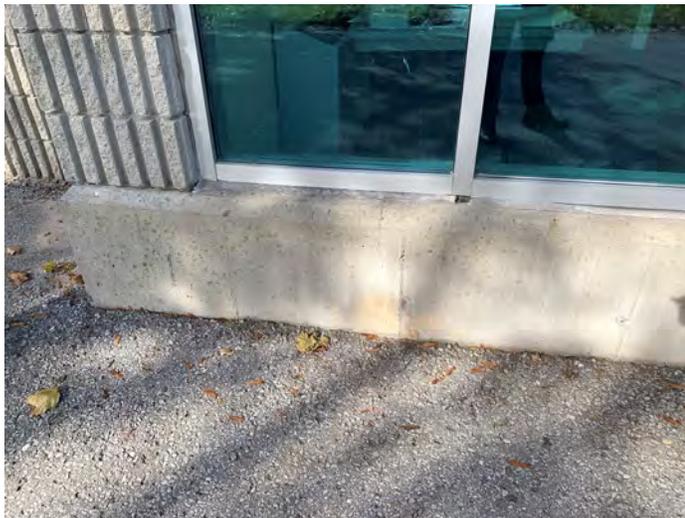
Photo 55 - West Elevation Foundation Wall Vegetation and Efflorescence

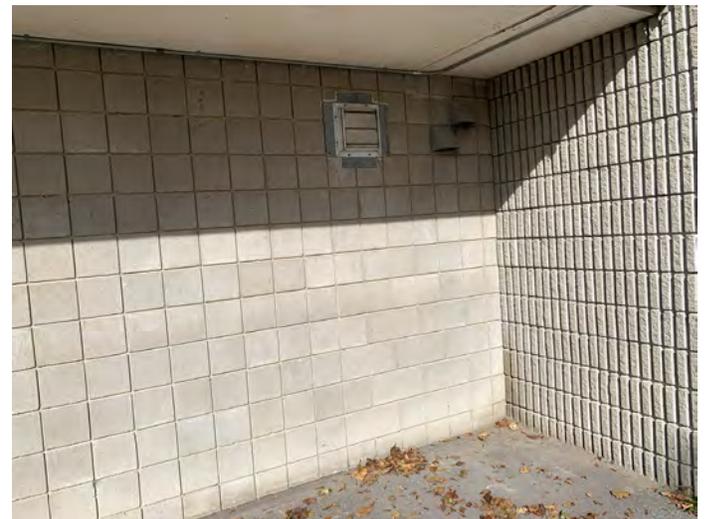
Photo 56 - West Elevation Block Wall Efflorescence

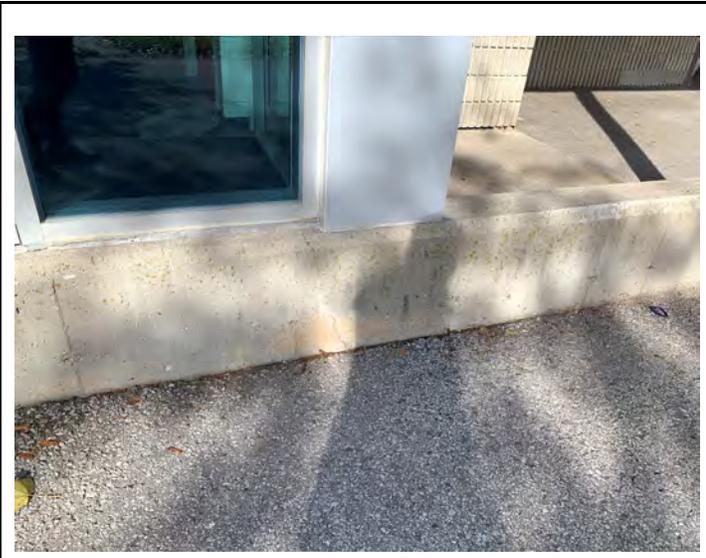
Photo 57 - West Elevation Foundation Wall Minor Cracking
