**Structural Condition Investigation, Report and Review for**  
**Rick MacLeish Memorial Community Centre**  
**91 Elliot Street, Cannington, ON**  
**The Corporation of the Township of Brock**

**BBA PROJECT NO. 22124**

**OCTOBER 13, 2022**

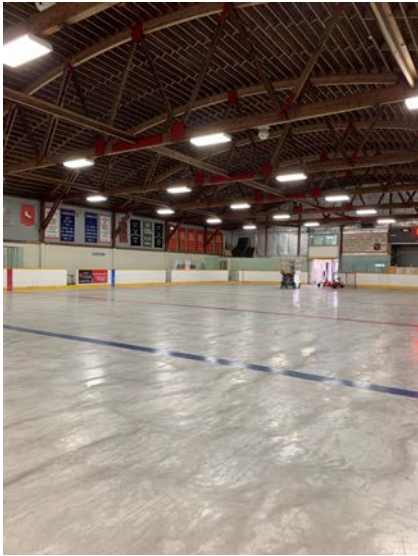
Photo 01

The existing roof framing system within the arena consists of pre-finished metal roof deck on 1" thick wood decking on 2x12 wood purlins spaced at 16" centres. These purlins are supported by timber bowstring trusses at 20'-0" centres (Photo 01). The existing roof framing system in the viewing area consists of 2x12 joists supported by 7"x30-7/8" glulam beams. The glulam beams frame into 7"x13" glulam columns (Photo 02).

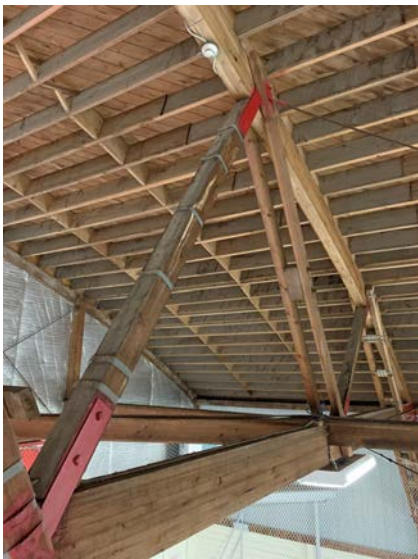
Photo 03

- We understand that previously completed banding repairs to the bowstring trusses, purlins, girts, and columns were completed at various locations (Photo 03). It appears that the repairs included the caulking and banding of truss elements with severe checking. Previously repaired elements do not appear to be further deteriorated. At some locations, banding showed signs of surface corrosion. Banding corrosion should be monitored to maintain the structural integrity of previously completed repairs.

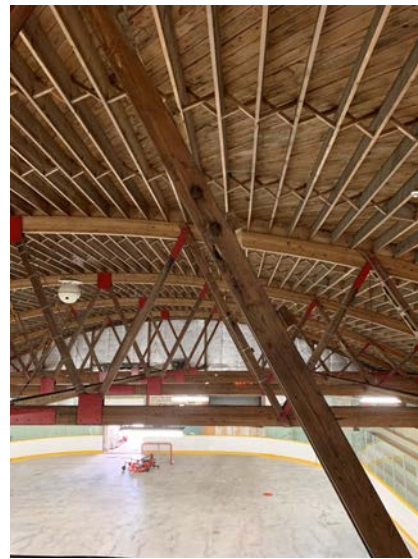
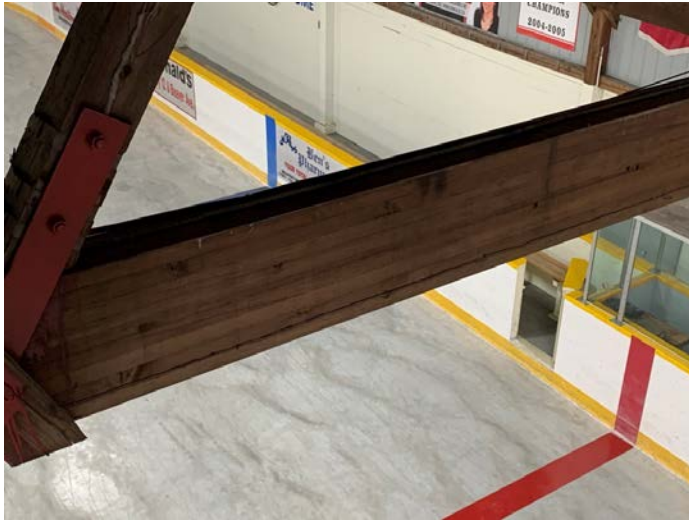
- Checking, delamination, and damage was observed at additional, unaddressed, bowstring truss elements, girts, and columns (Photo 04, 05). We recommend these areas be repaired to maintain the structural integrity of these elements.

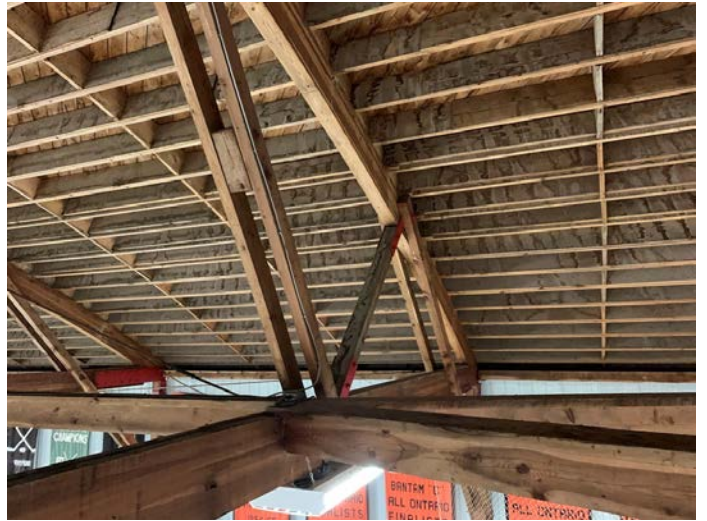
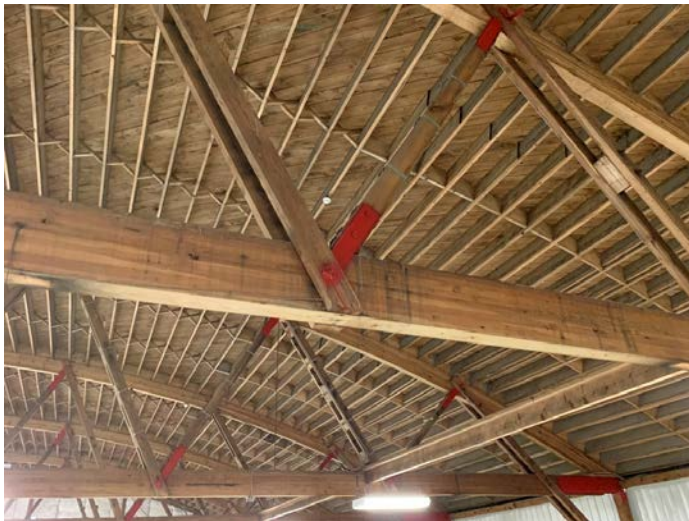
- Localized evidence of moisture was observed on the purlins, truss elements and on the underside of the wood decking (Photo 06, 07). Moisture penetration should continue to be monitored. Further investigation into the source may be required.

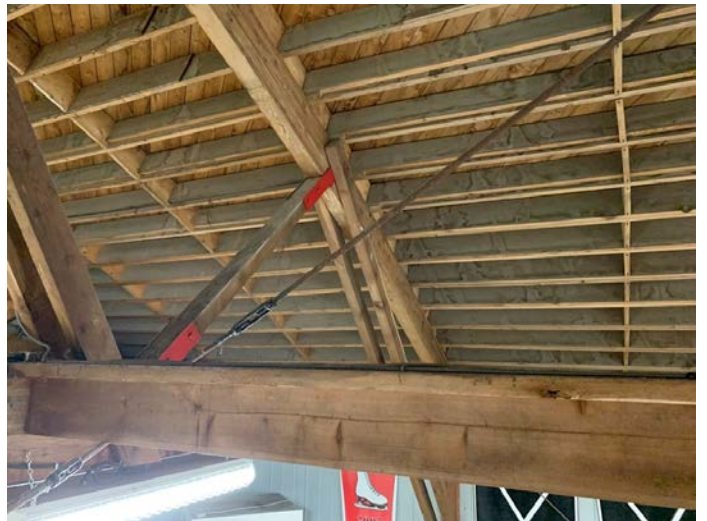
Photo 08

- Surficial corrosion was observed on most bracing rods (Photo 08). The corrosion levels appear minor at this time, however they should continue to be monitored for continued degradation.

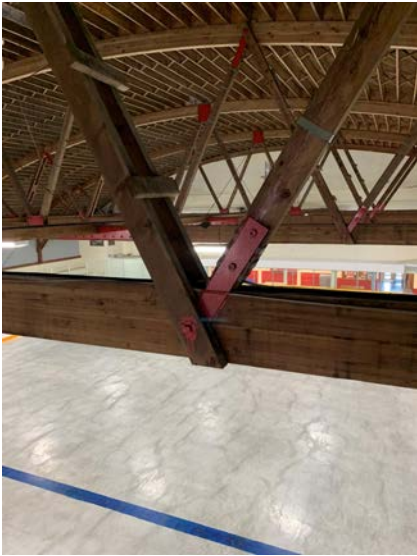
Photo 09

- Short thread extensions were observed at various truss and column connections (Photo 09), as well as at column connections. Short threads should be extended to achieve the required design capacities. Further investigation is required to determine the specific requirements and potential methods of executing this repair.

1. Complete an analysis of the figure skating support hoist system and support framing, if not previously complete.
2. Repair concrete at bleacher stairs.
3. Extend short erection bolts at roof framing connections.
4. Provide proper support of exterior stair posts.

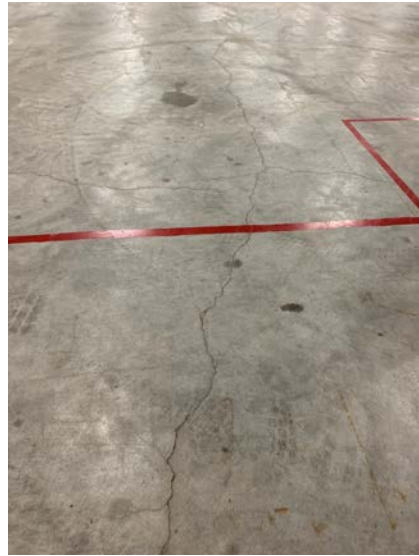
Photo 10

- Hairline surface cracks were observed throughout the rink slab. These are not a structural concern at this time however should continue to be monitored for further propagation.
- More significant cracking was observed at the south end of the rink slab (Photo 10). These cracks should be repaired to protect against continued deterioration.

1. Repair or replace concrete slab-on-grade at ice-resurfacer room.
2. Repair or replace concrete housekeeping pads.
3. Repair cracks in rink slab.
4. Rout out and repoint deteriorated/open/cracked mortar joints.
5. Repair damage to landscaping concrete retaining/stair structures.
6. Clean staining/efflorescence from concrete block walls.

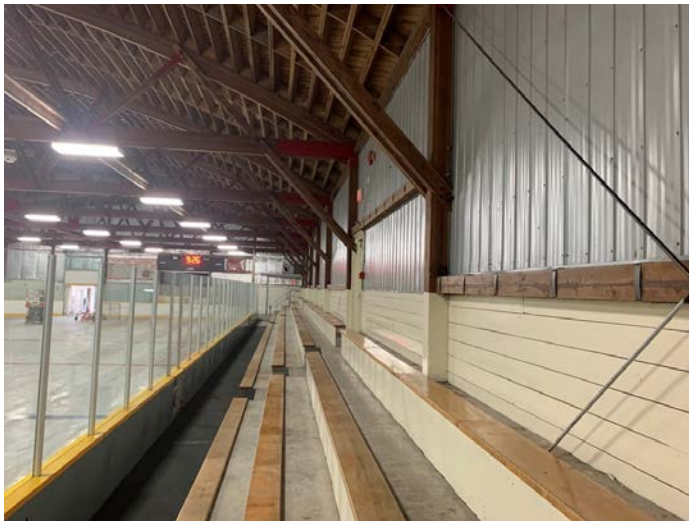
Photo 11

The existing concrete bleachers are located along the west side of the ice surface (Photo 11). Observations of the existing bleacher seating are as follows:

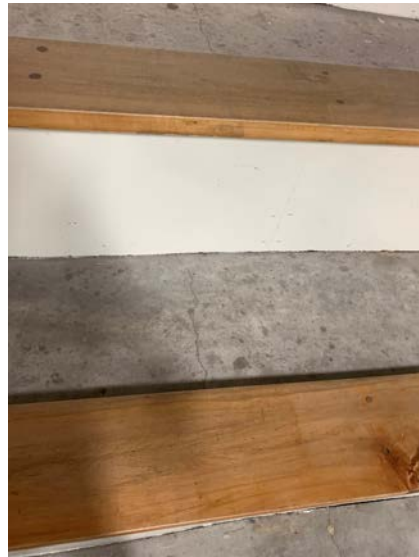
Photo 12

- Minor cracks were observed throughout the concrete bleachers, however these are not structural concerns at this time (Photo 12).
- Spalling and delaminating concrete were observed at a single location on the southernmost stair (Photo 13). This area requires to be repaired.

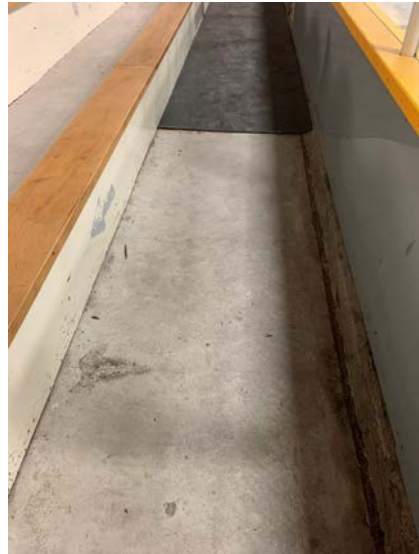
Photo 14

- Minor hairline/shrinkage cracks were observed on the surface of the apron slab (Photo 14). This surface cracking is typical of slab-on-grade and is not currently a structural concern. These should continue to be monitored for further deterioration.
- Concrete ramps around the apron slab appeared to be in good condition with no notable deterioration or damage.

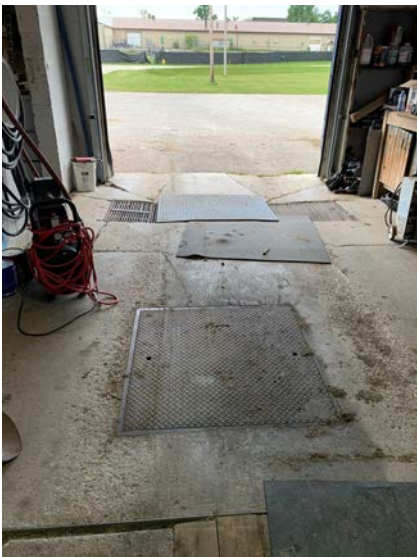
Photo 15

- Significant damage, deterioration and rutting was observed in the ice-resurfacer room (Photo 15). Localized areas of settlement may have also occurred around trench drains. Given the current condition, we recommend that the ice-resurfacer room slab be repaired or replaced.
- In the ice-making plant, the slab-on-grade appeared to be in good condition, with only minor hairline cracks observed. These cracks are not a structural concern at this time.
- Damage to the housekeeping pads within the ice-making plant was observed (Photo 16). We recommend these areas to be repaired.

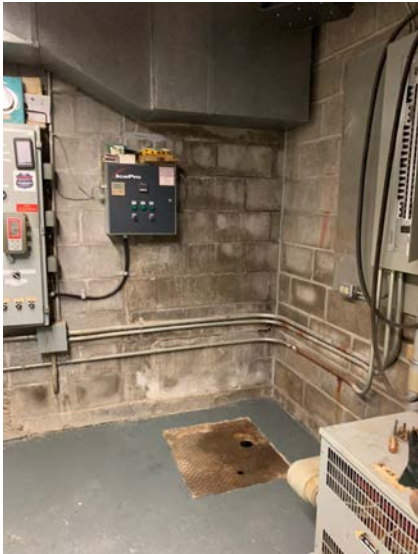
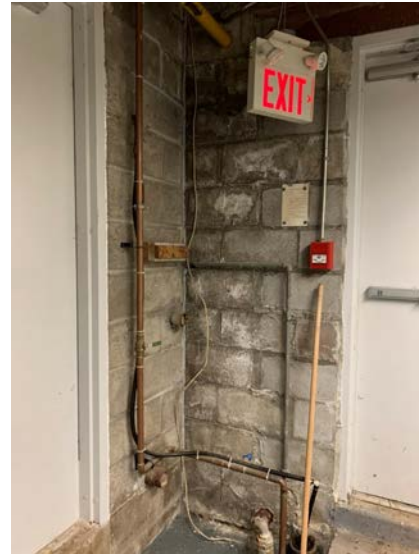
- Staining and efflorescence were observed on the interior face of the concrete block masonry walls in the ice-making plant, indicating the presence of moisture (Photo 17, 18). These areas should be cleaned and monitored for worsening conditions.
- Minor cracking, deteriorated mortar joints and other damage were observed in the ice-resurfer and mechanical rooms (Photo 19, 20, 21). These areas should be cleaned and monitored for worsening conditions.
- Deteriorated mortar joints were observed at some locations throughout the partition walls at the ground floor (Photo 22). It is recommended that these be routed and repointed with appropriate repair mortar.

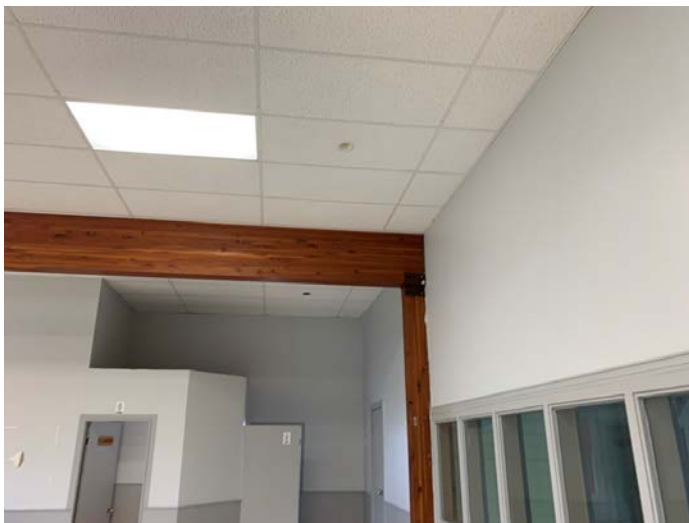
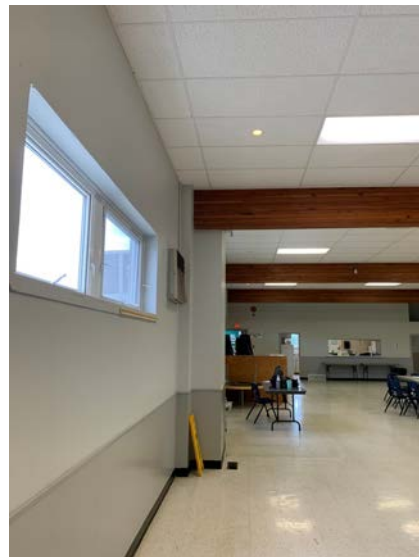
The roof framing consists of steel deck on 2x12 joists at 16" c/c, supported by 7"x30-7/8" glulam beams that bear on 7"x13" glulam columns and masonry piers (Photo 23, 24). Observations are as follows:

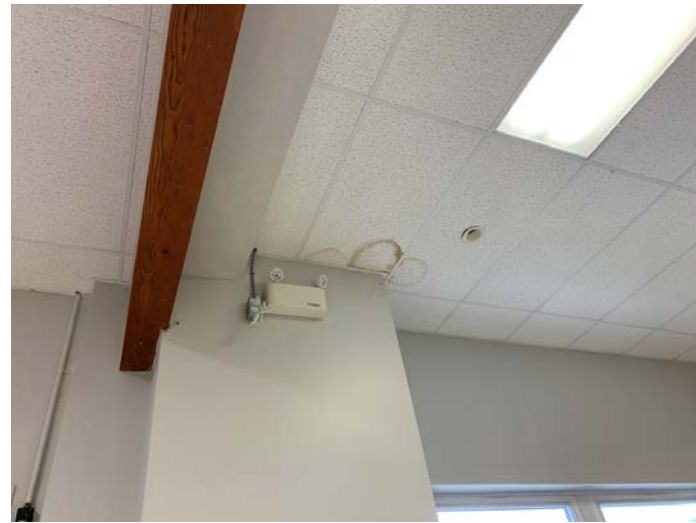
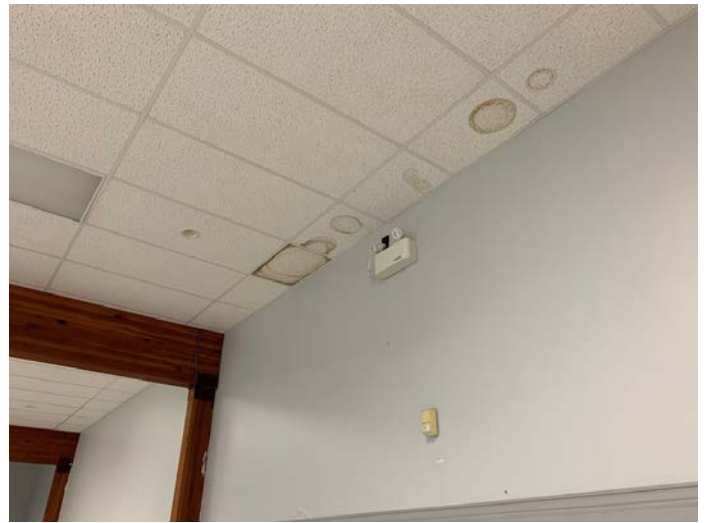
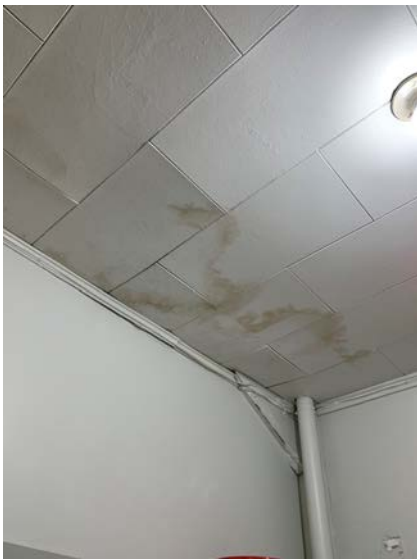
- Staining on suspended ceiling tiles indicate presence of moisture (Photo 25, 26, 27). Further investigation is required to determine the source and severity of moisture infiltration.
- Glulam beams and columns appeared to be in good condition with no notable damage or deterioration.

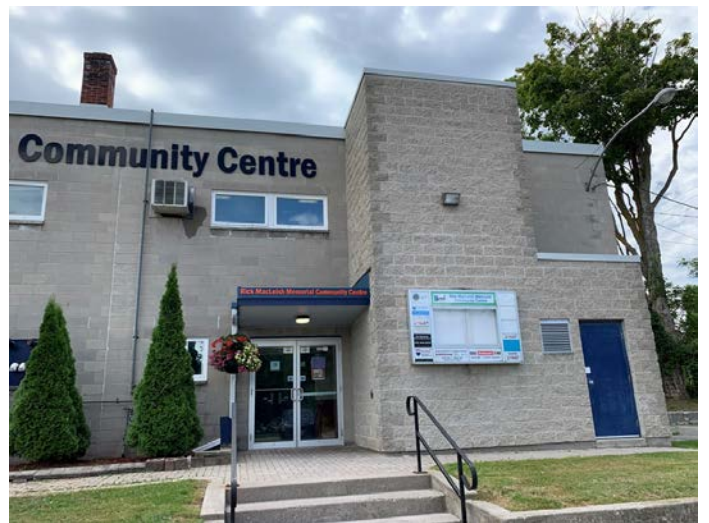
Photo 28

The north elevation generally consists of concrete block masonry (Photo 28). Located on the north elevation are two building entrances with cantilevered canopies, as well as the more recent addition of the elevator shaft. The addition consists of split-face concrete block masonry walls. The canopy framing was concealed from view during our investigation. Observations are as follows:

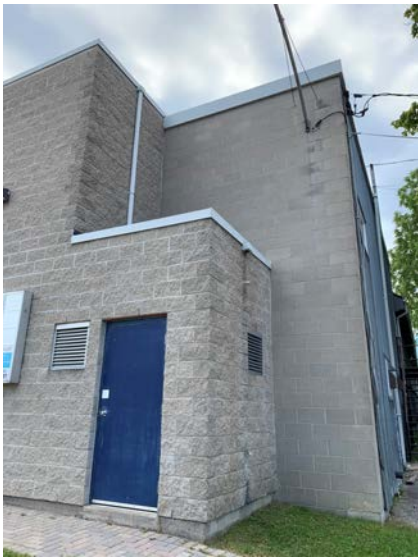
Photo 29

- Minor deterioration and staining were observed on the split-face block at the elevator room roof down spout location; it appears that the downspout has been removed (Photo 29).
- Deteriorated mortar joints, damage and staining were observed below the windows (Photo 30). It is recommended that cracked joints be routed and repointed with appropriate repair mortar.
- Significant cracking was observed in the concrete landscaping retaining walls and stairs (Photo 31). Repair is recommended as to avoid further damage and deterioration from water penetration and freeze-thaw action.

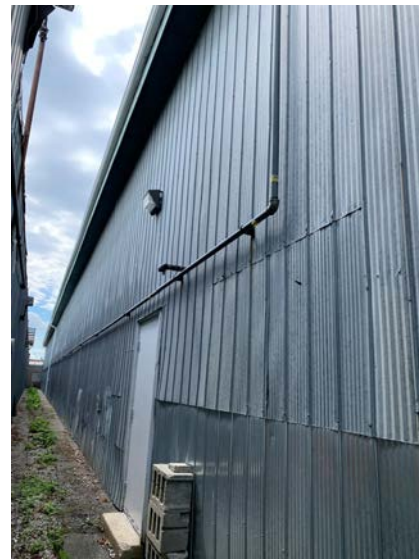
Photo 32

The exterior east elevation generally consists of full height pre-finished metal cladding (Photo 32). Observations are as follows:

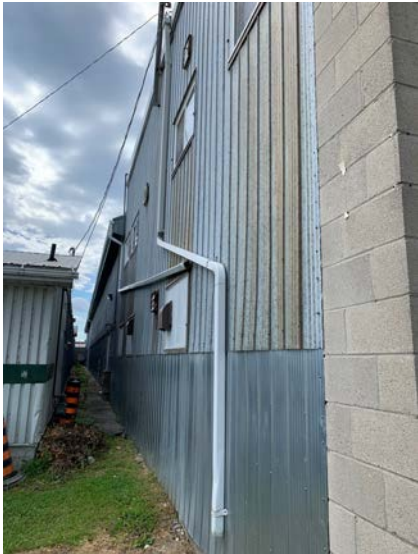
Photo 33

- Minor corrosion was observed on the metal cladding below windows (Photo 33). These areas should continue to be monitored for further degradation.
- Damaged and deformed metal cladding observed at various locations (Photo 34, 35).

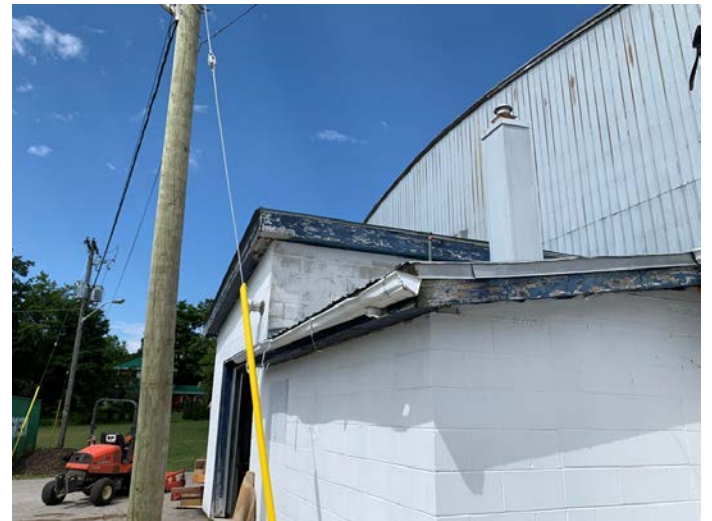
Photo 36

The south elevation generally consists of concrete masonry block walls with pre-finished metal cladding above (Photo 36). Located on the south elevation is the ice-resurfacers and ice-making plant extensions, as well as a mechanical unit support structure (Photo 37). Observations are as follows:

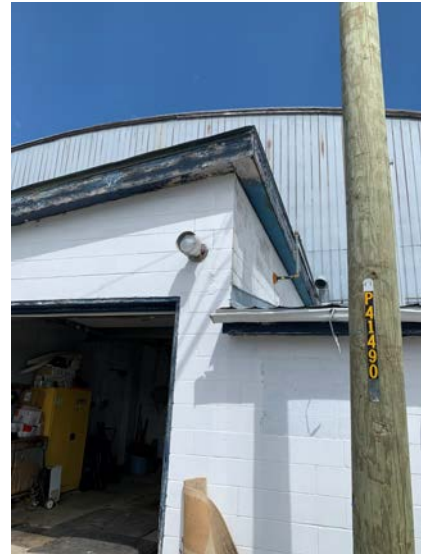
Photo 38

- Paint peeling and deterioration were observed along timber roof framing at the ice-resurfacers and mechanical rooms. Any areas of rot should be removed and replaced. Other areas should be re-painted.
- Concrete block masonry walls appear to be in fair condition (Photo 38).
- Minor surface corrosion was observed throughout original metal cladding (Photo 39). Corrosion should continue to be monitored.

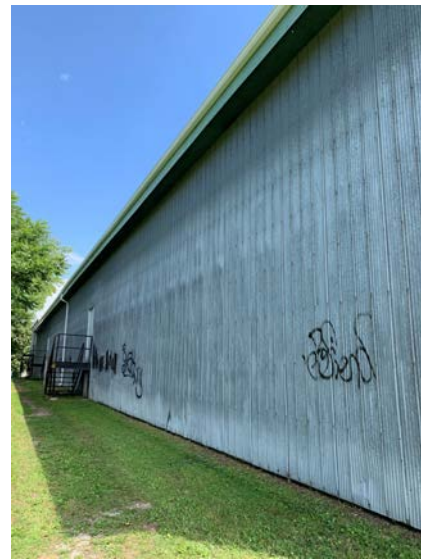
Photo 40

The exterior west elevation generally consists of full height metal cladding (Photo 40). Also located on the east elevation are two external steel stairs. Observations are as follows:

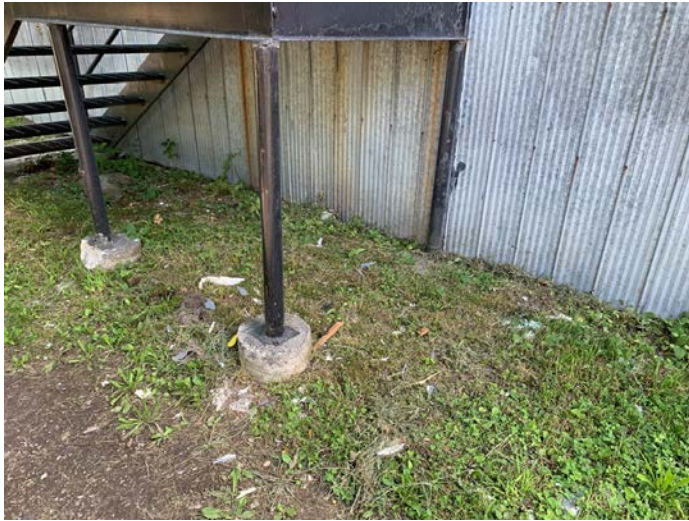
Photo 41

- Minor surface corrosion was observed throughout original metal cladding (Photo 41). Corrosion should continue to be monitored.
- Surface corrosion and paint peeling was observed on the steel stair. Corroded steel and peeling paint should be cleaned and the framing re-coated.
- The north-most steel stair column is not bearing on proper foundation and is missing anchor bolts (Photo 42). A suitable foundation should be installed below support posts. Further analysis would be required to confirm the adequacy of the stair framing for support of current dead and live loading.
