**Structural Condition Investigation, Report and Review for
Sunderland Brock Memorial Arena
20 Park Street, Sunderland, ON
The Corporation of the Township of Brock**

BBA PROJECT NO. 22124

OCTOBER 13, 2022

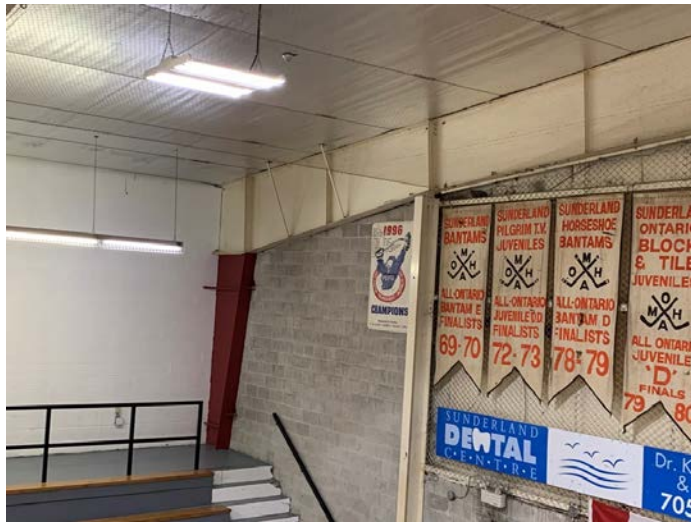
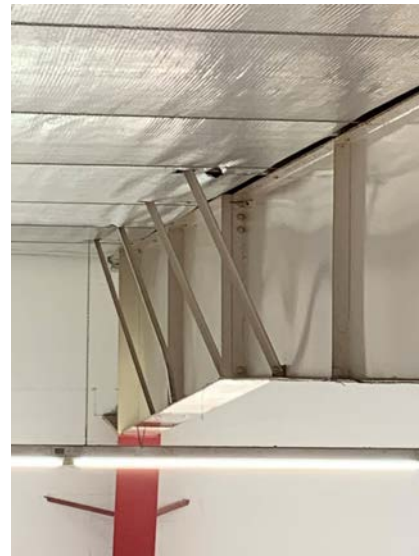
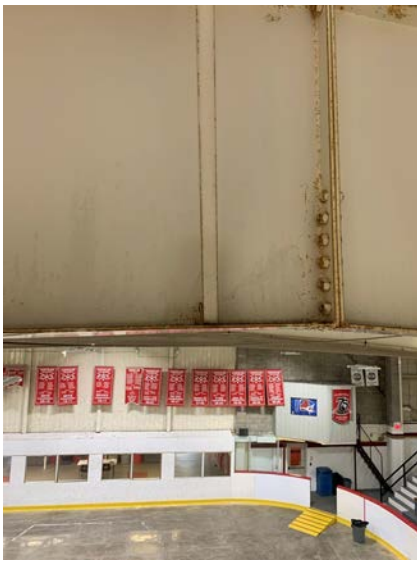
- Missing and/or damaged lateral support braces and bolts were observed at several locations throughout the pre-engineered steel frames. (Photos 004, 005, 006, 007). These must be replaced to reinstate the structural integrity of the frame.

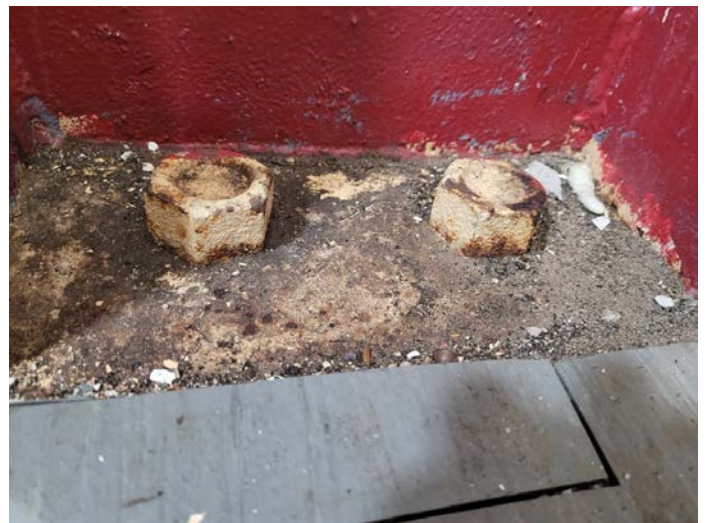
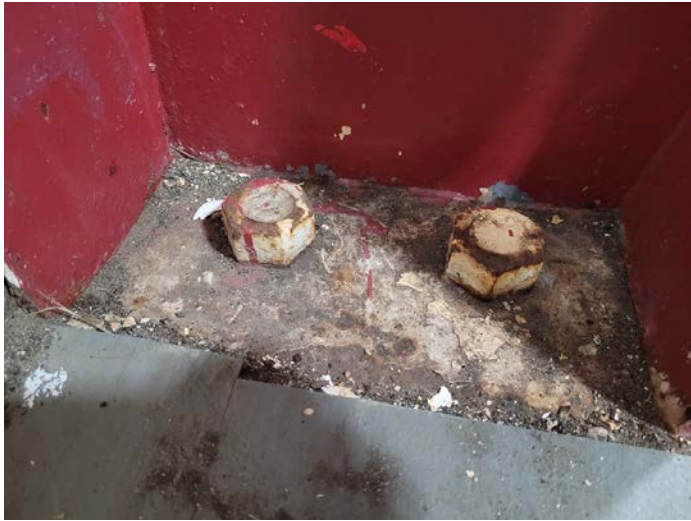
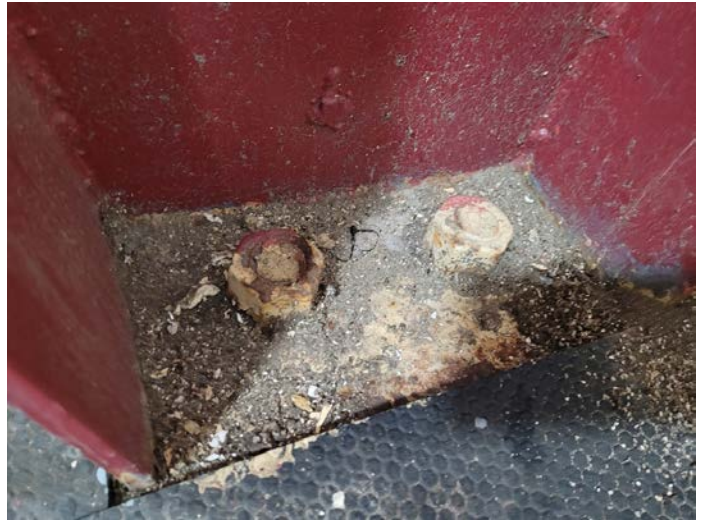
- Short thread extensions were observed on several of the column baseplate anchor bolts and should be extended (Photo 008, 009, 010). Further review is required to determine the specific requirements and options for repair.

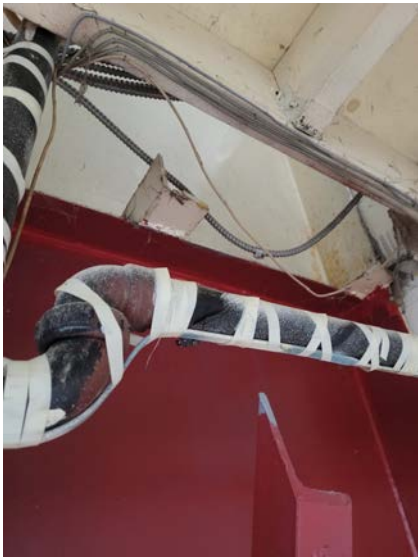
Photo 11

- Lateral support bracing has been removed to accommodate platform at the column in the northeast corner of the arena (Photo 011). Missing bracing components must be replaced to reinstate the structural integrity of the frame.

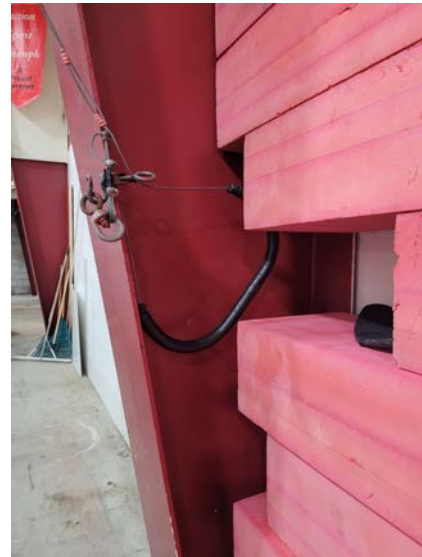
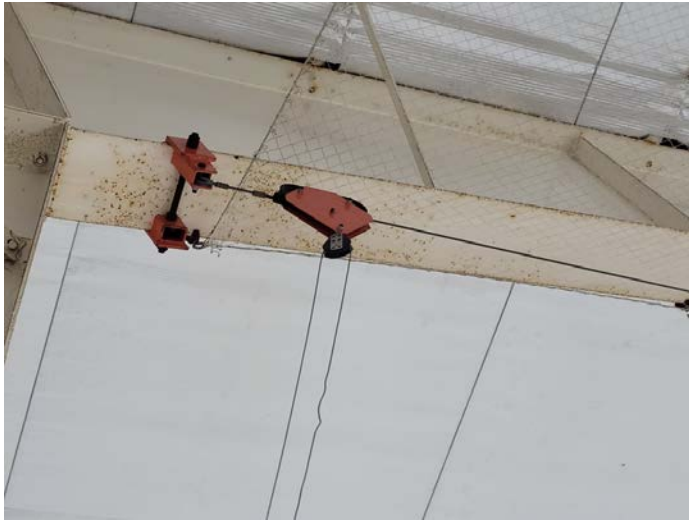
- It appears that a figure skating support hoist has been installed along one of the frames near the south end of the arena. It is unclear whether the hoist connections or supporting framing have been engineered (Photo 012, 013). Further review is required to determine whether the existing system is sufficient to support the necessary loading conditions.

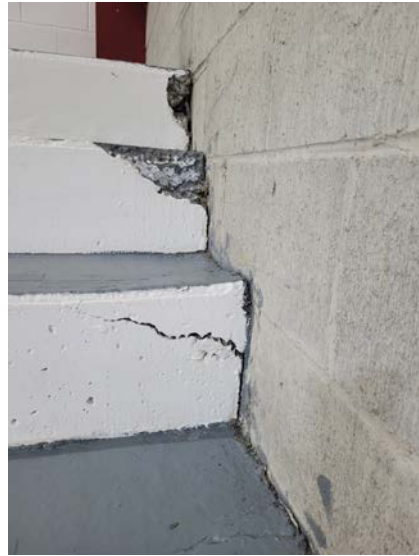
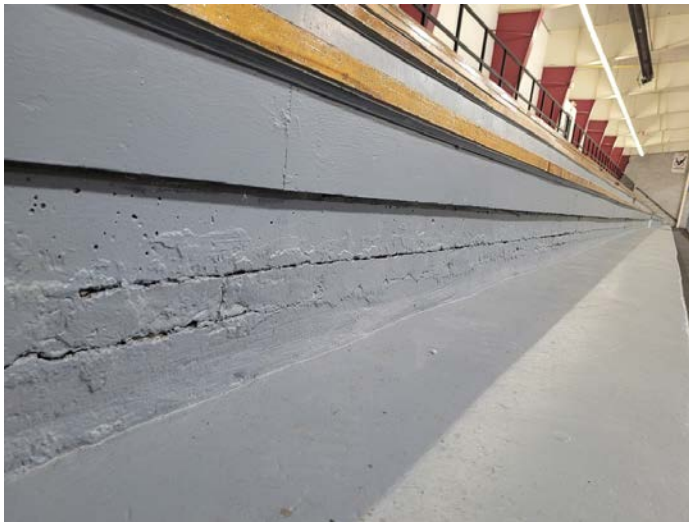
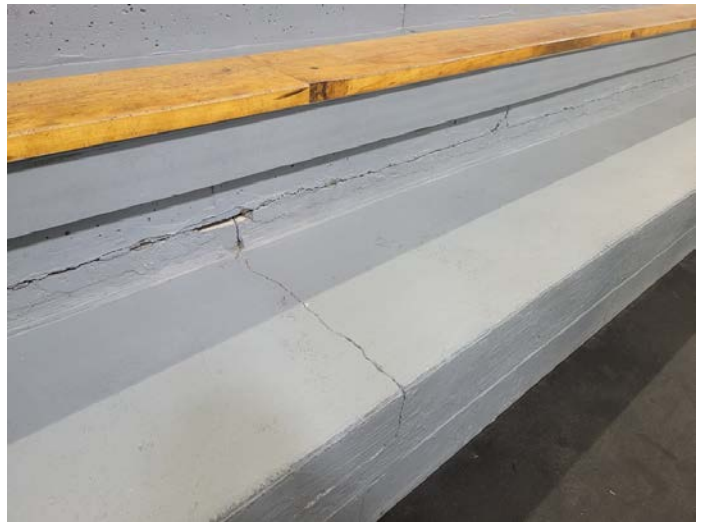
- Concrete damage was observed through the northmost stairs (Photo 017, 018). It is recommended that this damage be repaired to prohibit further structural degradation and eliminate the potential tripping hazard that currently exists.
- Minor cracking and damage was observed throughout (Photo 019, 020). These cracks are not currently a structural concern however, they should continue to be monitored for further deterioration.
- On the underside of the bleachers, minor honeycombing was observed. As the honeycombing is not significant, and no spalling or delamination was observed, no structural action is required. It is recommended that these areas continue to be monitored.

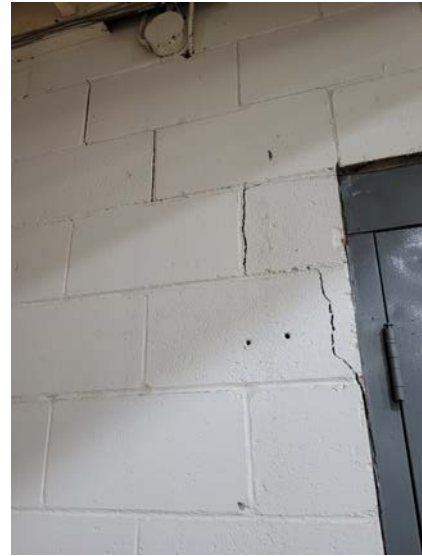
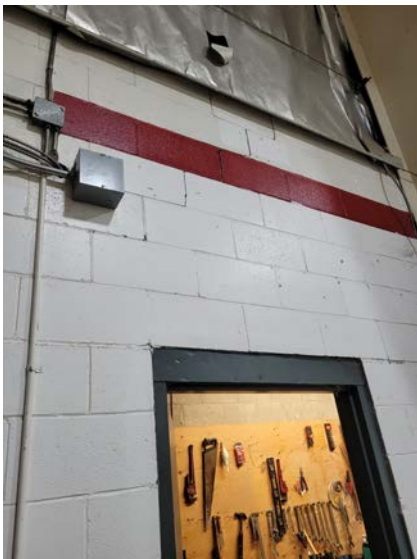
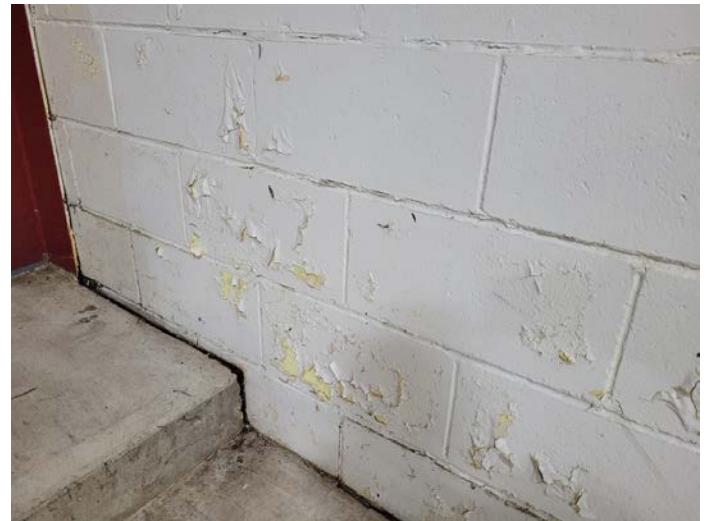
- Step cracking, peeling paint, staining, evidence of moisture and deteriorated mortar and control joints were observed along each of the perimeter concrete block walls, including at the ice-resurfacers room (Photo 021, 022, 023, 024). In many areas the block wall is unprotected from the elements and is uninsulated.

Continued exposure to the elements and freeze-thaw cycles will lead to more significant structural deterioration in time. Deteriorated mortar joints should be routed and repointed while areas of minor staining, peeling paint, etc. should continue to be monitored for further deterioration. Consideration should be given to painting/sealing the exterior block to add further protection should installation of a proper rainscreen not be viable.

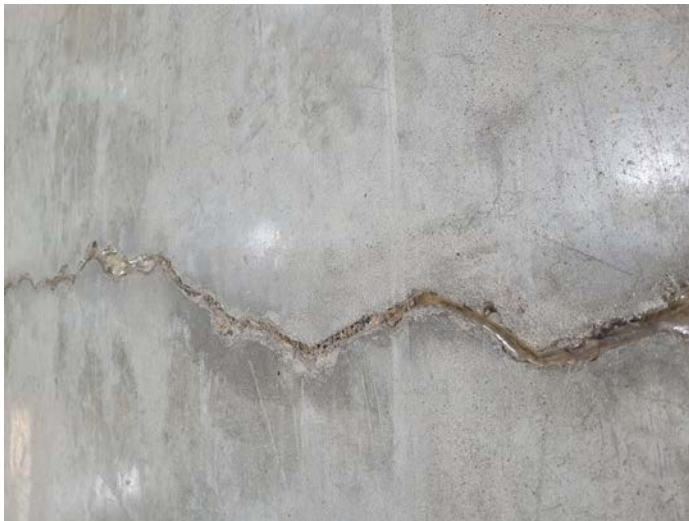
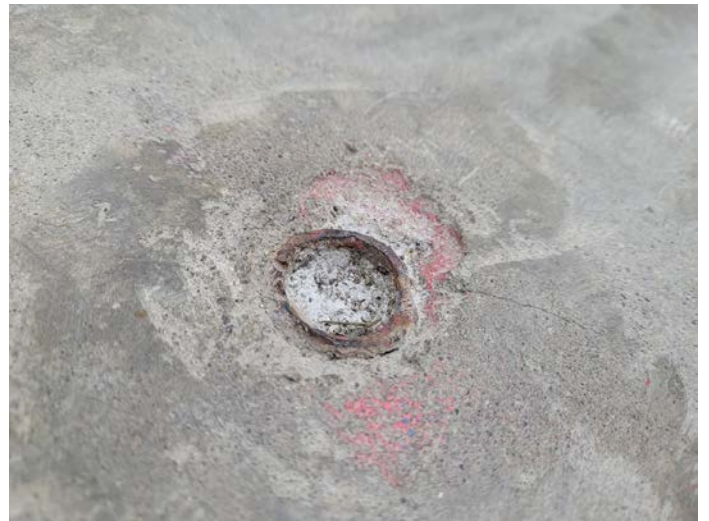
- Cracks were observed throughout the rink slab (Photo 026). These should be repaired to prevent further degradation.
- Previous repairs have been completed to other more substantial areas of cracking (Photo 027). Some areas of repair appear to have performed while others appear to have worsened. Worsening slab conditions may indicate a larger issue at hand. Further investigation and review should be completed to determine a reasonable timeframe for replacement.
- Various areas of damage around concrete inserts were observed (Photo 028). These areas should be repaired.

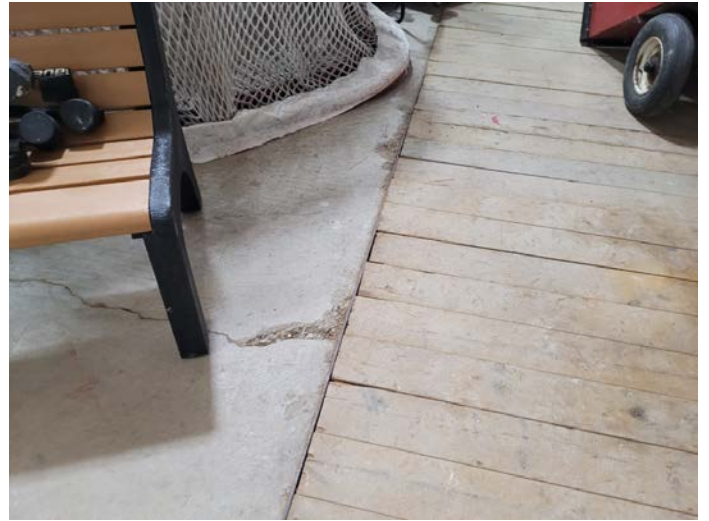
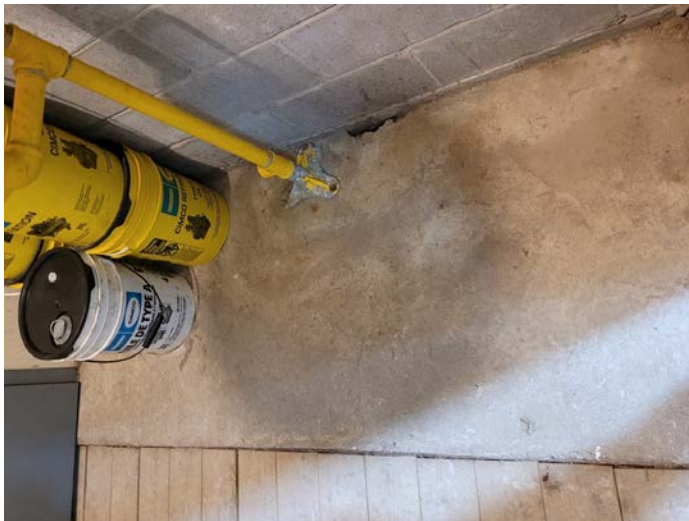
- Cracks were observed throughout the apron slab (Photo 029). While not a structural concern at this time, we recommend that these areas continue to be monitored and eventually repaired.
- Minor surface wear and damage were observed at some locations (Photo 030, 031). These areas should continue to be monitored for further deterioration.

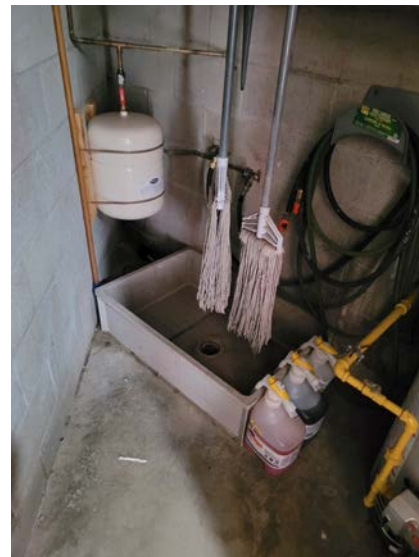
Photo 32

- Minor to moderate staining and damage were observed at the slab on grade and housekeeping pads within the mechanical pump room and janitor's closet (Photo 032).
- Minor cracking was observed throughout the basement slab on grade.

Generally, the exposed concrete slab-on-grade areas appeared to be in fair condition. Areas of cracking, staining or damage should continue to be monitored for worsening conditions and repaired if necessary.

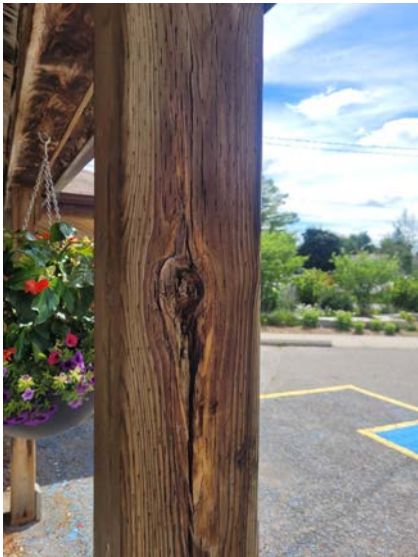
- Significant checking was observed in most timber columns (Photo 034, 035). Further investigation is required to determine the severity of the checking and to confirm whether there has been any reduction in column capacity.

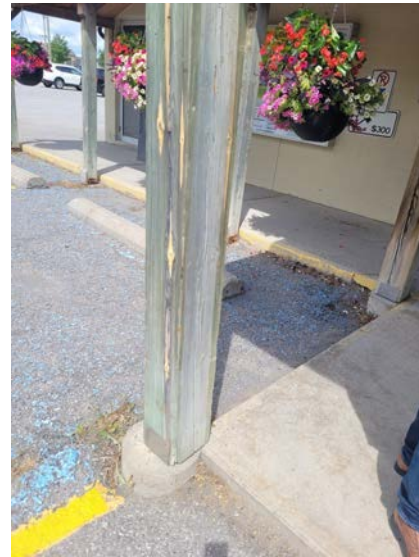
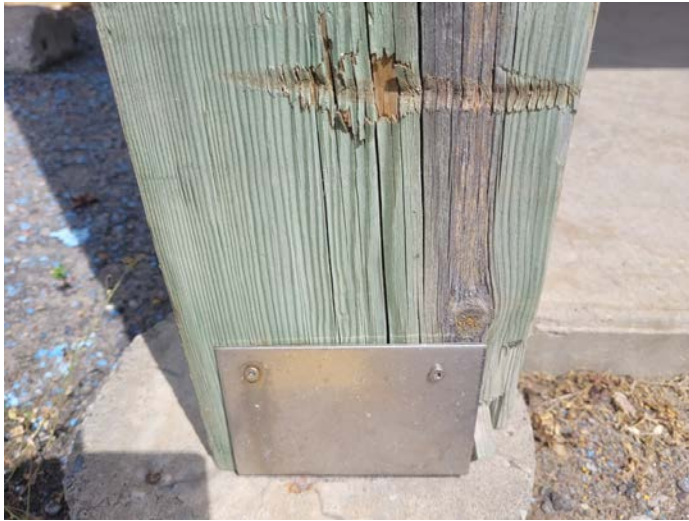
- It appears that one (1) wood column has been impacted, likely from a vehicle, is damaged/skewed and has shifted off the supporting foundation (Photo 036, 037). This column and associated connections must be replaced or repaired to replaced.

1. Complete repairs to wood canopy at south entrance including replacement of any damaged wood columns, reinstating shifted/damaged connections, confirming extent of column checking and potentially installing bollards to protect against further impact.
2. Complete repairs to exterior exit stairs and associated foundations on the east and west sides of the arena.
3. Reinststate damaged or missing lateral support braces at the pre-engineered frames.
4. Replace missing bolts on pre-engineered frames.
5. Extend short anchor bolt threads at bases of pre-engineered columns.
6. Complete an analysis of figure skating support hoist system and supporting framing.
7. Repair concrete stairs at bleachers.

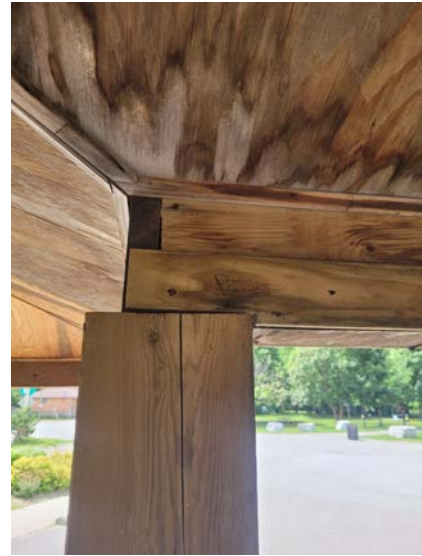
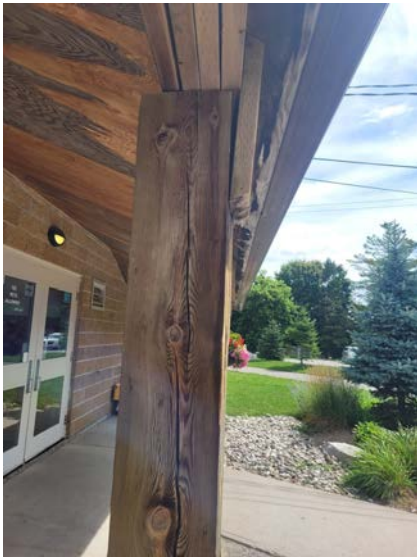
- Various columns appear to have shifted and are no longer centered along the main canopy support beam (Photo 038, 039). Repairs to this area are required to ensure proper connection between the beam and columns.

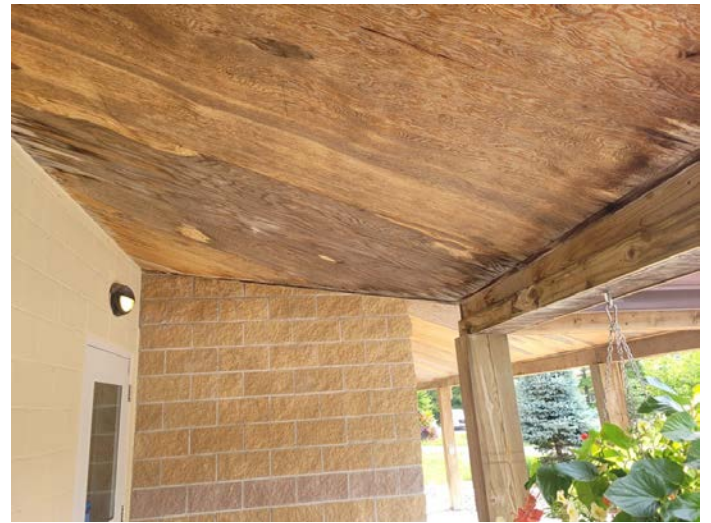
Photo 40

- Evidence of moisture and staining was observed at the underside of the plywood liner below the canopy framing (Photo 040). Further intrusive investigation is required to confirm the condition of the canopy framing system and whether moisture has adversely affected the structural system.

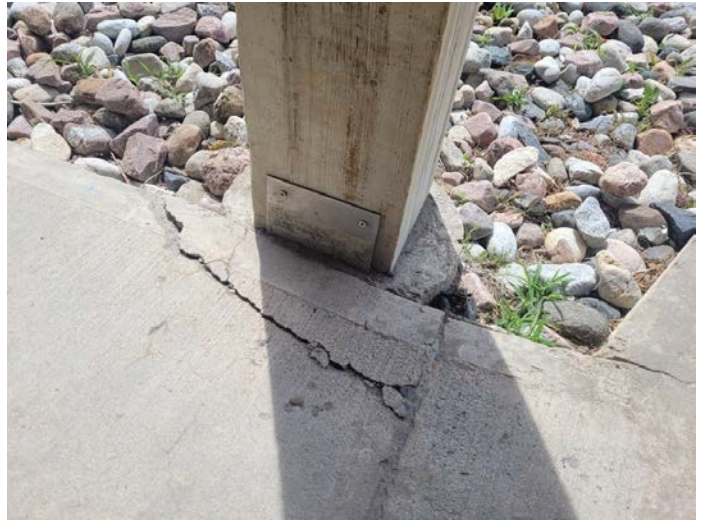
- Concrete spalling was observed at various locations on the exterior concrete sidewalk (Photo 041, 042). While not a structural concern, loose concrete and void in the slab should be removed and repaired to prevent further degradation and to eliminate potential tripping hazards.

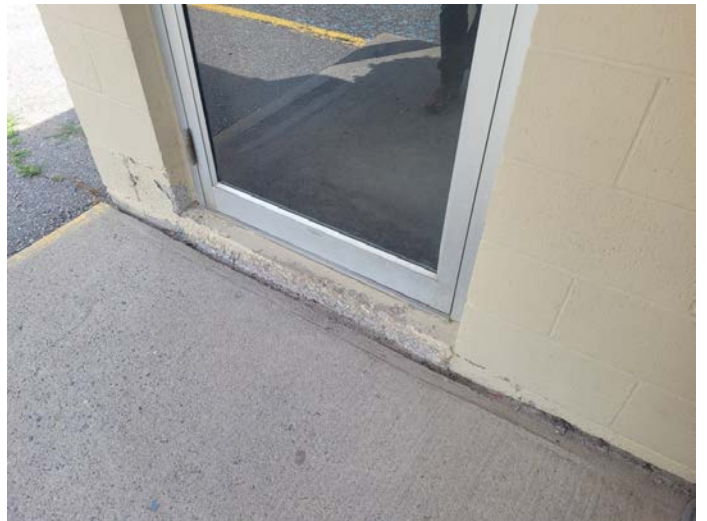
- Various damage was observed at the entryway thresholds (Photo 043, 044). These areas should continue to be monitored for further deterioration.
- Deteriorated mortar joints were observed at some locations along the south elevation. These should be routed and repointed.

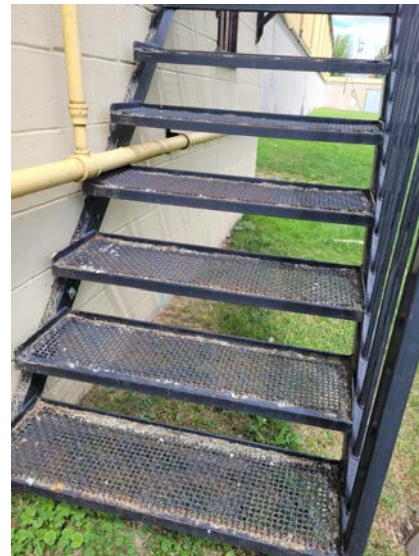
Photo 46

- Minor surface corrosion and paint peeling was observed on the steel stair (Photo 046). This condition should be monitored, and the stair eventually repainted to protect against more significant corrosion.
- The existing stair acts as an exit from the second floor community room however does not appear to be structurally stable to support the required loading currently prescribed by the Ontario Building Code. While this is an existing condition and may not require upgrade by code, we recommend that this stair be further reviewed for potential upgrades to landing grating and support connections.

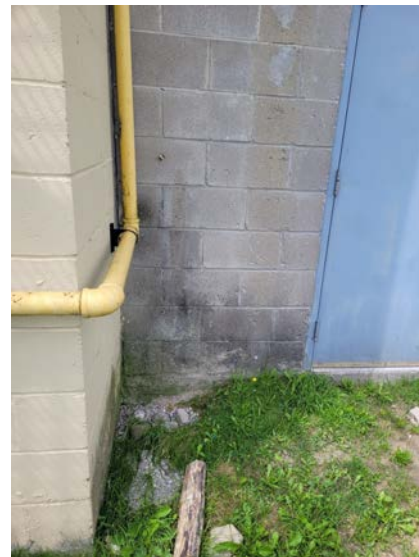
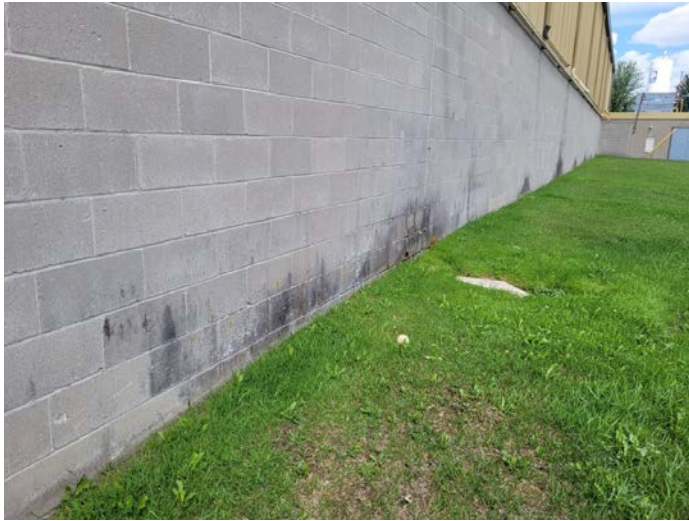
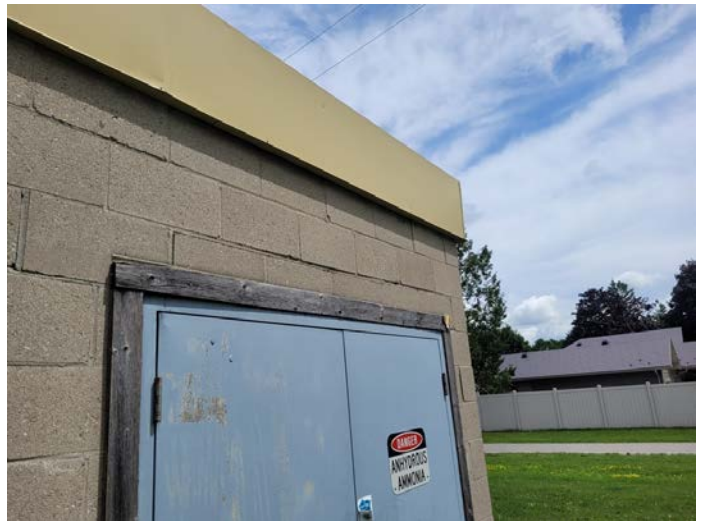
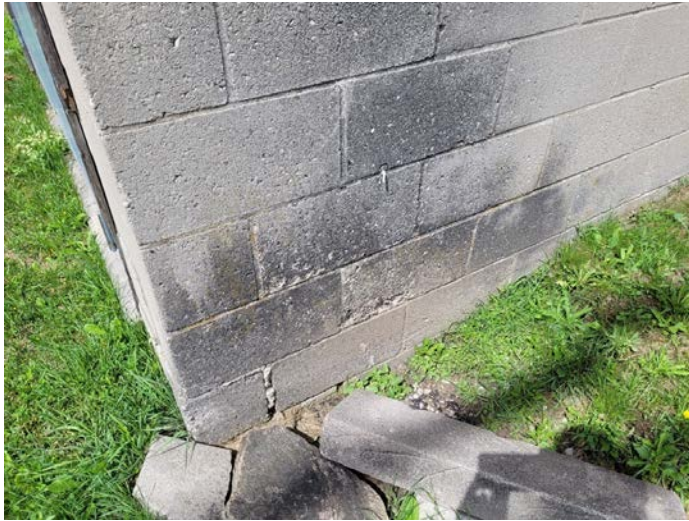
- Various areas of damage were observed at the base of the concrete masonry block wall throughout the wall, particularly at downspout discharge locations (Photos 047, 048, 049). Block wall damage and staining should be repaired and consideration given to modifying the downspouts to direct water away from the building structure.
- Caulking at expansion joints was cracked, damaged, or missing in several locations (Photo 050). It is recommended that the caulking be replaced to avoid further damage from water penetration and freeze-thaw action.
- Deteriorated mortar joints were observed at some location along the east elevation, including at the arena plant (Photo 051, 052, 053). It is recommended that cracked joints be routed and repointed with appropriate repair mortar.

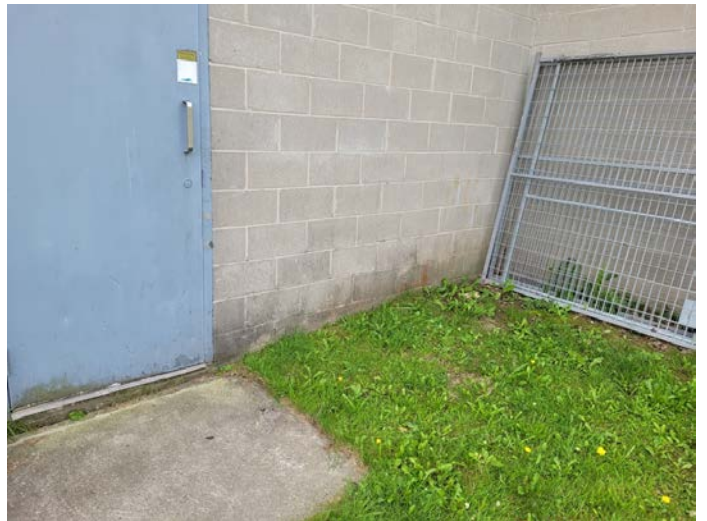
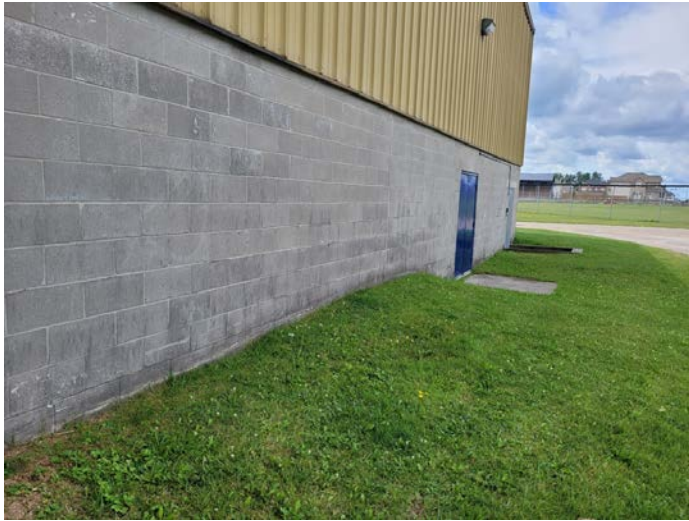
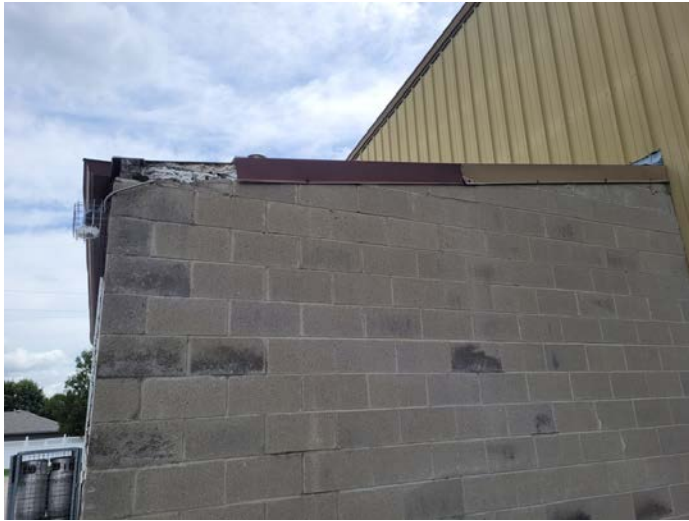
- Surficial corrosion was observed on the mechanical unit support structure (Photo 055). This structure should continue to be monitored.
- Minor deterioration and staining were observed at various locations along the base of the concrete masonry block wall on the north elevation (Photo 056, 057). Recommendations regarding exterior concrete block walls are discussed previously.
- Deteriorated mortar joints were observed at some locations along the block wall (Photos 058, 059, 060). It is recommended that cracked joints be routed and repointed with appropriate repair mortar.
- Damage to the metal roof flashing was observed at the northwest corner of the ice-resurfacers room (Photo 061). This damage should be repaired to protect against further moisture infiltration.

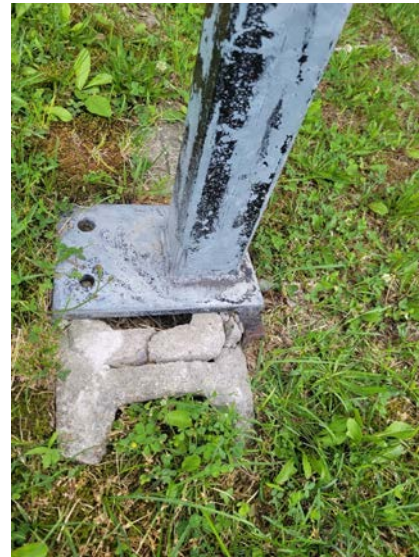
Photo 68

- The posts for the steel stair are not properly connected to the supporting concrete block structure (Photo 068). Further, the concrete block is not an acceptable foundation. New base connections and foundation structures are required for support of this stair.
- The existing stair acts as an exit from the second floor however does not appear to be structurally stable to support the required loading currently prescribed by the Ontario Building Code. While this is an existing condition and may not require upgrade by code, we recommend that this stair be further reviewed for potential upgrades to landing grating and support connections.

The west elevation generally appeared to be in fair condition. However, the existing second floor exit stair requires to be upgraded or replaced.
