BEAVERTON TOWN HALL BUILDING CONDITION ASSESSMENT REPORT

TOWNSHIP OF BROCK

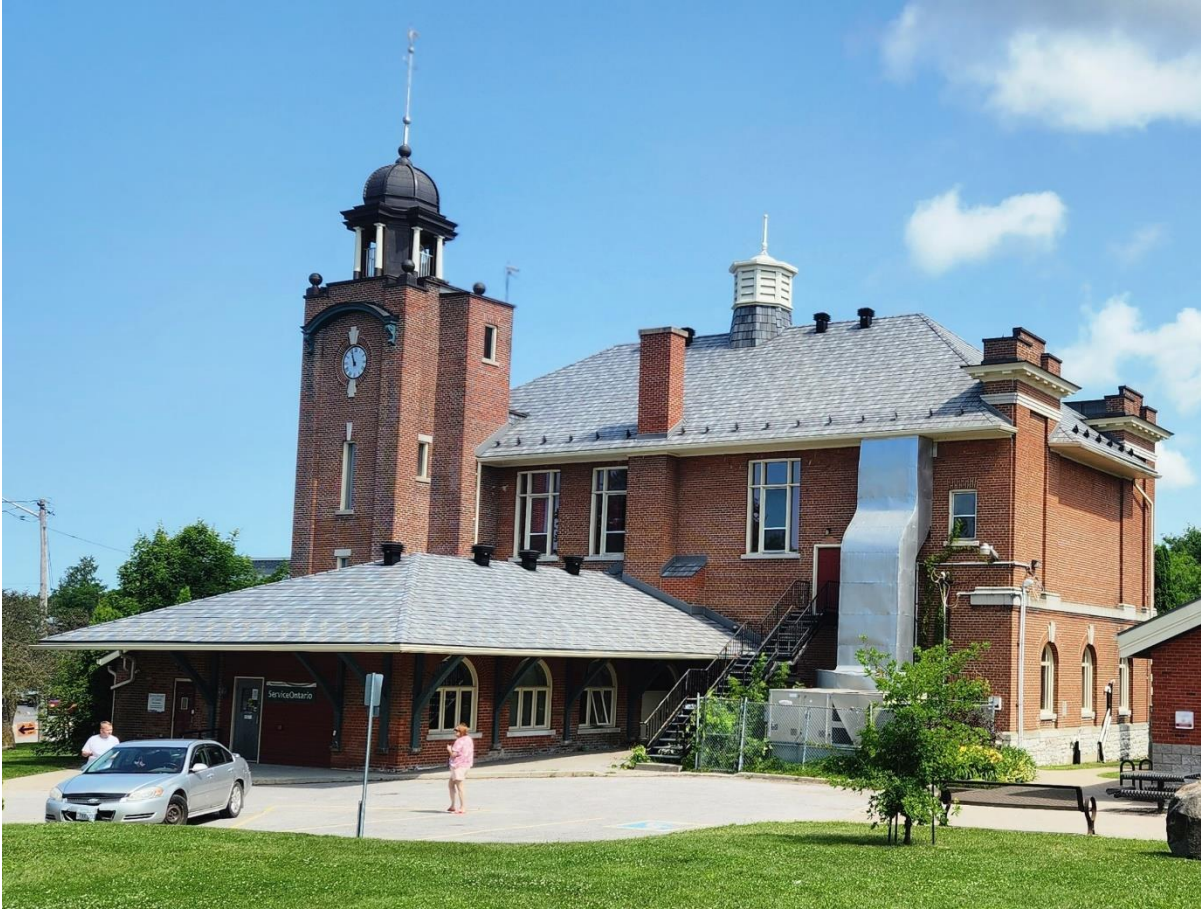
LARKIN ARCHITECT LIMITED

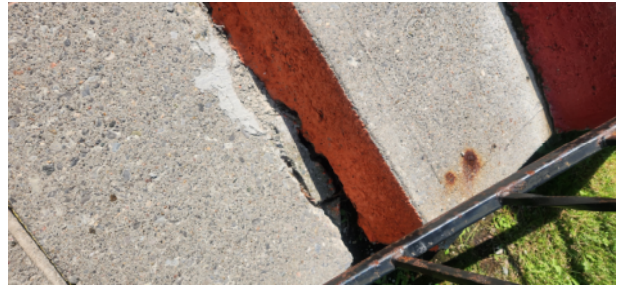
FIG. Div.2. 2 – Deterioration at Front Steps

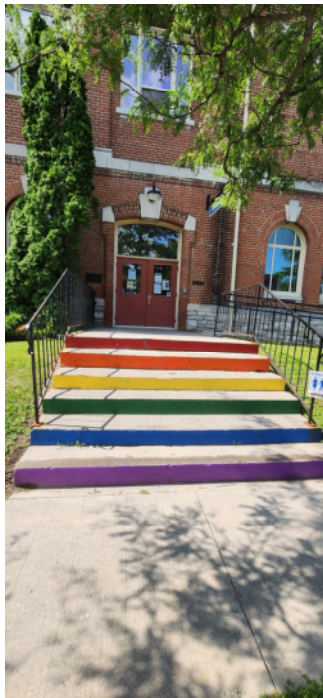
FIG. Div.2. 3 – Northeast Entrance

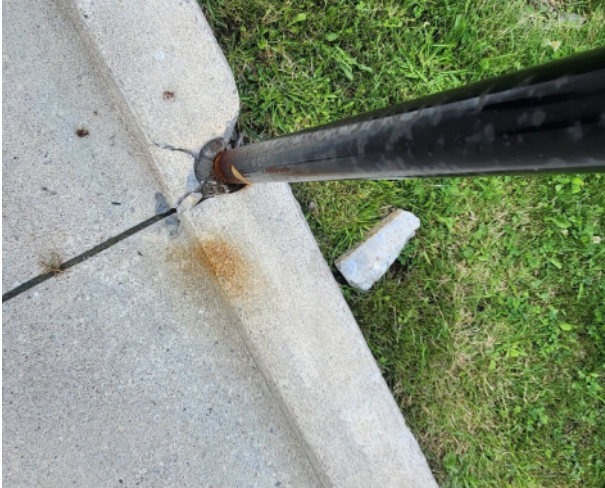
FIG. Div.2. 5 – Rusting Handrail Post Spalling Concrete Curb

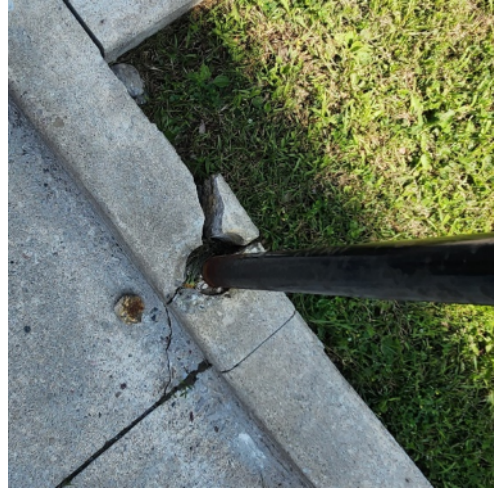
FIG. Div.2. 6 – Rusting Handrail Post Spalling Concrete Curb

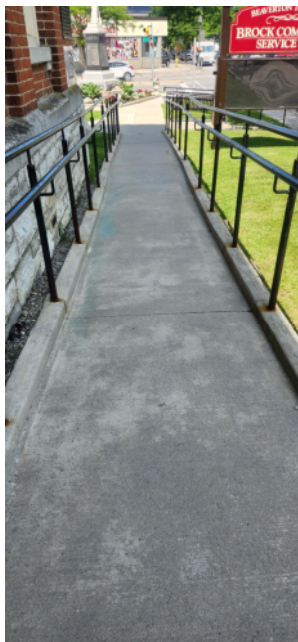
FIG. Div.2. 7 – Barrier-free Ramp

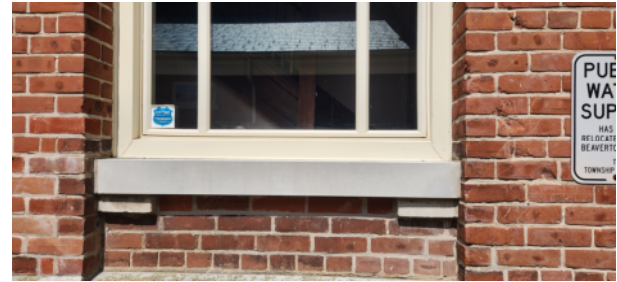
FIG. Div.3. 2 – Precast Concrete Sill Replacement

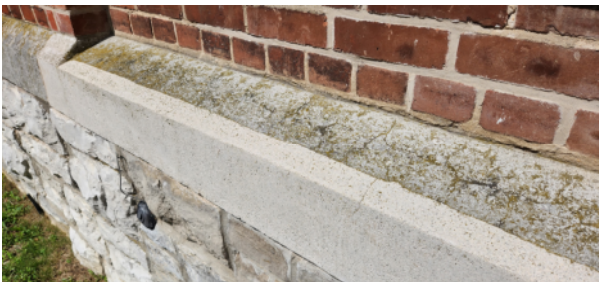
FIG. Div.3. 3 – Repaired Stone Sill

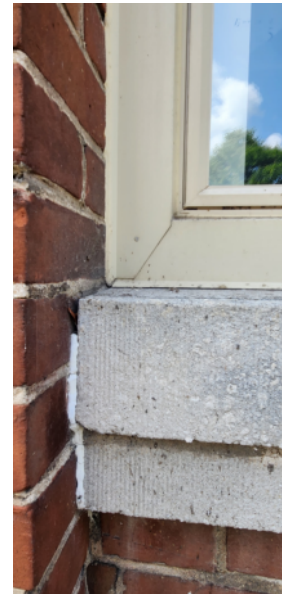
FIG. Div.3. 4 – Deteriorated Caulking Joint at Sill

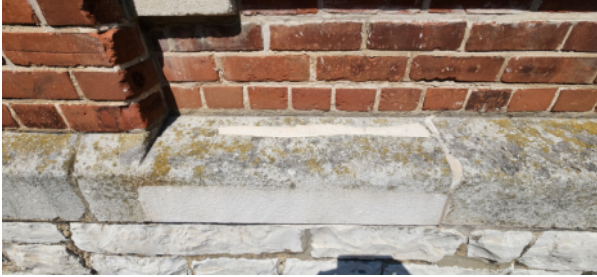
FIG. Div.3. 5 – Stone Sill Repairs

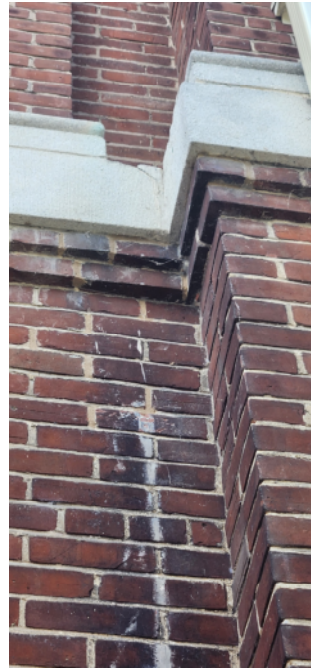
FIG. Div.3. 6 – Crack in Roman Stone Banding

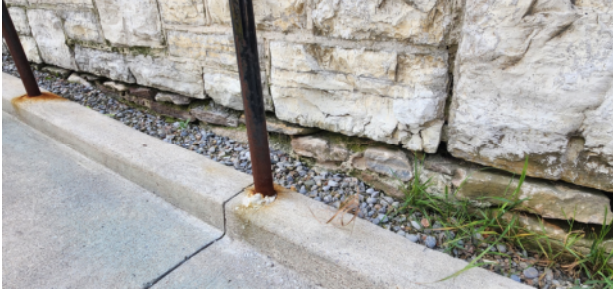
FIG. Div.4. 1 – Loss of Mortar Adjacent to Ramp

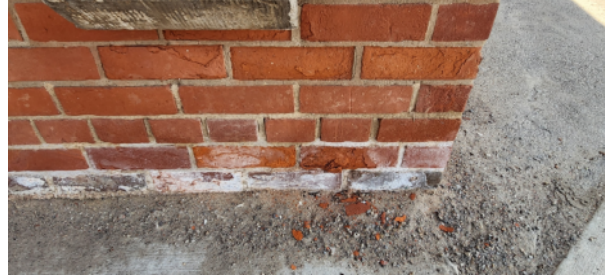
FIG. Div.4. 2 – Masonry Deterioration due to De-icing Salts

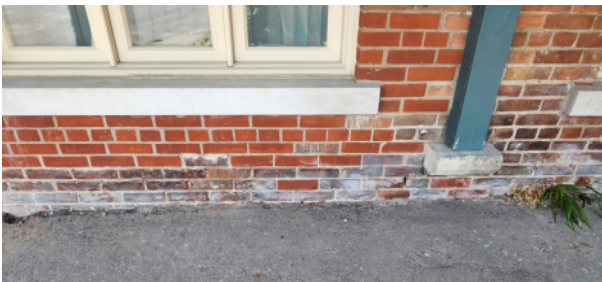
FIG. Div.4. 3 – New Precast Concrete Window Sill and Deteriorated Masonry Below

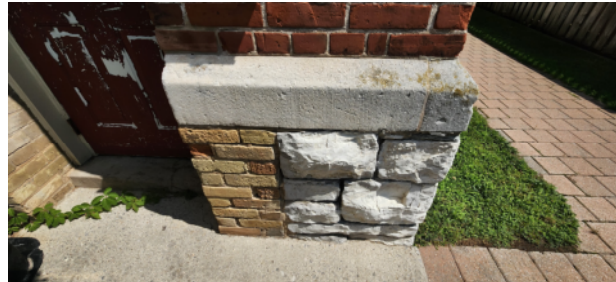
FIG. Div.4. 4 – Deteriorated Masonry Mortar Joints

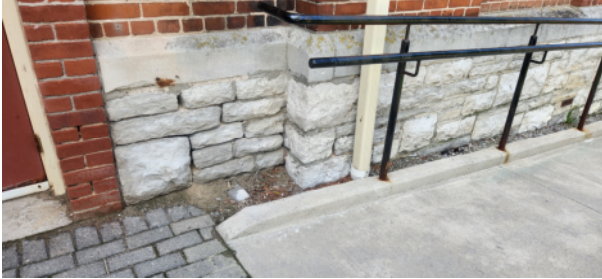
FIG. Div.4. 5 – Loss of Mortar at Front Entrance

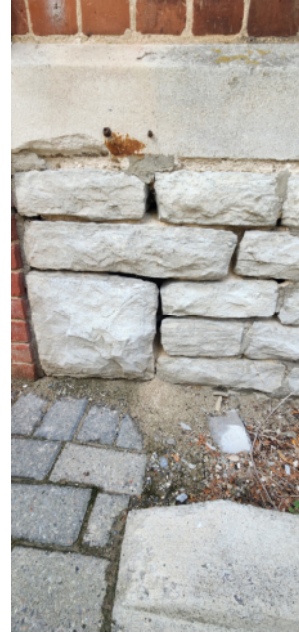
FIG. Div.4. 6 – Deteriorated Mortar Joints

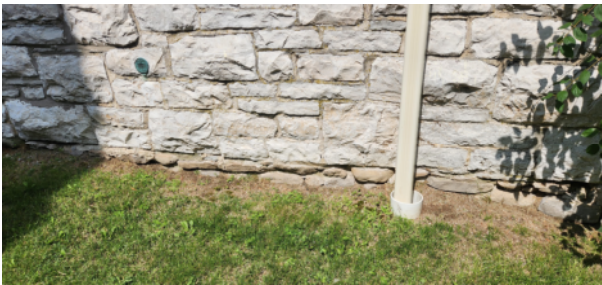
FIG. Div.4. 7 – Deteriorated Mortar Joints at Grade

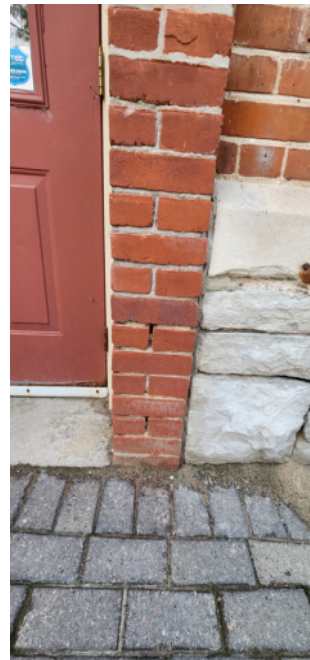
FIG. Div.4. 8 – Deteriorated Mortar Joints

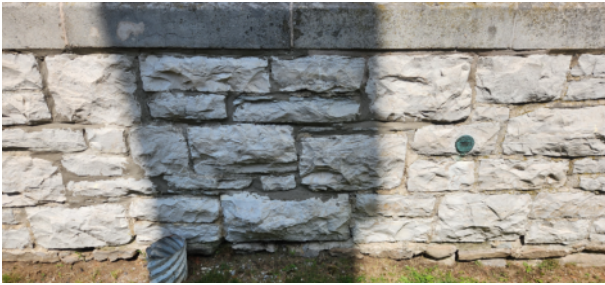
FIG. Div.4. 9 – Non-compatible Mortar Repairs

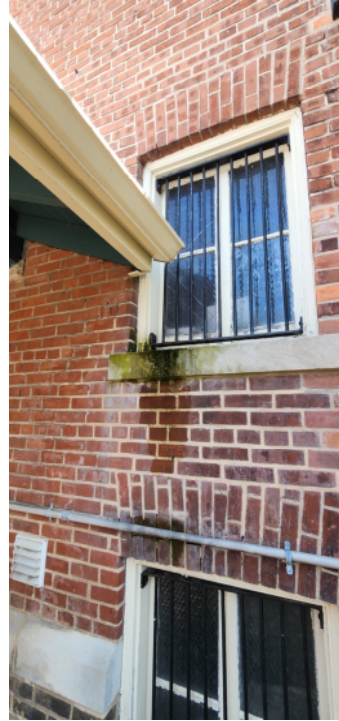
FIG. Div.4. 10 – Water Damage at Eave trough Overflow

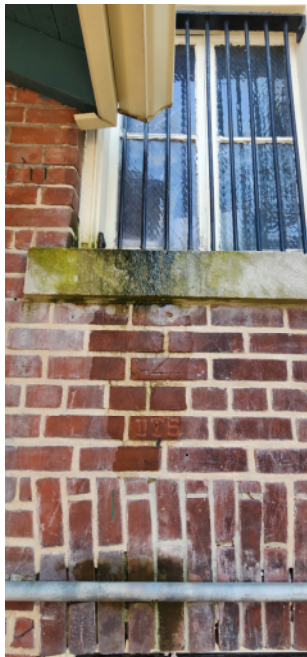
FIG. Div.4. 11 – Spill from Eave trough causing damage to masonry

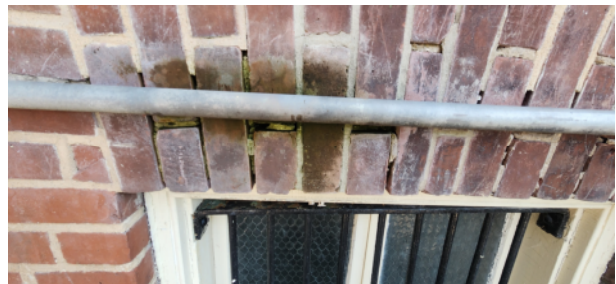
FIG. Div.4. 12 – Deteriorating Mortar Joints at Window Arch

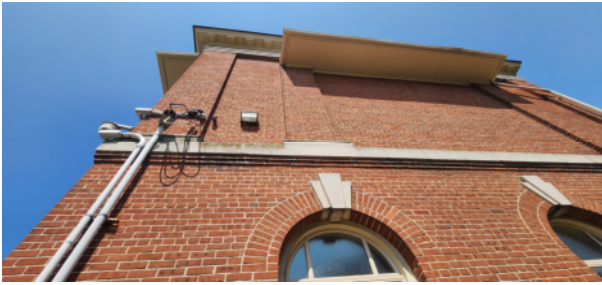
FIG. Div.4. 13 – General View of Tower Masonry

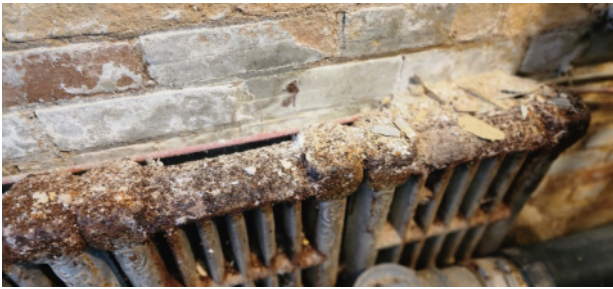
FIG. Div.4. 19 – Masonry Deterioration in Basement Due to Moisture Infiltration

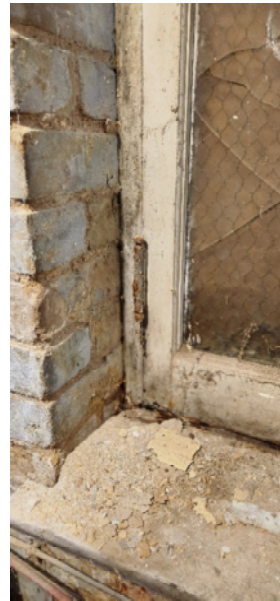
FIG. Div.4. 20 – Masonry Deterioration in Basement Due to Moisture Infiltration 3 @ Window Well

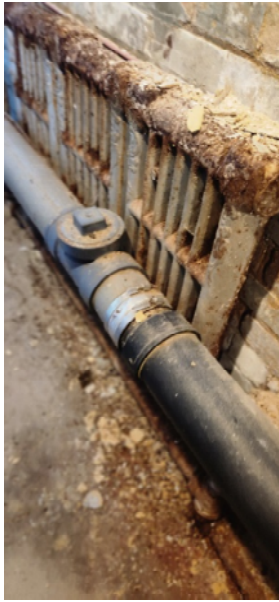
FIG. Div.4. 21 – Masonry Deterioration in Basement Due to Moisture Infiltration 2

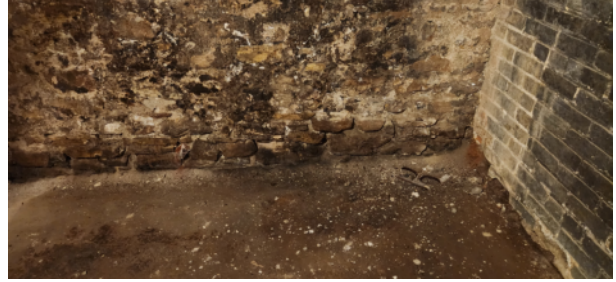
FIG. Div.4. 22 – Deteriorating Mortar in Rubble Foundation Wall

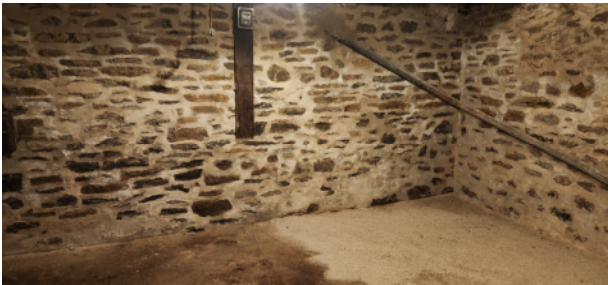
FIG. Div.4. 23 – Restored Masonry Joints in Area that Still Exhibits Moisture Infiltration

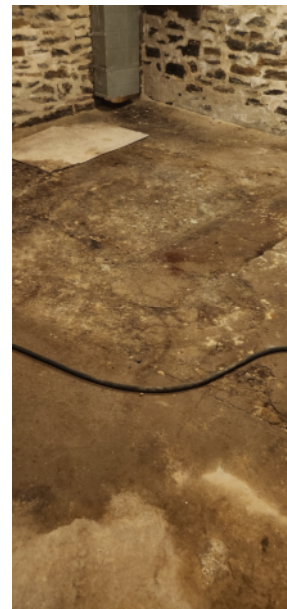
FIG. Div.4. 24 – Evidence of Moisture Infiltration at Basement Floor

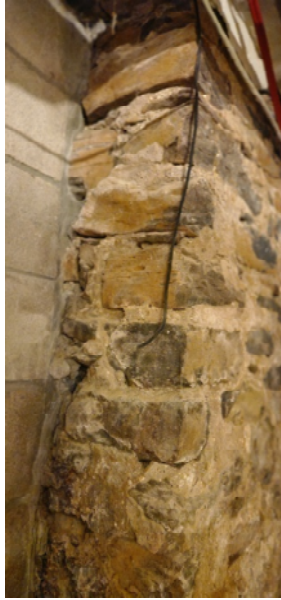
FIG. Div.4. 25 – Missing Mortar in Original Rubble Stone Foundation

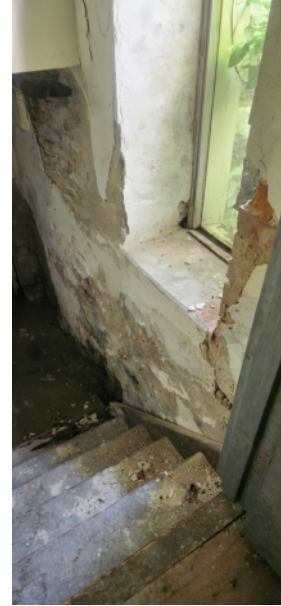
FIG. Div.4. 26 – Evidence of Moisture Infiltration at Stair to Basement

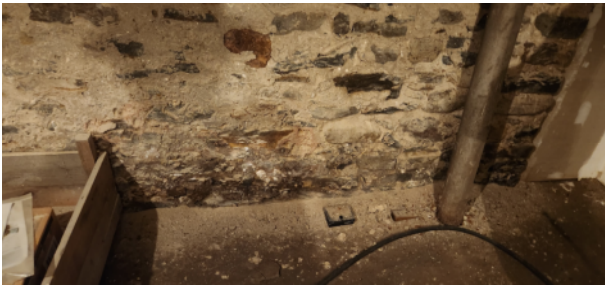
FIG. Div.4. 27 – Deteriorating Masonry Joints

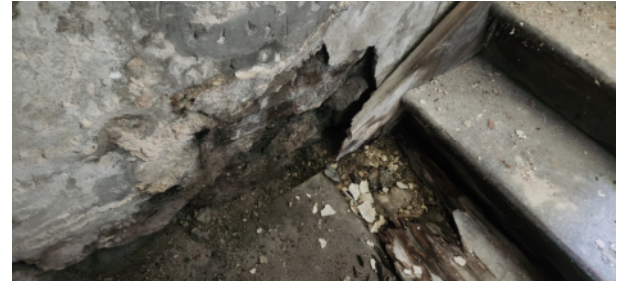
FIG. Div.4. 28 – Damage to basement foundation and stair due to moisture infiltration

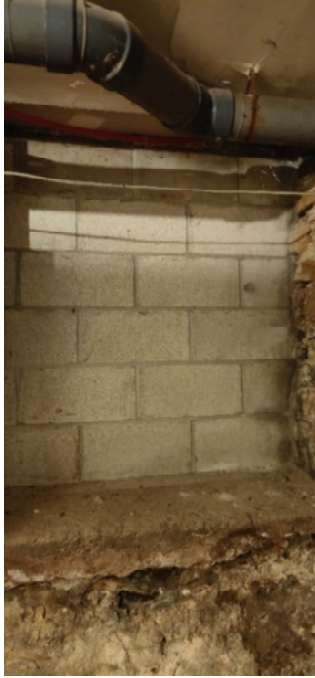
FIG. Div.4. 29 – Evidence of Moisture Infiltration at Basement

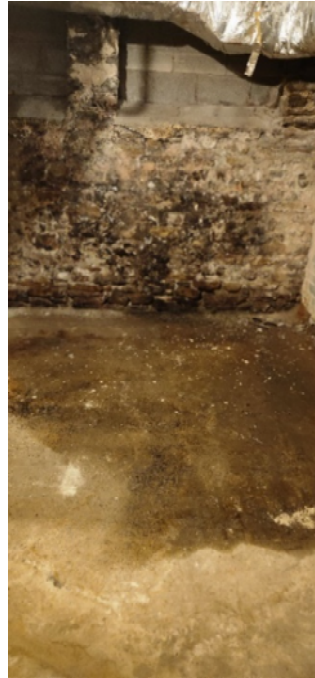
FIG. Div.4. 30 – Evidence of Water Infiltration on Floor Slab

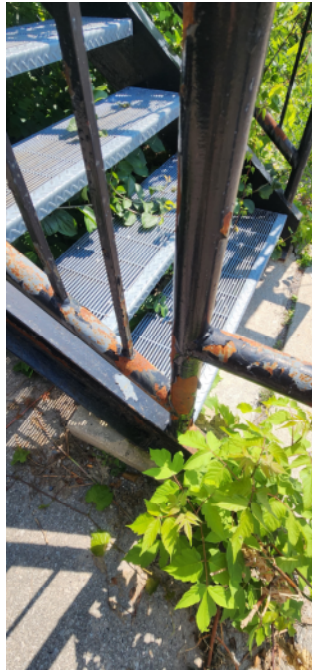
FIG. Div.5. 1 – Detail of Metal Corrosion on Fire Escape

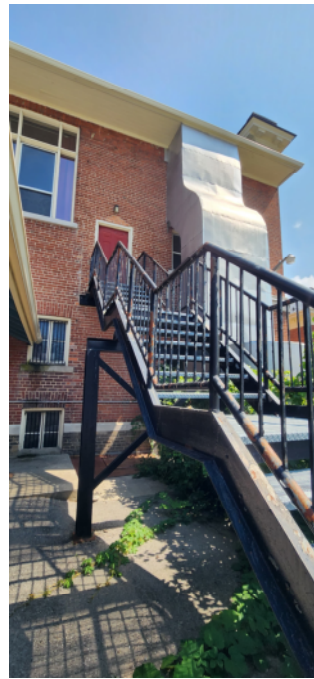
FIG. Div.5. 2 – Corrosion of Metal Fire Escape

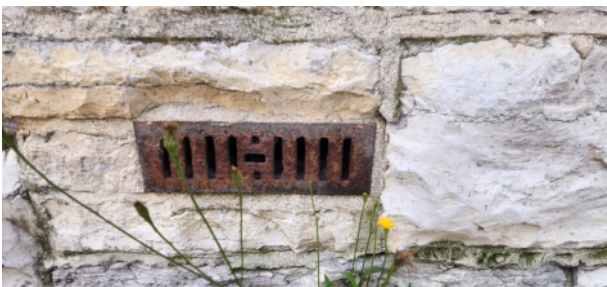
FIG. Div.5. 3 – Crawl Space Ventilation

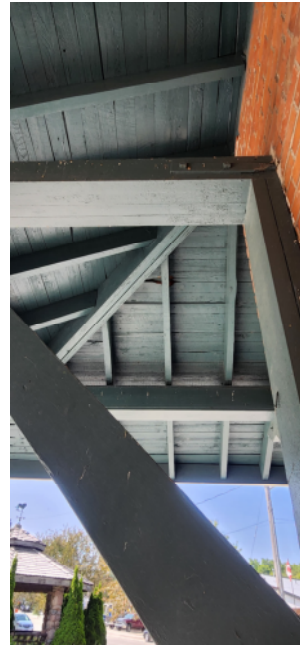
FIG. Div.6. 2 – Minor Damage to Canopy Roof Deck

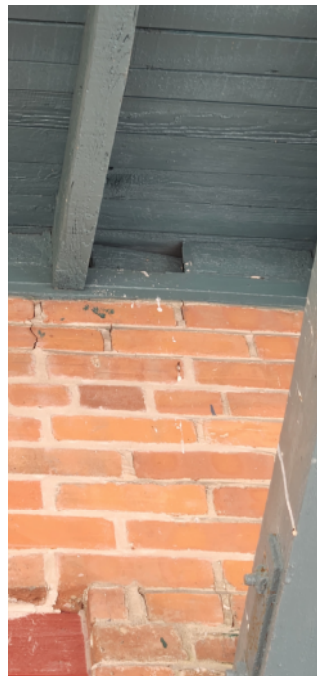
FIG. Div.6. 3 – Minor Damage at Canopy Roof Deck Crown Mold

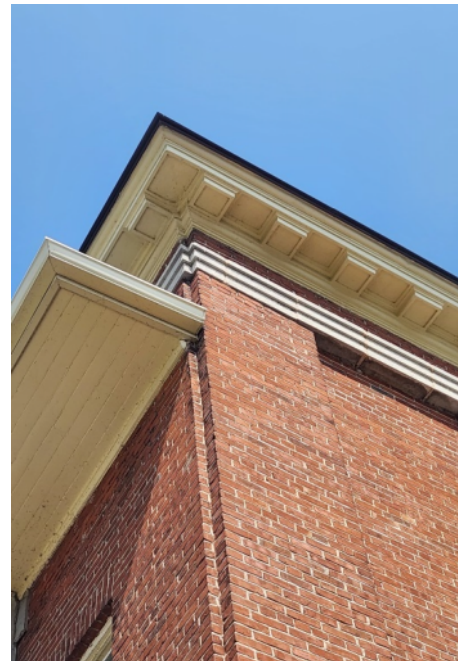
FIG. Div.6. 4 – Painted Wood Soffit

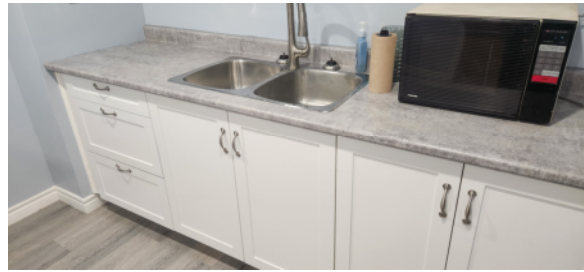
FIG. Div.6. 6 – Refurbished Kitchenette in Service Ontario Space

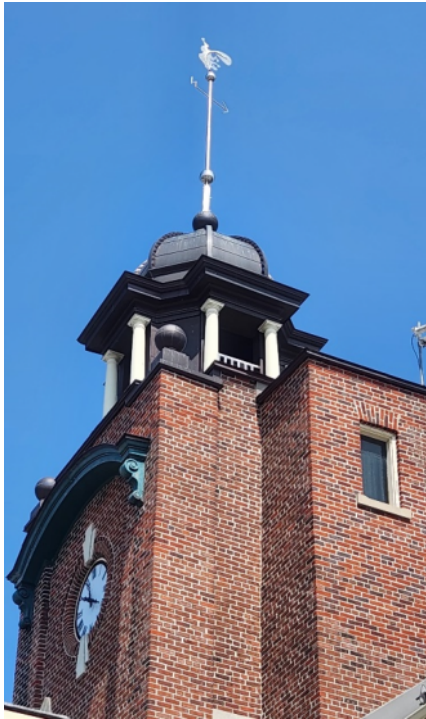
FIG. Div.7. 1 – View of Restored Tower Cupola

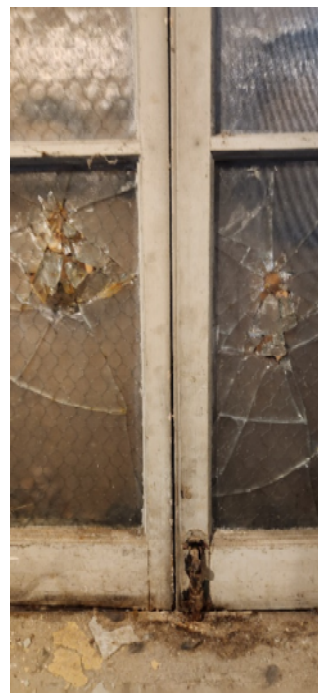
FIG. Div.8. 4 – Basement Window Damage

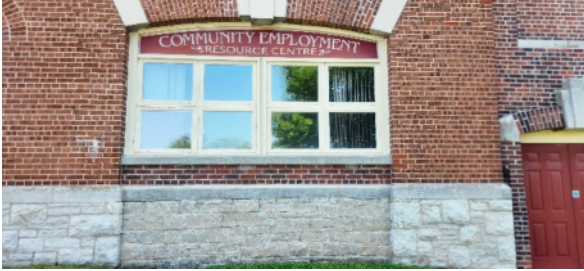
FIG. Div.8. 5 – North Façade at Old Doors Now Infilled

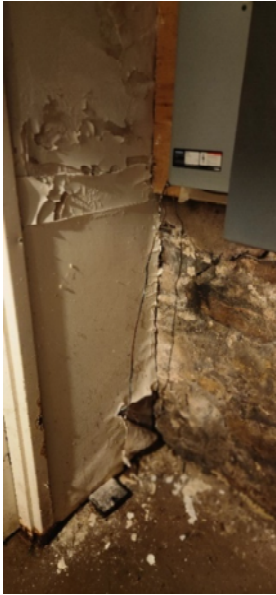
FIG. Div.9. 1 – Drywall Damage Due to Moisture Infiltration into Basement

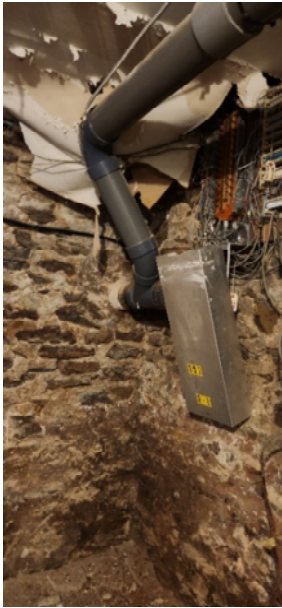
FIG. Div.9. 2 – Deteriorated Fire Separation at Ceiling in Basement

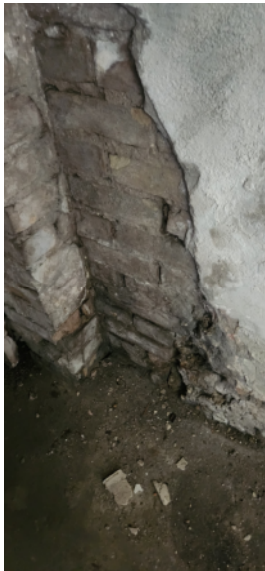
FIG. Div.9. 3 – Plaster Damage in Stair to Basement

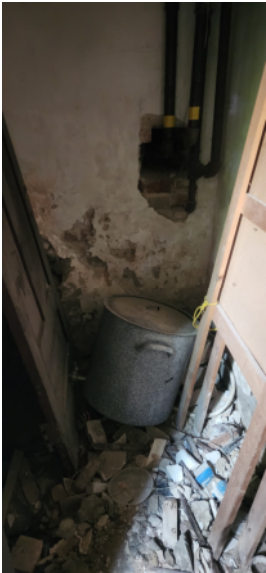
FIG. Div.9. 4 – Damage and Debris in Stair to Basement

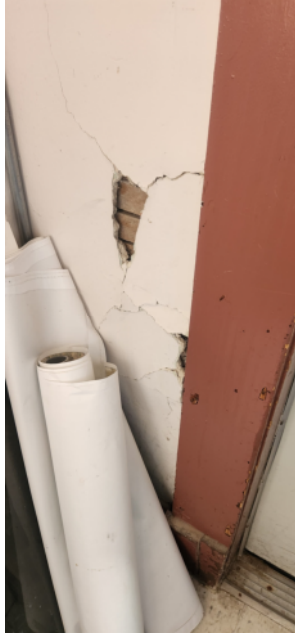
FIG. Div.9. 5 – Plaster Damage in Auditorium Exit Stair

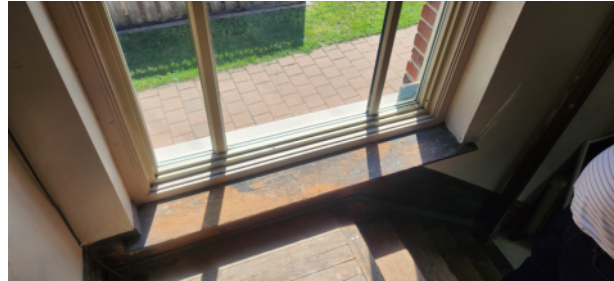
FIG. Div.9. 6 – Some Deteriorated Plaster at Window Surround in Auditorium Stair

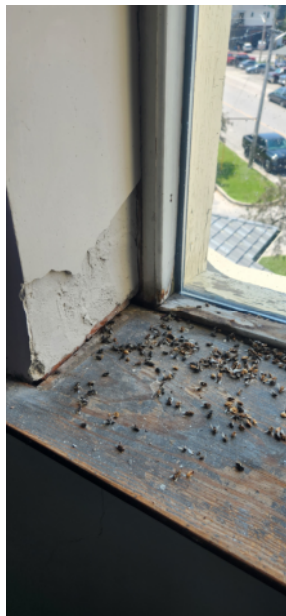
FIG. Div.9. 7 – Plaster Deterioration at Tower Stair

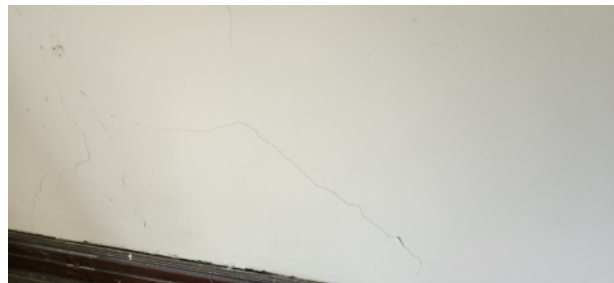
FIG. Div.9. 8 – Plaster Delamination at Tower Stair

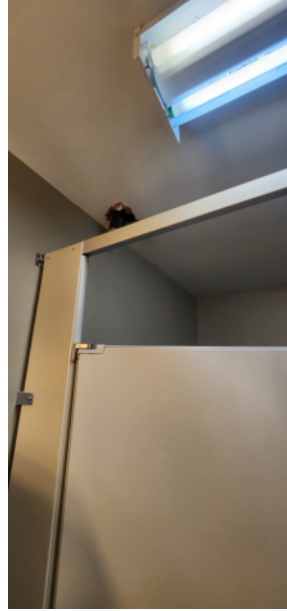
FIG. Div.9. 14 – Drywall Ceiling Damage in Washroom

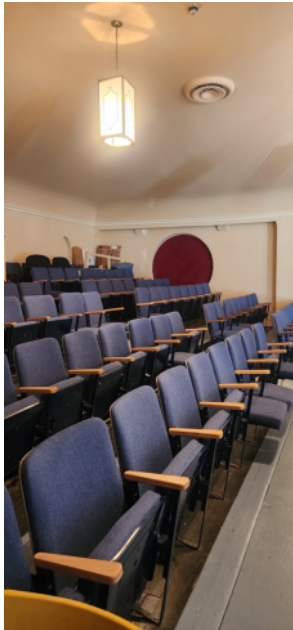
FIG. Div.12. 1 – Beaverton Hall Auditorium Seating
