SUNDERLAND TOWN HALL BUILDING CONDITION ASSESSMENT REPORT

TOWNSHIP OF BROCK

LARKIN ARCHITECT LIMITED

SEPTEMBER 2023

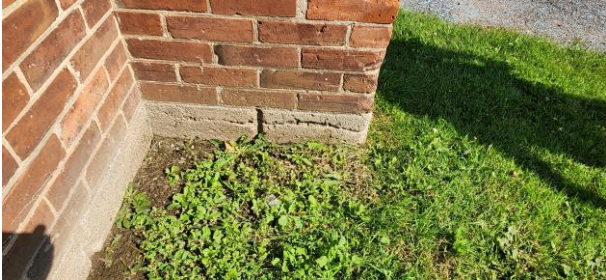
FIG. Div.3. 8 – East Wall Foundation

There is a crack in the east wall foundation which should be repaired with a historically appropriate patching material such as those produced by Jahn Masonry Mortars. (Refer to Fig. Div. 3.8).

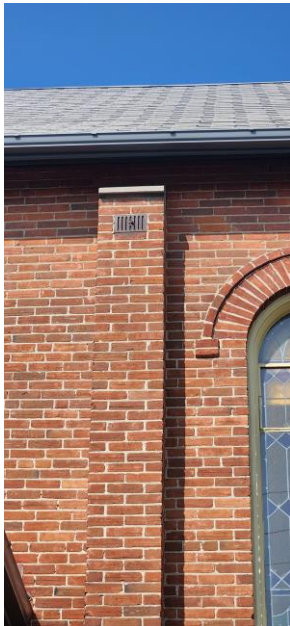
FIG. Div.4. 7– East Elevation Pilaster

Fig. Div. 4.7 illustrates a vent in the masonry pilaster on the east elevation. It occurs on all four pilasters and is speculated to represent a form of passive ventilation for the auditorium as similar vents can be seen at the floor of the auditorium in alignment with the ones at the top of the pilasters. There does not appear to be any deterioration associated with these vents, so no action is required at this time. Fig. Div. 4.8 indicates a crack in the masonry telegraphing from the precast Roman Stone sill likely caused by freeze-thaw cycling or an impact. This should be

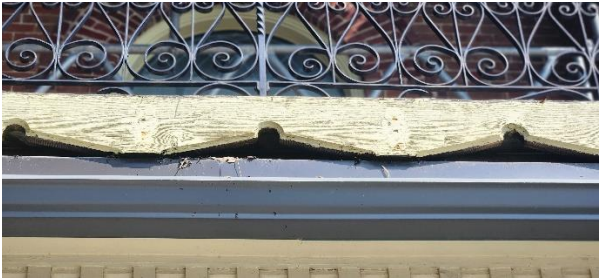
FIG. Div.6. 2 – Balcony Front Fascia

Generally, the exterior wood elements of the building are in good condition. However, the protective coatings appear to be deteriorating and should be prepped and re-finished soon to avoid deterioration. (Refer to Fig.'s Div. 6.4 to 6.7). Fig. Div. 6.1 and 6.2 illustrate the condition

of the exterior balcony facias which are showing sufficient deterioration of the finishes and underlying wood to require replacement soon. The surface of the deck should be re-finished at the same time and the supporting structure and roof membrane (not visible) should be checked to determine its condition. Fig. Div. 6.3 indicates the balcony soffit to be in good condition with no signs of leaking from above. This work has been included in the phased building envelope restoration process as identified in the cost spreadsheet.

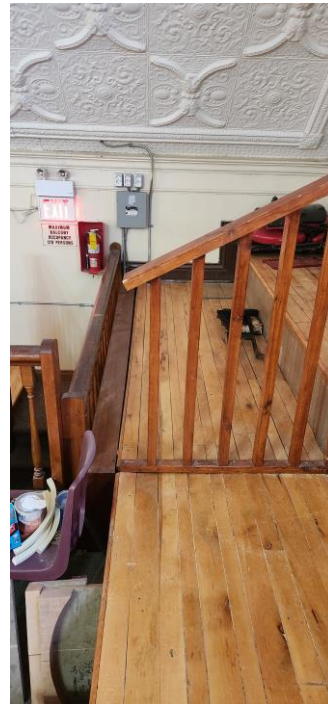
FIG. Div.6. 8 – Balcony Storage

Fig. Div. 6.8 indicates a wooden handrail that separates the balcony storage area from the seating area. Access to this area is precarious and the lack of a railing to protect crew from falling into the stair well represents a risk that should be remedied. A proper latched gate to this area should also be considered.

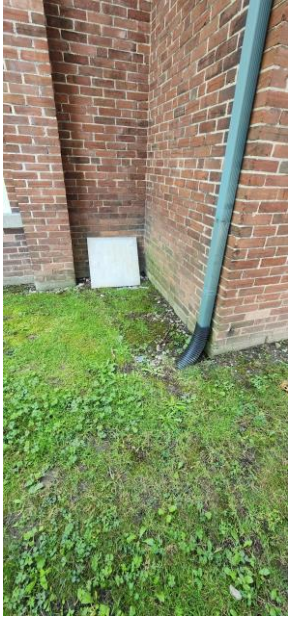
FIG. Div.7. 1- Buried Downspout Drainage

The building does not have a basement, so the condition of the foundations was not determined although there does not appear to be any indication on the interior of rising damp. Fig. Div. 7.1 indicates a buried drainage pipe directing downspout water to the French drain. Despite what is presumably a shallow depth, the pipe reportedly does not freeze in winter.

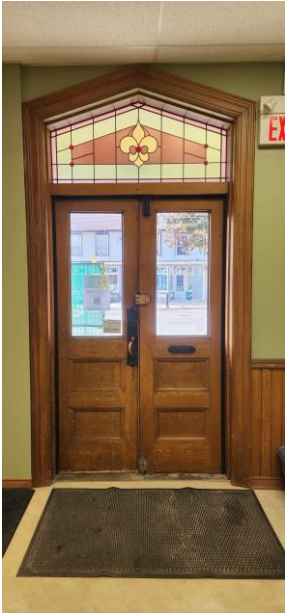
FIG. Div.8. 2 – Front Doors (Interior)

Fig.'s Div. 8.1 and 8.2 illustrate the front doors to the town hall which are typical of their time, but do not meet current code standards for exiting. Drawings to provide a compliant single door with barrier-free operator were tendered recently and LAL is awaiting direction from the Township on next steps. Fig.'s Div. 8.3 and 8.4 illustrating the exterior balcony doors were part of the same tender process. In this case, the doors have deteriorated to the point at which they require replacement, but do not require accessibility, so can be replicated.

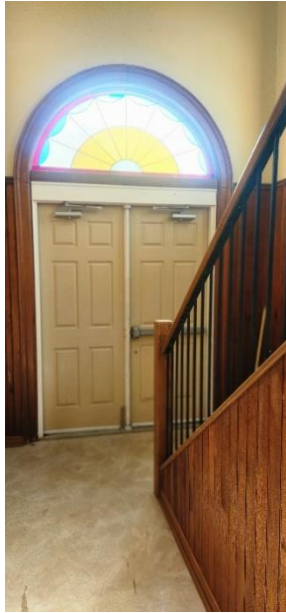
FIG. Div.8. 7 – East Exit Doors

installed at your discretion. The doors themselves are painted hollow metal and appear to be in good shape. It should be noted that the door is not signed as an exit and should be to avoid confusion when exiting. (Refer to Fig. Div. 8.7).

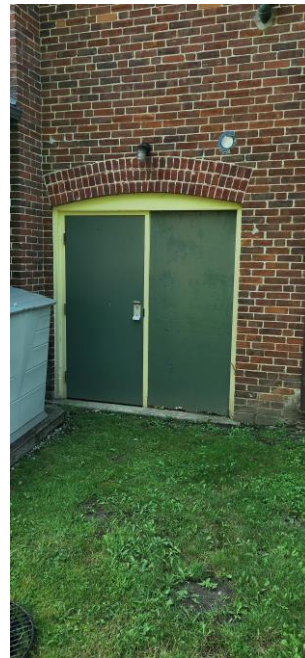
FIG. Div.8. 8– Rear Exit Door 1

Fig.'s Div. 8.8 & 8.9 illustrate the rear exit doors that serve the banquet hall and associated washrooms. One of the two original doors has been permanently blocked with a fixed painted plywood panel since the space behind is now part of a washroom. Both the base of the painted wood frame and the painted plywood panel are showing signs of deterioration likely due to moisture. It may be prudent to replace these with a hollow metal frame, door, and fixed panel.

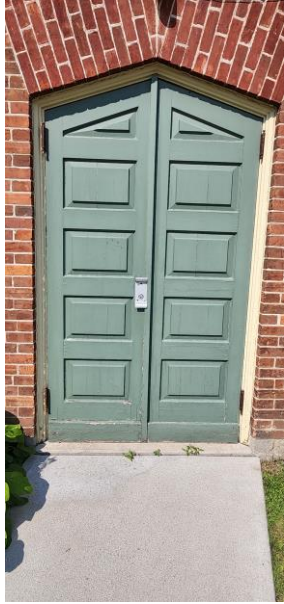
FIG. Div.8. 10 – East Doors to Kitchen

Fig.'s Div. 8.10 & 8.11 illustrate the east doors to the kitchen. These are convenience doors and do not constitute a code compliant exit as there is a raised sill at the door threshold. The doors themselves are panelled wood and require re-finishing to avoid future deterioration.

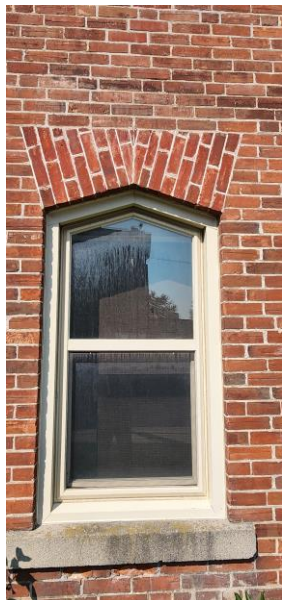
FIG. Div.8. 16 – East Window

Fig. Div. 8.16 illustrates a vinyl window with prefinished aluminum flashings installed on the exterior side of the original wood window. It appears to be in good condition. The masonry below the window appears to be deteriorating. It is interesting to note that the bricks that form the flat arch above the windows appear to have been stained a darker red. This is also evident in a diamond shape on the front gable, on all the roman masonry arches over the windows and the rose window masonry surround.

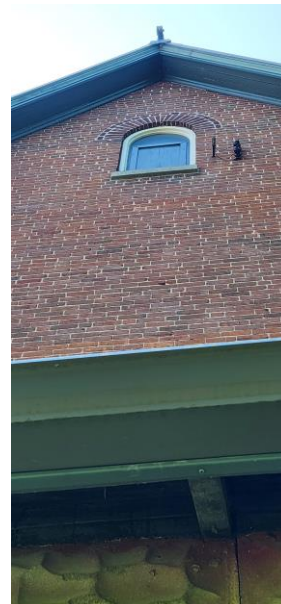
FIG. Div.8. 17 – Rear Elevation Attic Access

Fig. Div. 8.17 illustrates the high portal to the attic. As such, the attic was not accessed.

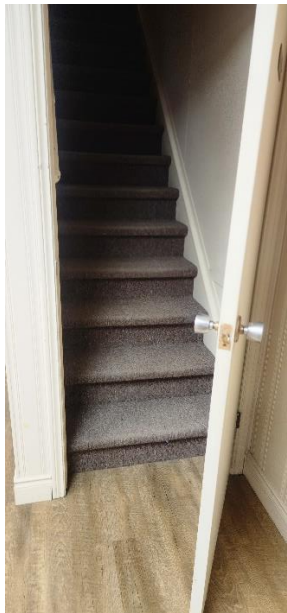
FIG. Div.8. 20- Back Stair to Auditorium

Fig. Div. 8.20 illustrates a service stair that connects the auditorium stage with the lower banquet hall, frequently used as a rehearsal and/or green room for productions in the

auditorium. The wooden door breaches the required fire separation between floors and should be replaced with a fire rated hollow metal door and frame with fire-rated closer and latch. From a building code perspective, it should have a landing at the bottom although the code does not require a retroactive compliance.

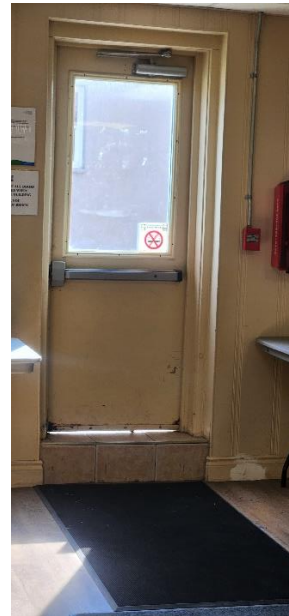
FIG. Div.8. 21 – Exit Door from Rear Meeting Room

Fig.'s Div. 8.21 & 8.22 illustrate the exit door from the rear meeting room which is neither signed as an exit nor is it code compliant because of the step at the threshold. Ideally, this exit should be made accessible with a landing and ramp.

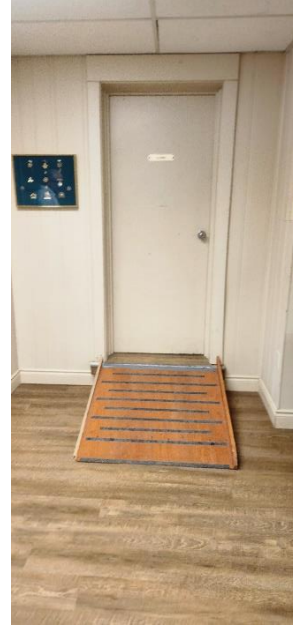
FIG. Div.8. 23 – Door to Lobby from Rear Meeting Room

Fig. Div. 8.23 illustrates the door from the banquet hall to the front lobby. It is served with a non-code-compliant temporary ramp for barrier-free accessibility. Ideally, it too should have a compliant landing and ramp.

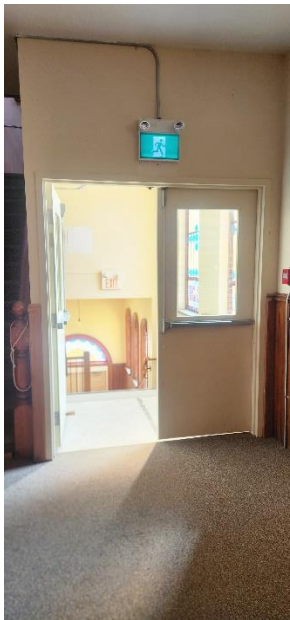
FIG. Div.8. 24 – Lobby Access to East Exit

Fig. Div.8.24 illustrates the signed lobby access doors to the east exit which were presumably installed as part of the Fire Code upgrades completed in the 1990's. These doors should not be held open with a door stop. If leaving it open facilitates day to day access, then a fire rated hold device linked to the fire alarm system should be installed. Note the exit sign beyond. It would be prudent to install another exit sign directly above or adjacent to the exterior door. Similarly, all existing exit signs should be upgraded to the "green running man" style that meets current code standards. Refer also to DIVISION 16 – ELECTRICAL.

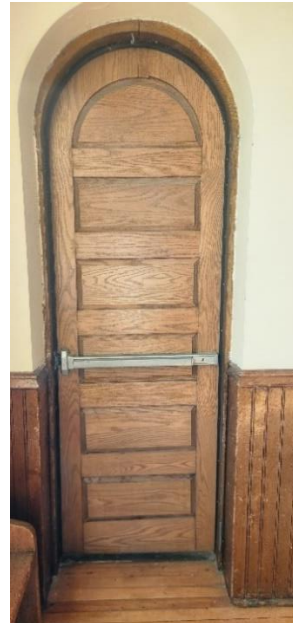
FIG. Div.8. 25 – East Fire Escape Exit Door

Fig. Div. 8.25 illustrates the exit door from the auditorium to the fire escape. Its width is only 29" but meets acceptable code standards for existing buildings. Fig. Div. 8.26 illustrates gaps in the weatherstripping which causes wind whistling through the gaps. New weatherstripping should be installed to remedy this situation.

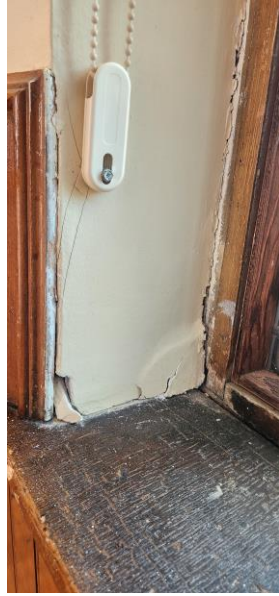
FIG. Div.9. 1 – Plaster at Auditorium West Window Sill

Generally, the interior finishes are in good condition except for some drywall/plaster deterioration at window surrounds (Refer to Fig.'s Div. 9.1 to 9.3 inclusive) and some cracks in the drywall/plaster proscenium arch. (Refer to Fig.'s Div. 9.4 to 9.6 inclusive). The plaster at the window surrounds can be patched after the exterior wood windowsills have been repaired, repainted, and re-sealed since the likely cause of water infiltration is due to this problem.

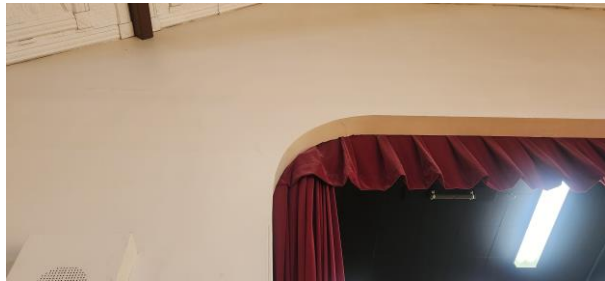
FIG. Div.9. 4 – Proscenium Arch 1

The cracks on the stage proscenium do not appear to be of a structural nature. For aesthetic purposes, these cracks could be repaired and monitored to see if they re-appear. It is noted

that there are no control joints in the drywall/plaster and the cracks could indicate that the wall is creating its own control joints as it moves through the seasons.

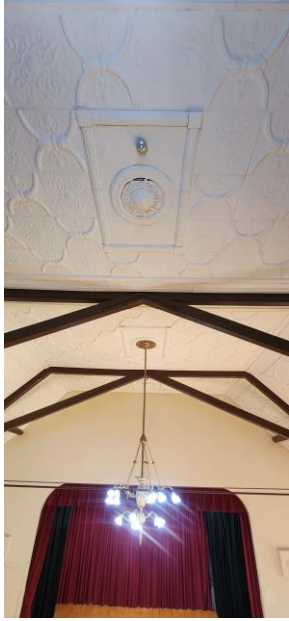
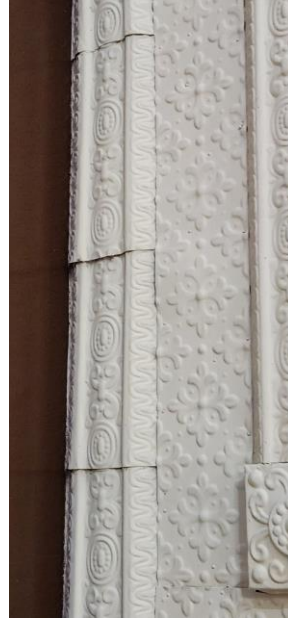
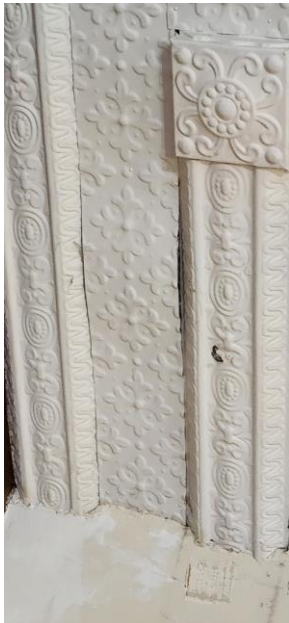
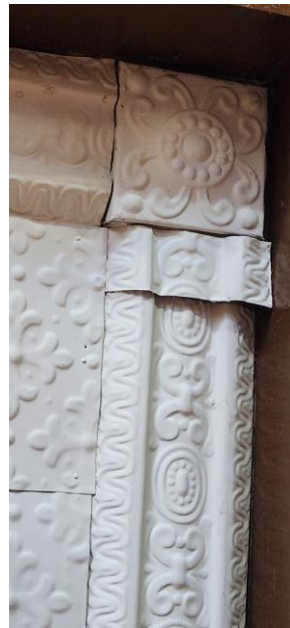
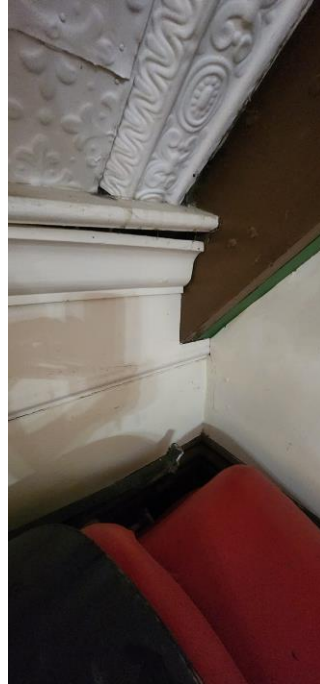
The decorative tin ceiling in the auditorium appears to be in good shape. (Refer to Fig.'s Div. 9.9 to 9.14 inclusive). As indicated in the photographs, there appear to be a few locations where the tin may have become released from its fasteners. These should be monitored and re-secured where required.

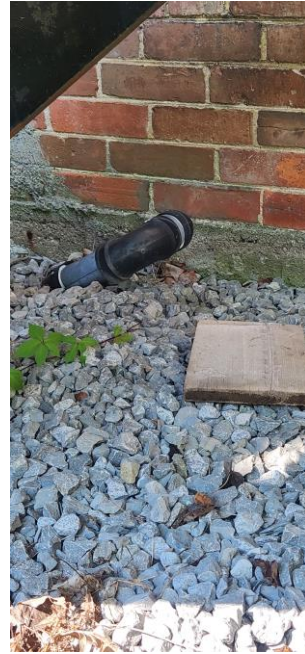
FIG. Div.15. 2– East Wall Projecting Vent Pipe

Fig. Div. 15.2 illustrates an anomalous vent pipe found at grade on the east elevation next to another round aperture stuffed closed with a glass pop bottle. It was indeterminate as to what these apertures were for and whether they are currently actively serving the facility. Further investigations may be warranted.

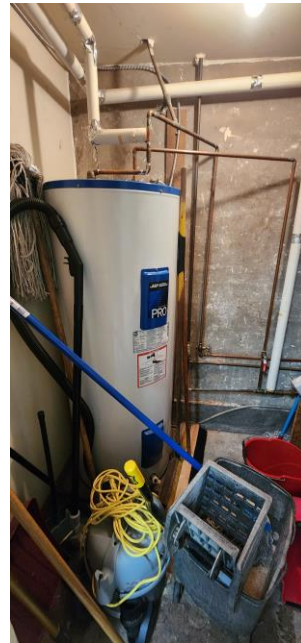
FIG. Div.15. 4 – Utility Box

Fig. Div. 15.4 illustrates the current janitorial/utility closet accessible from the interior of the building. The electric water heater appears to be relatively new. It was noted that some of the domestic water piping to the unit is not insulated. It was advised that no flammable cleaning supplies are stored in the closet therefore eliminating the building code requirement to have the room fire isolated from the remainder of the facility. There was no exhaust fan observed in this room.

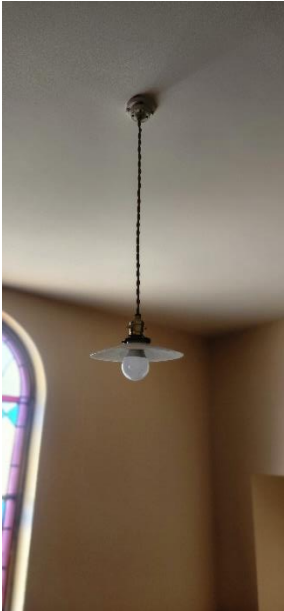
FIG. Div.16. 2 – Light Fixture Serviced by Knob and Tube Wiring

We were advised that the existing knob and tube wiring did not present a fire hazard. (Refer to Fig. Div. 16.2)
