# Brock Township Municipal Office

**BUILDING SYSTEMS ASSESSMENT**

Brock Township

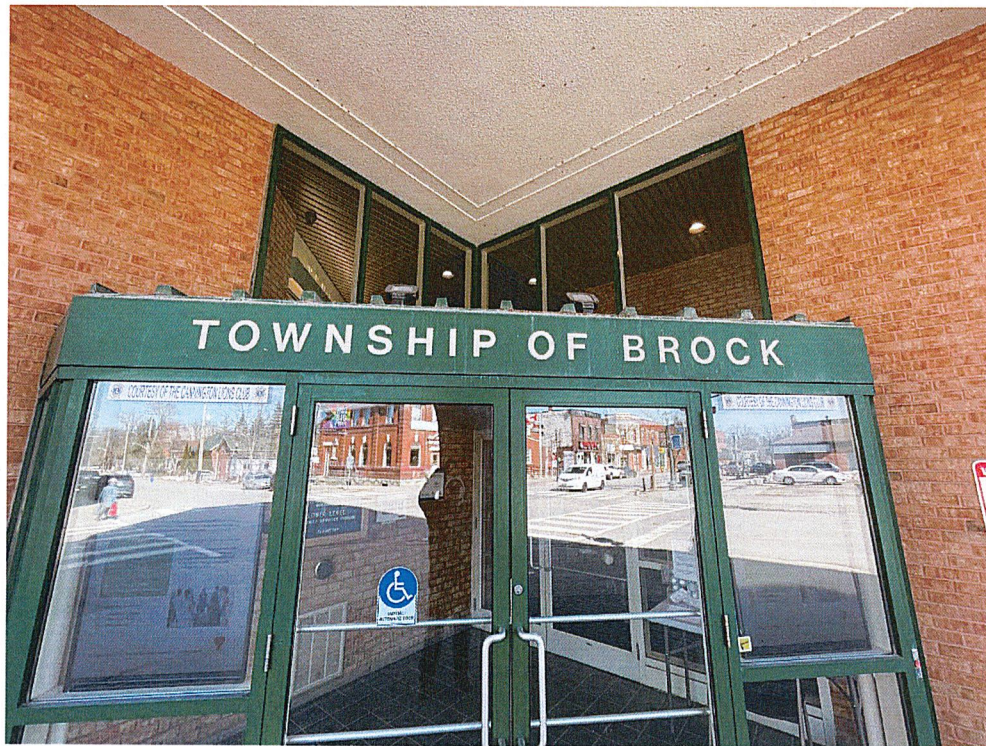
The corner entrance relies on light structural steel framing to support aluminum storefront entrance complete with an exposed 1 ½ inch steel deck painted to match over the vestibule area (Photographs 3.1.1). The front entrance is showing some minor signs of corrosion (Photograph 3.1.2 and 3.1.3). It is recommended that the steel deck over the area is power washed, assessed for sandblasting as may be required and the storefront entrance repainted for protection purposes (Photograph 3.1.4).

Photograph 3.1.1: Front Entrance

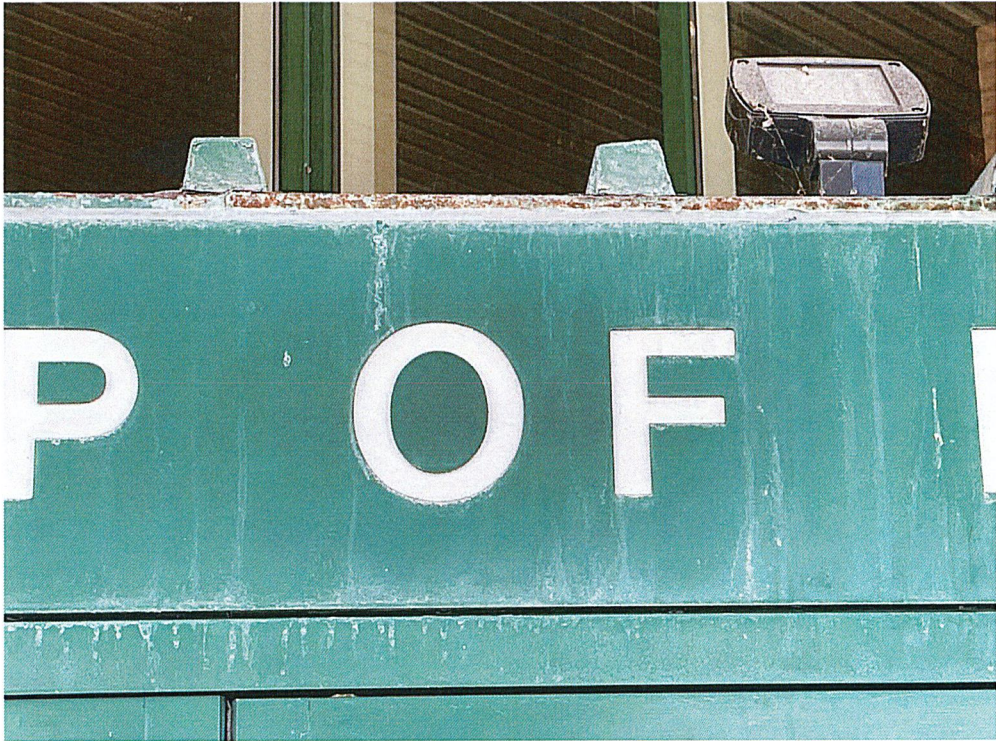
Photograph 3.1.2: Minor Corrosion

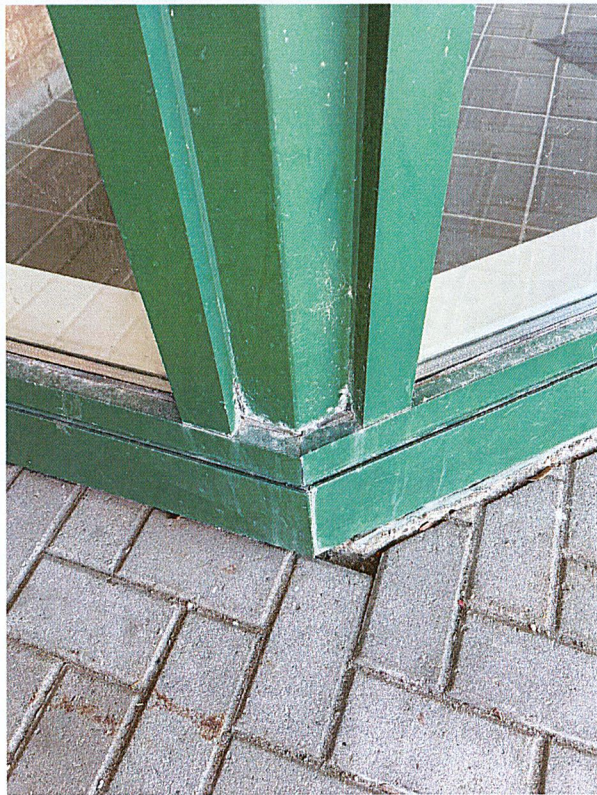
Photograph 3.1.3: Storefront Base

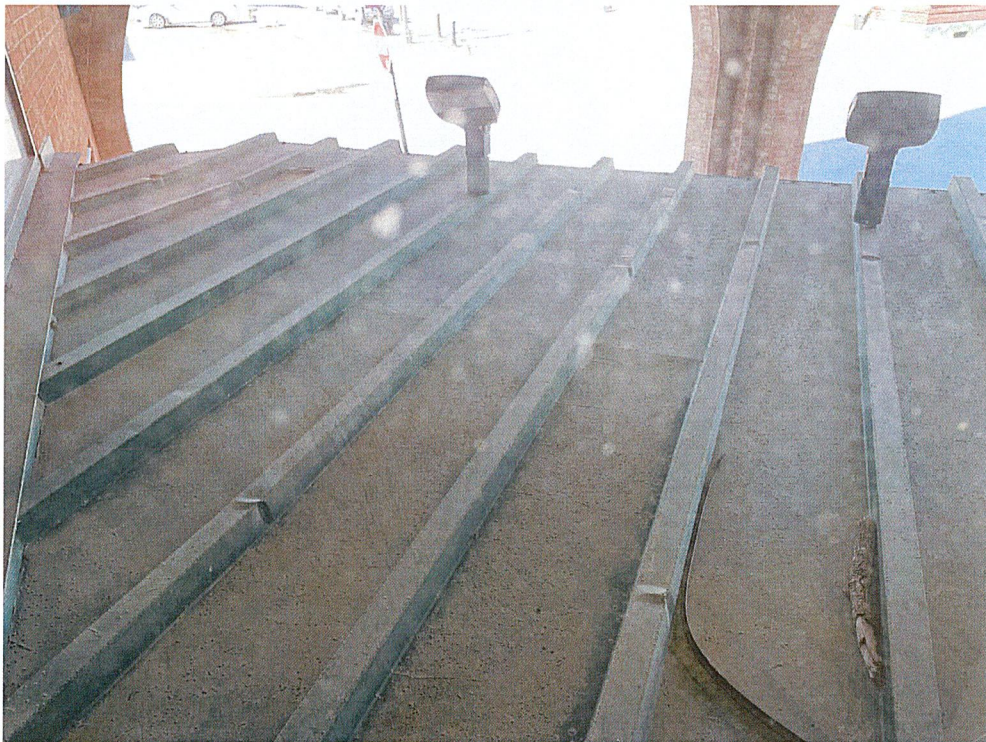
Photograph 3.1.4: Front Entrance Deck

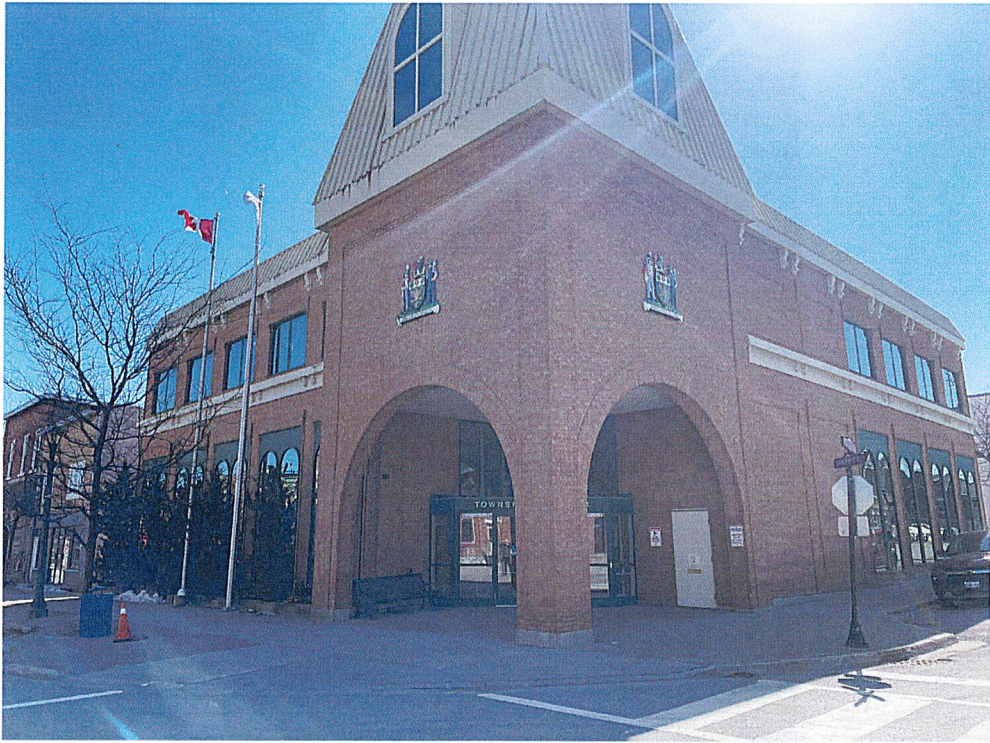
utilizes a prominent reinforced brick arch (8'-10" radius) on the north and west façade (Photograph 3.1.8). The arches are deteriorating, and they need to be repointed (Photograph 3.1.9 and 3.1.10). We observed a moderate level of brick deterioration in isolated areas (Photographs 3.1.11 and 3.1.12). Selant replacements are required at expansion joints (Photograph 3.1.13)

Photograph 3.1.8: Front Brick Arches

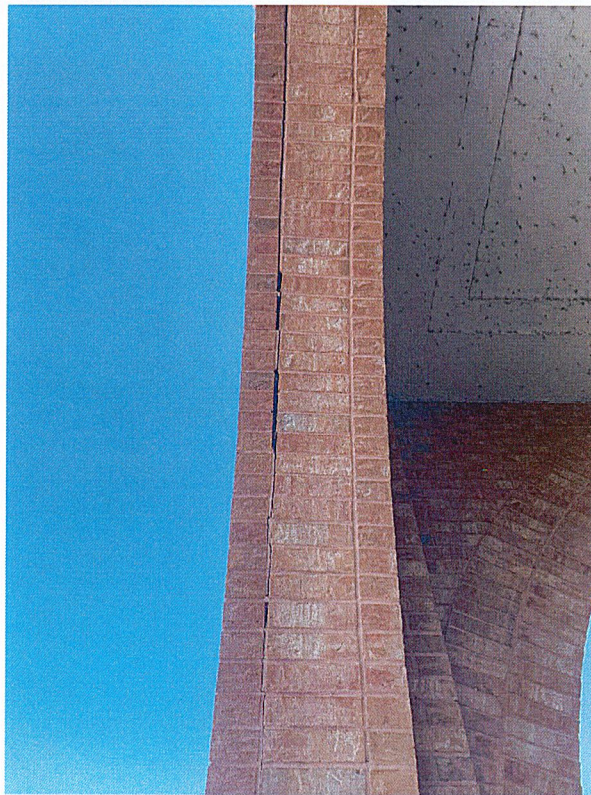
Photograph 3.1.9: Arch Deterioration - West

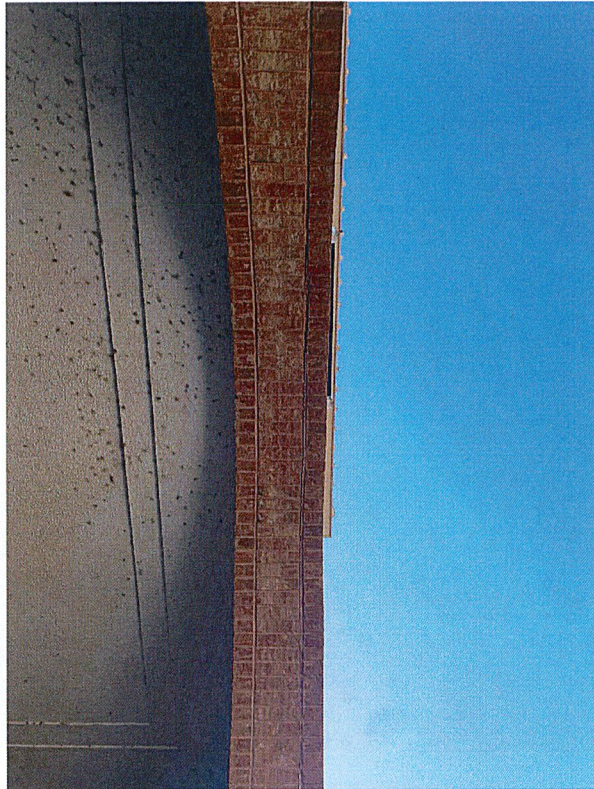
Photograph 3.1.10: Arch Deterioration - North

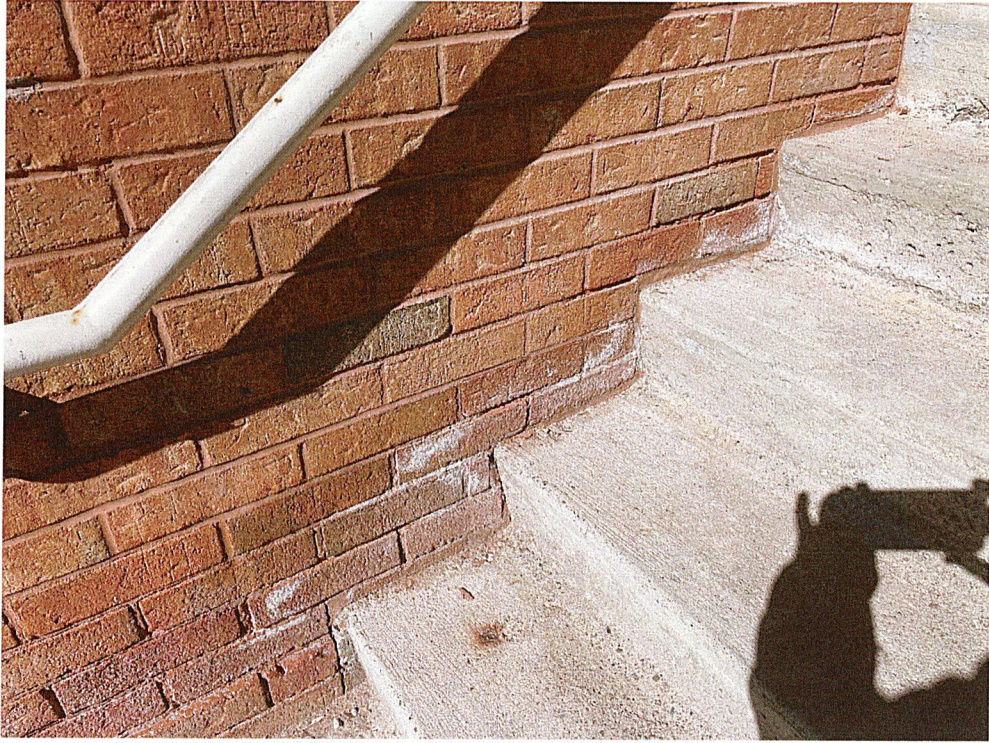
Photograph 3.1.12: Efflorescence

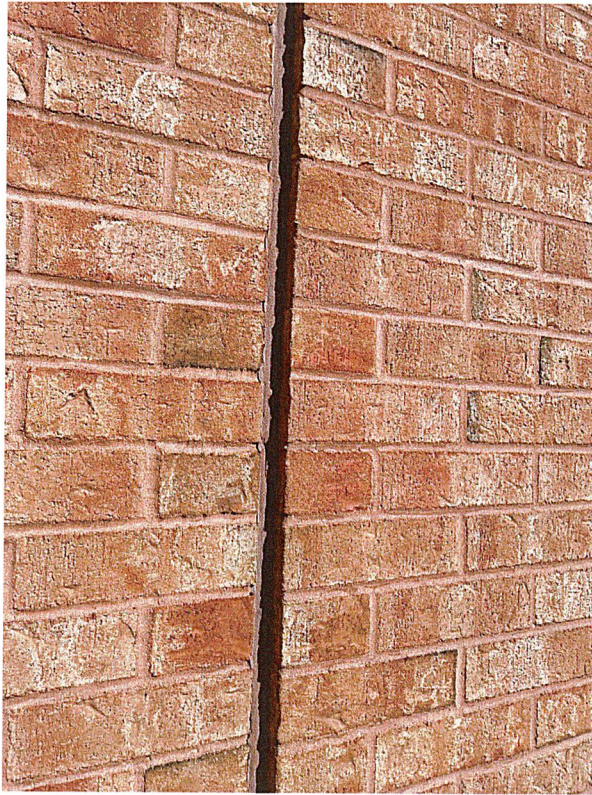
Photograph 3.1.13: Expansion Joint Seal

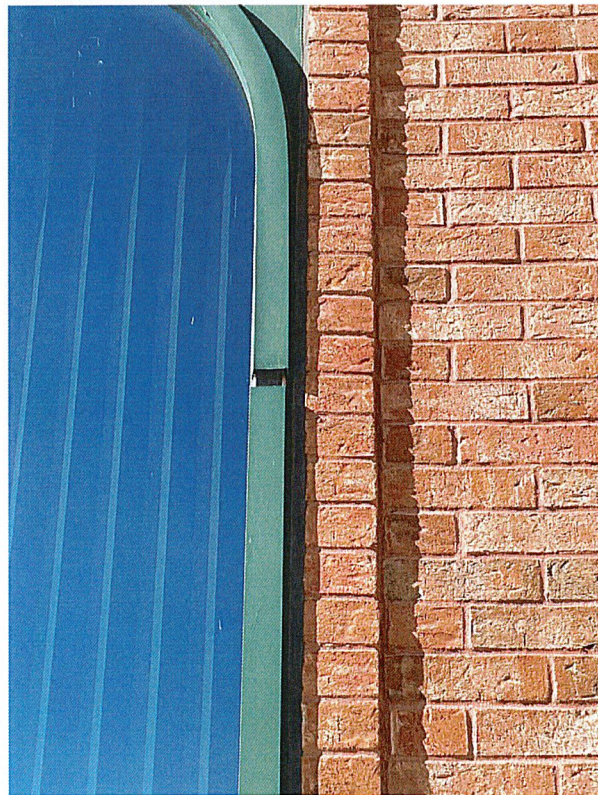
The parapet and tower fascia are of prefinished metal construction. Entrance doors are of prefinished metal and aluminum storefront construction. All windows are constructed with prefinished aluminum frames with reflective thermal glazing (Photograph 3.1.14). At various locations, the aluminum window frame snap cap has slipped allowing for a gap for water infiltration (Photograph 3.1.15 and 3.1.16)

Photograph 3.1.15: Window Cap Gap

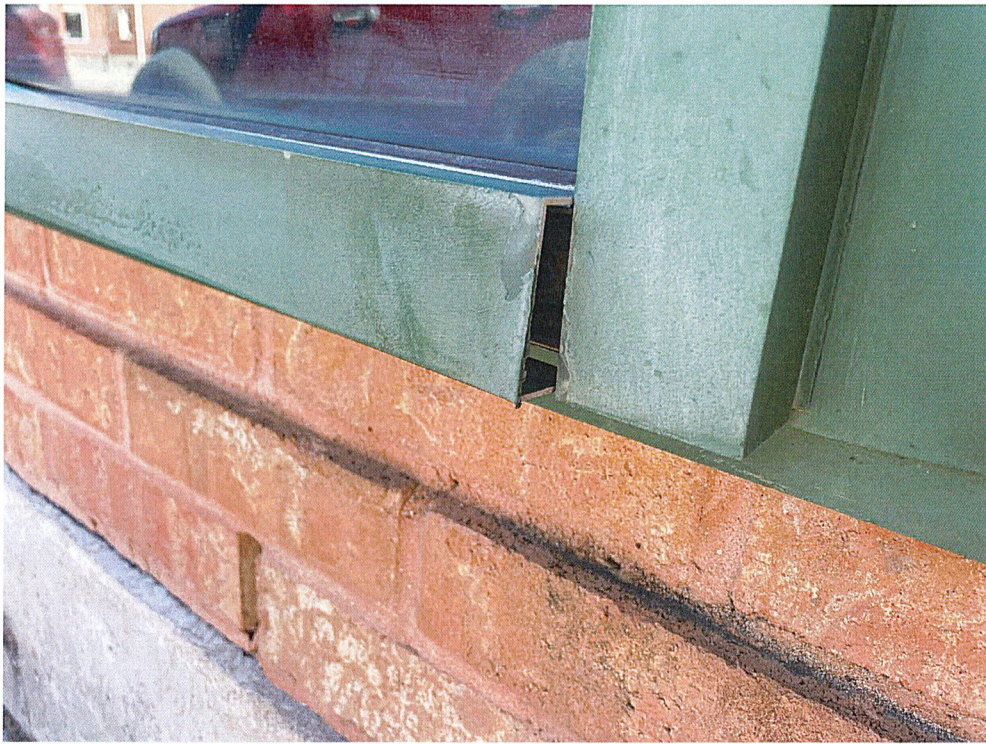
Photograph 3.1.16: Window Cap Sill Gap

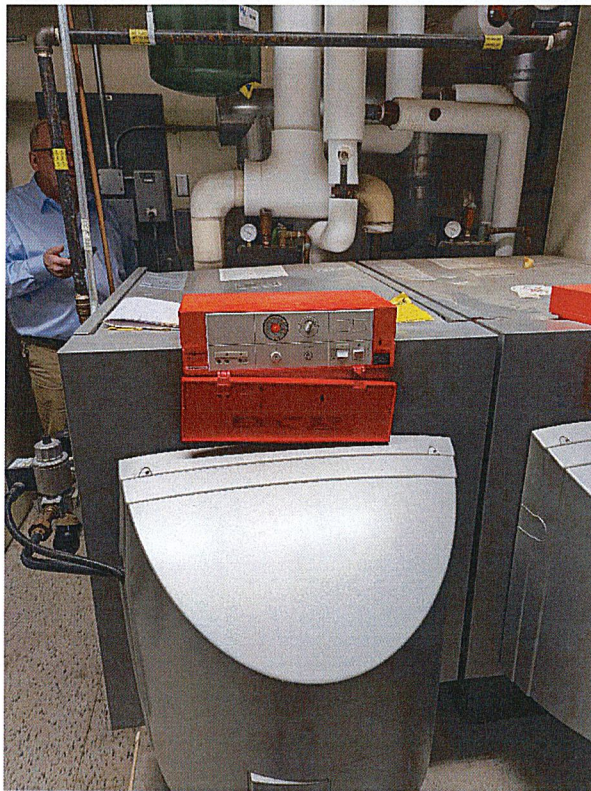
The Mechanical Room contains two natural gas-fired non-condensing Viessmann model Vitola 200 cast iron boilers which are replacements of the originally labeled B1 and B2 boilers on the original permit drawings (Photograph 3.2.1.1). The nameplate information on each unit indicates a heating output capacity of 249,000 BTUH. The nameplate label indicates the boilers were manufactured in 2006, suggesting they have been in service for 19 years. Cast iron boilers have a useful service life expectancy of 30-35 years. A barometric pressure relief damper is installed on the exhaust system of the boiler and a combustion air vent has also been provided. The boilers are controlled by a Tekmar 261 boiler controller which is controlling the boiler setpoints, capacity, and sequencing. The boilers are provided with a Watts OEM 170 low water cut-off.

Photograph 3.2.1.1: Boiler B-1

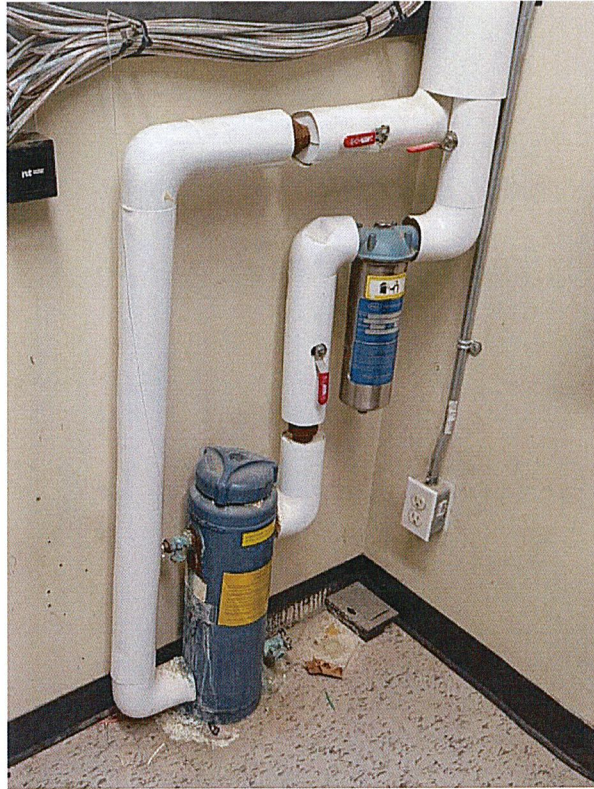
The boiler's heating circuit piping includes a chemical pot feeder and filter. The pot feeder shows signs of wear, indicating possible leaks in the gaskets. This unit was likely installed during the original construction and is now 30 years old. It is recommended to replace a chemical pot feeder if it displays cracked caps, worn gaskets, or clogged filters, or if it is over 15 years old (Photograph 3.2.1.2).

Photograph 3.2.1.2: Hydronic System Chemical Pot Feeder

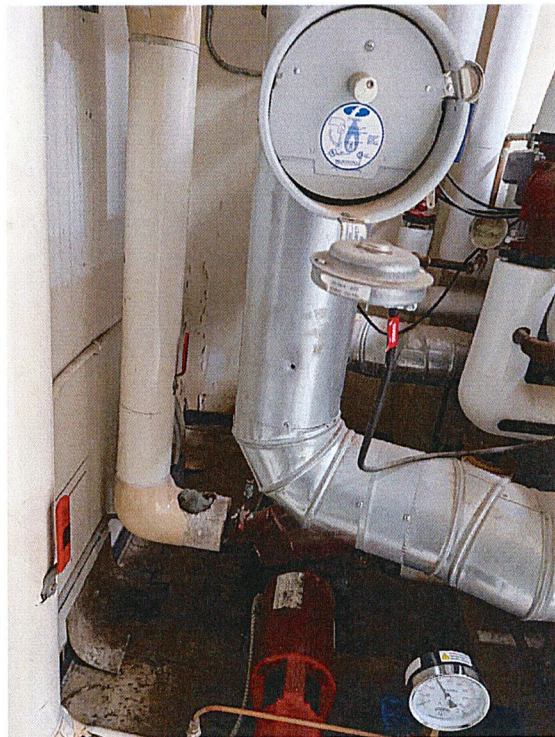
A cable was seen to be resting on the exhaust duct of the boilers, which is a potential fire hazard. The electrical wire should be relocated and properly supported (Photograph 3.2.1.3).

Photograph 3.2.1.3: Cable on Exhaust Duct

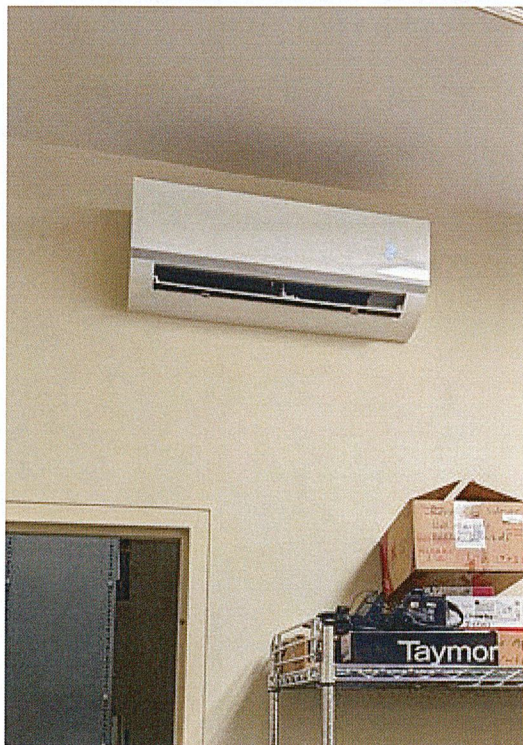
A 1-ton (12,000 BTUH) split air conditioning system (AC Unit) cools the IT room and is controlled by a thermostat located in the IT room. The system includes a wall-mounted indoor evaporator unit, and an outdoor condensing unit located behind the building in the fenced-off generator area. The age of the equipment appears to be from 2018 based on the serial number and appears to be in good condition. (Photograph 3.2.1.5 and 3.2.1.6). The typical useful life of the equipment is 15 years.

Photograph 3.2.1.5: Air Conditioner- Indoor Unit

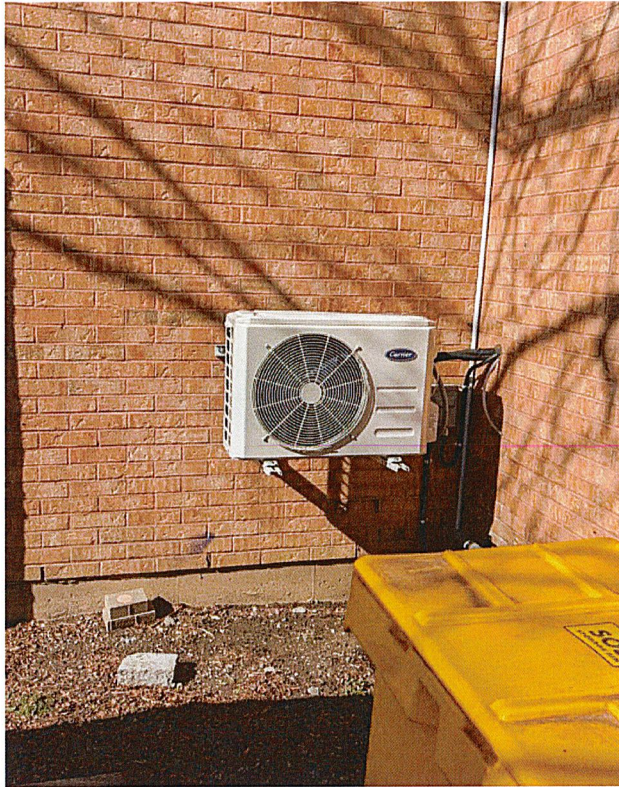
Photograph 3.2.1.6: Air Conditioner- Outdoor Unit

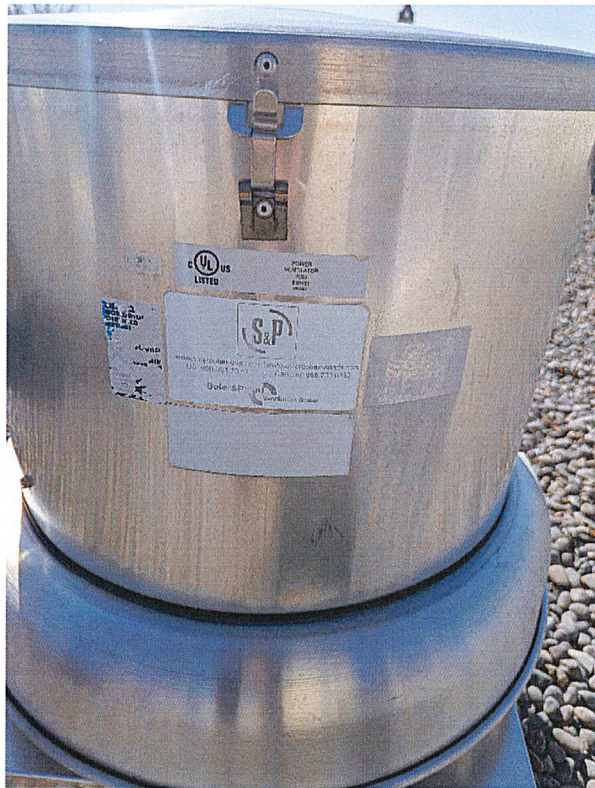
The buildings washrooms are ventilated by a centrifugal downblast roof exhaust fan labeled EF-2 on the as-built drawings. The nameplate data label on the fan was worn out and the model and age of the fan are unknown. However, the fan appears to have been replaced sometime in

the last 20 years. Centrifugal fans typically have a useful service life of 25 years (Photograph 3.2.1.8). The fan is controlled by a 7-day programmable electronic time switch that should be programmed in accordance with the building's typical occupied and unoccupied schedule.

Photograph 3.2.1.8 - Washroom Exhaust Fan

N/A	VVT Rooftop Unit Controls	Fair	Replace controls with an updated controls system when rooftop units are replaced or when there are issues with the controls.
EF-1	Elevator Exhaust Fan	Fair	Replace within the next 1-5 years.
EF-2	Bathroom Exhaust Fan	Fair	Replace within the next 1-5 years.

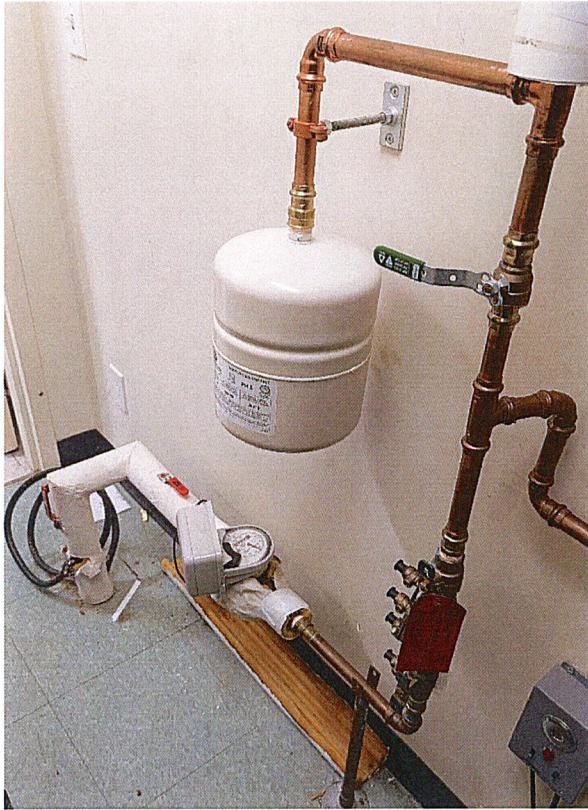
The double check valve backflow preventer for the building's domestic water supply shows surface corrosion, and the inspection tag indicates it was last inspected in 2013 (Photograph

3.2.2.2). This backflow preventer needs to be inspected yearly in accordance with Canadian Standards Association (CSA) B64.1 "Selection and installation of backflow preventers/maintenance and field testing of backflow preventers". The typical lifespan of a backflow preventer is 10 years, and this backflow preventer has exceeded its life expectancy and should be replaced.

Photograph 3.2.2.2: Building Backflow Preventer

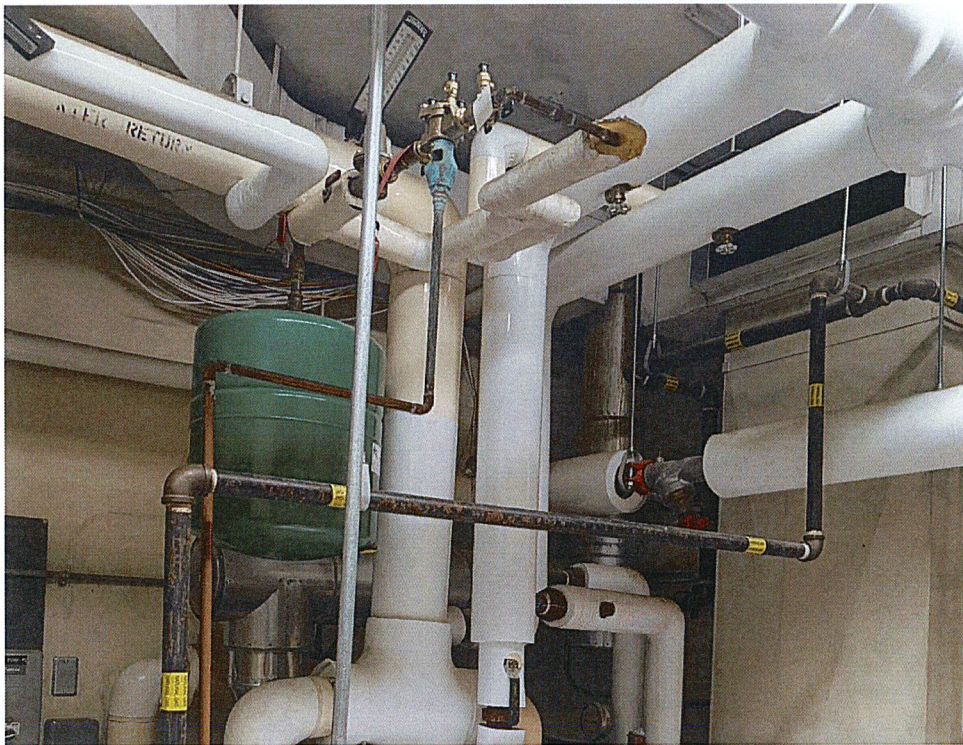
The backflow preventer for the boilers was replaced in 2024 and is inspected annually (Photograph 3.2.2.3).

Photograph 3.2.2.3: Hydronic Backflow Preventer

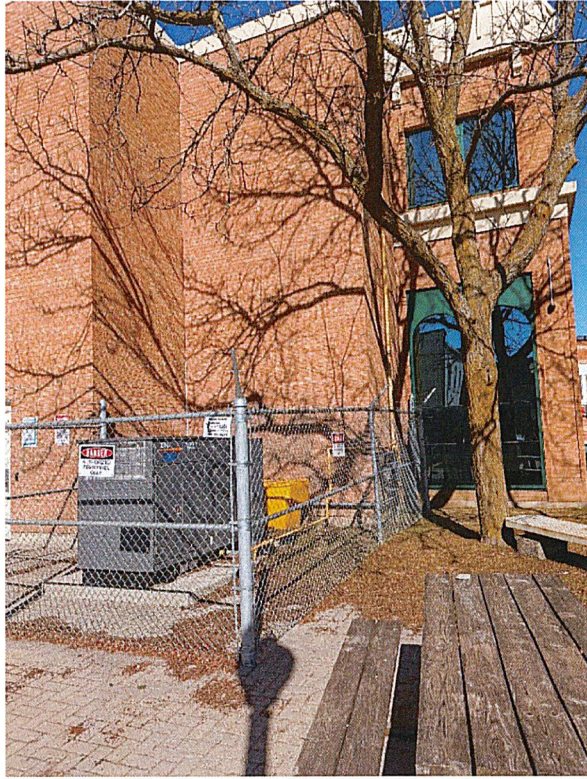
The generator appears to be a Generac Industrial Power generator (Photograph 3.2.3.1). The model number was not visible to review, and the generator was not on when the building condition assessment was conducted. In discussion with facility management, it was noted that the generator requires between 7 to 11 in w.c. to operate and is currently being provided with 7 in w.c.

Photograph 3.2.3.1 Generator

TAG	DESCRIPTION	RATING	RECOMMENDATION
N/A	Generator Natural Gas Engine	N/A	Monitor operation of generator, if there is inconsistent operation, review the manufacturer’s installation guidelines for natural gas pressure.
