Brock Township Building Assessment

MANILLA HALL
16990 SIMCOE STREET
Manilla

File 425001 | July 25, 2025

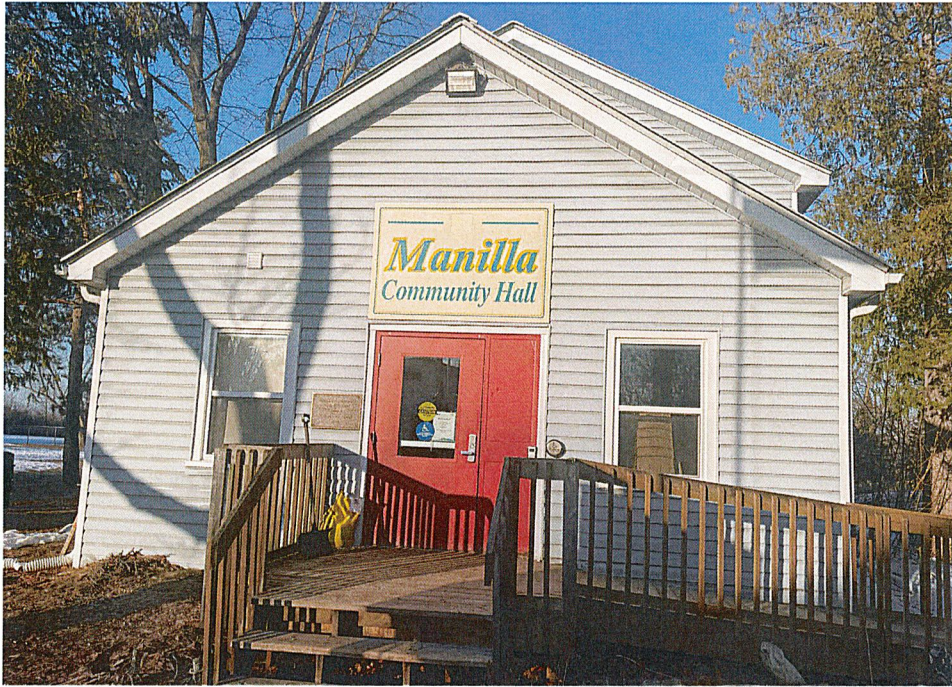
Tatham Engineering Limited (Tatham) was retained to perform a Building Assessment of the Manilla Hall, located at 16990 Simcoe Street, Manilla. We visited the site on March 18, 2025 and spoke with Wayne Ward to identify any areas of concern and provide details on operating procedures. An overall photograph of the building has been included as Photograph 1 in Appendix A.

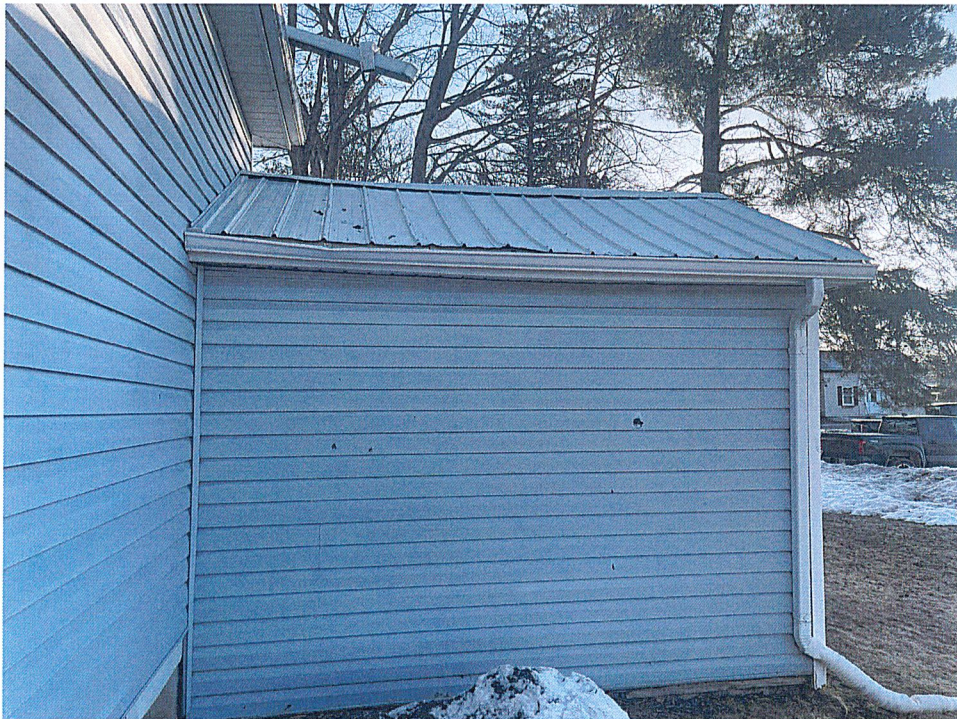
Photograph 3.1.1

1. The age of the existing metal roof could not be determined, however, the roofing appeared to be weathered with some localized damage at various locations along the perimeter (see Photograph 3.1.1). We recommend completing a complete roof replacement including ice/snow guards to protect the roof and structure against damage from future snow events.

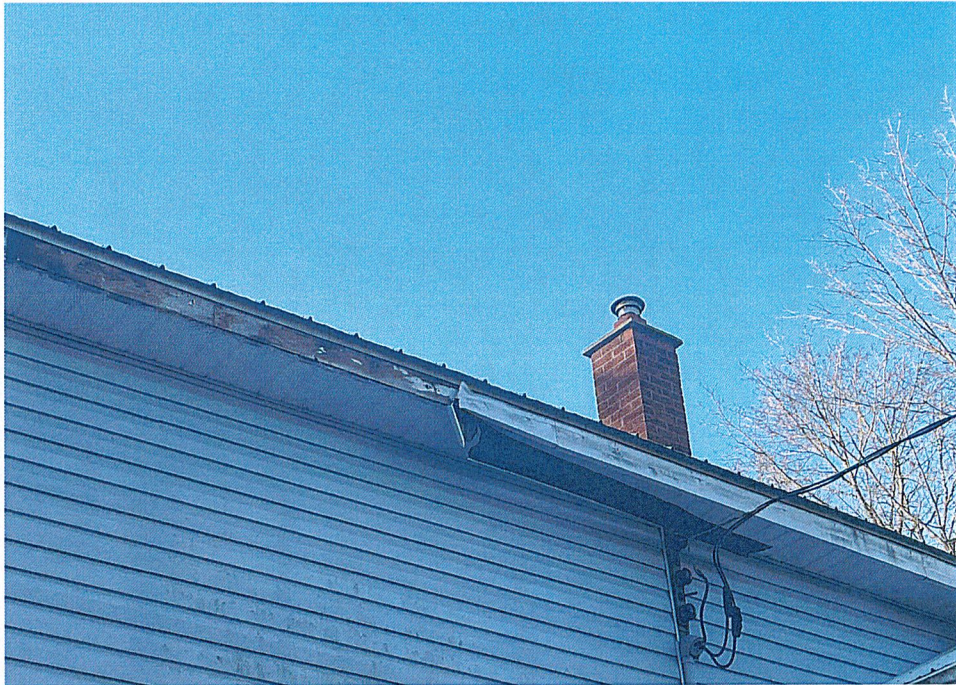
Photograph 3.1.2

2. The building fascia and soffit has been damaged due to snow pile-up (see Photograph 3.1.2). We recommend a new fascia and soffit be applied in conjunction with a roof replacement.

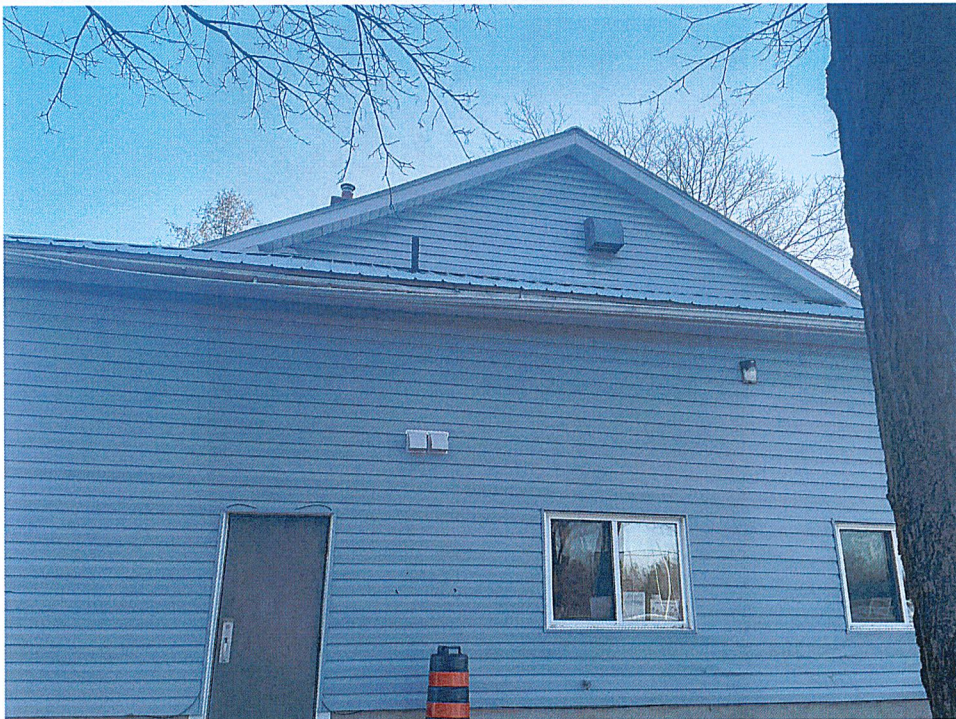
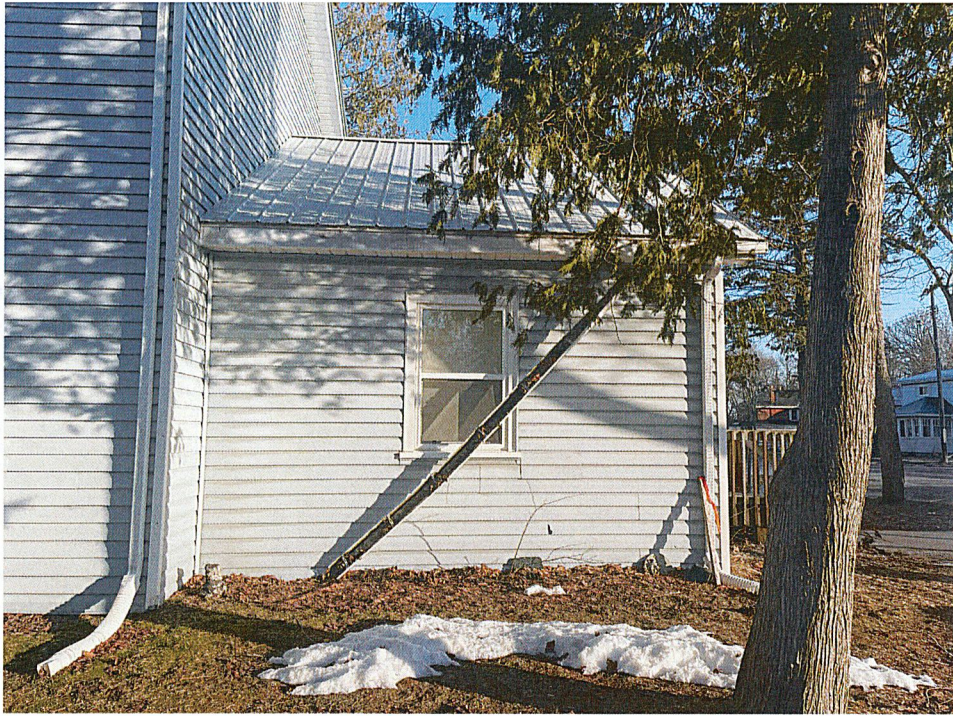
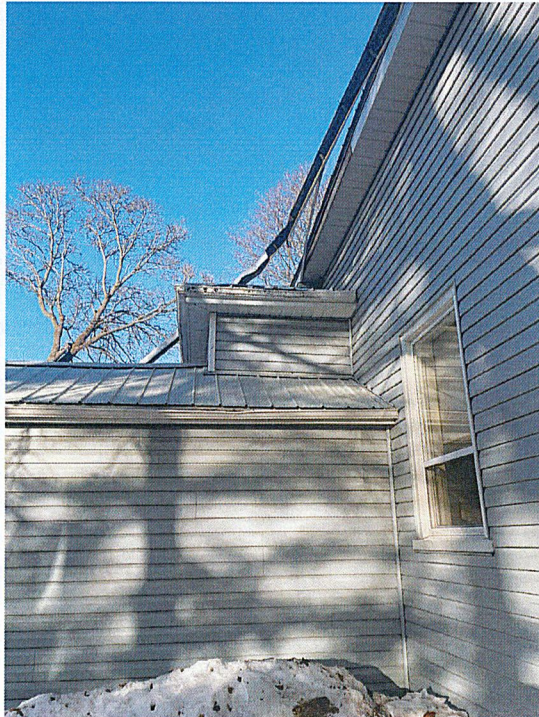
3. The building utilizes eavestroughs and downspouts to direct water away from the existing building perimeter and improve overall site drainage. The existing eavestroughs are in poor condition, damaged and in need of replacement (see Photograph 3.1.3, 3.1.4 and 3.1.5). New eavestroughs and downspouts are recommended, however, they are prone to damage during heavy snow fall events. The use of snow guards will provide enhanced protection.

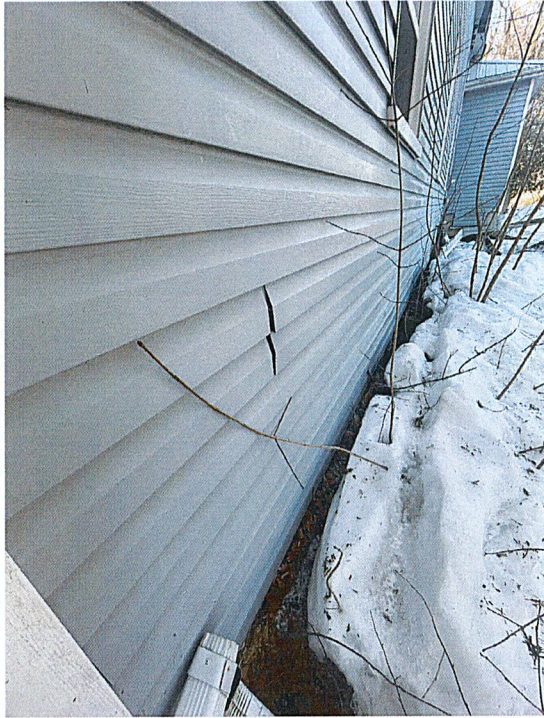
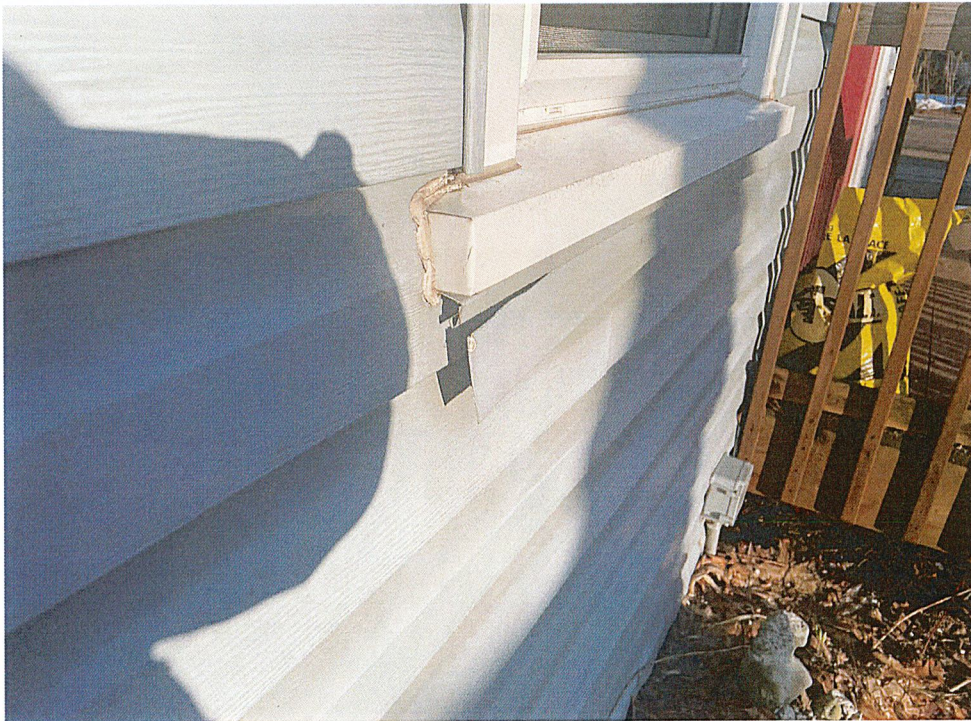
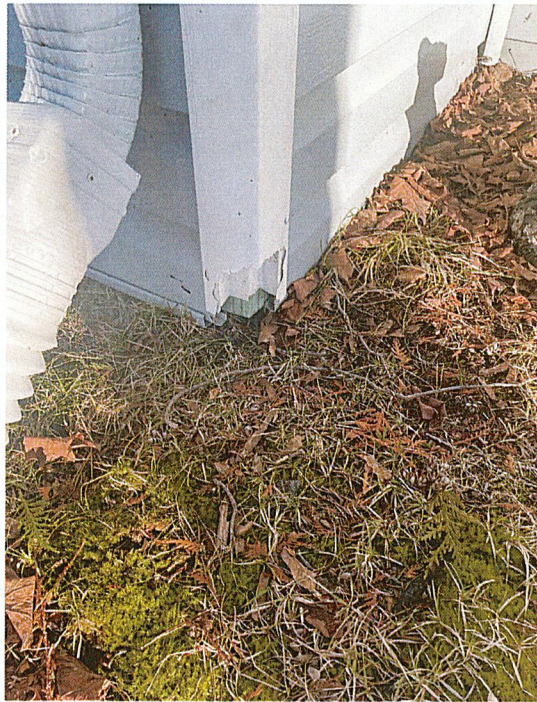
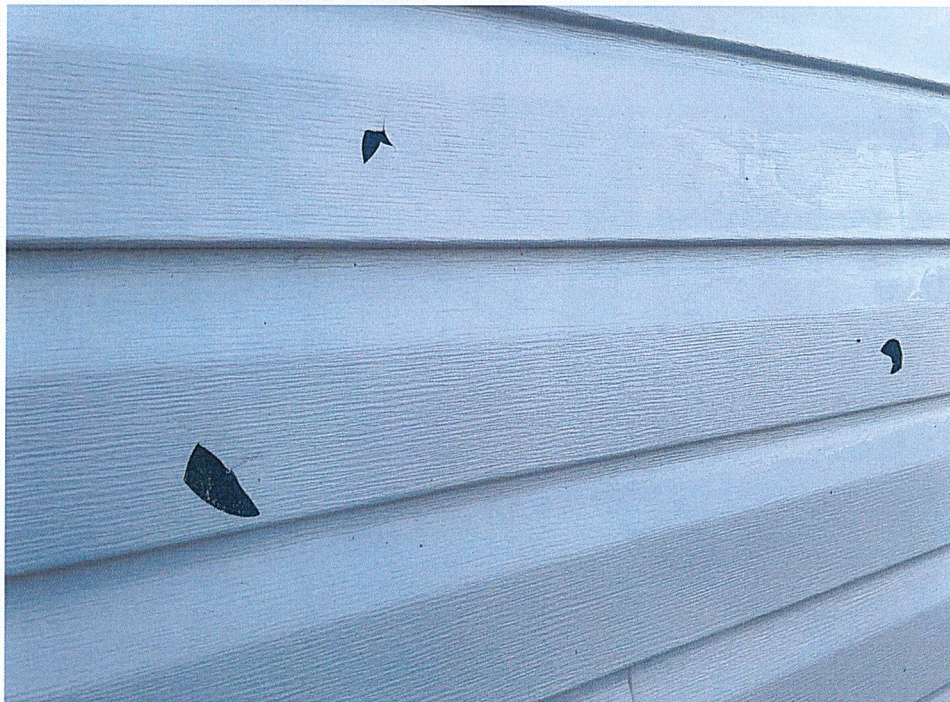
4. The existing vinyl siding has aged and is showing signs of deterioration and cracking. Over time, UV exposure will compromise the siding (see Photograph 3.1.6, 3.1.7, 3.1.8 and 3.1.9). Replace broken sump pump drainpipe and seal opening to protect the building envelope (see Photograph 3.1.10).

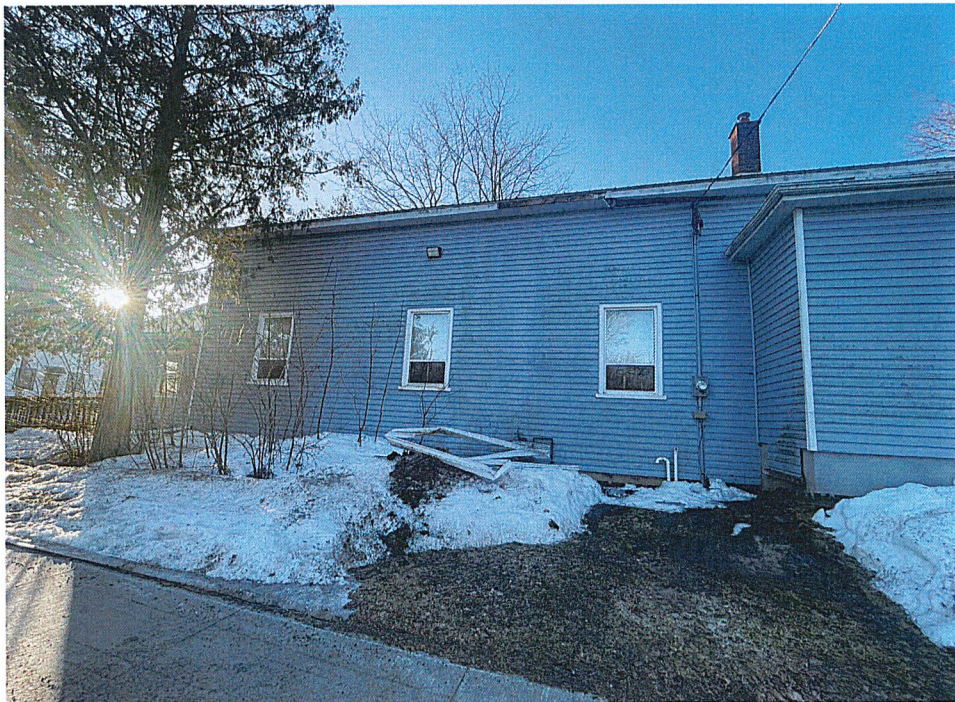
Photograph 3.1.11

5. Until such time as the siding is scheduled for replacement, we recommend the siding is washed to remove the mildew stains, particularly on the north elevation (see Photograph 3.1.11).

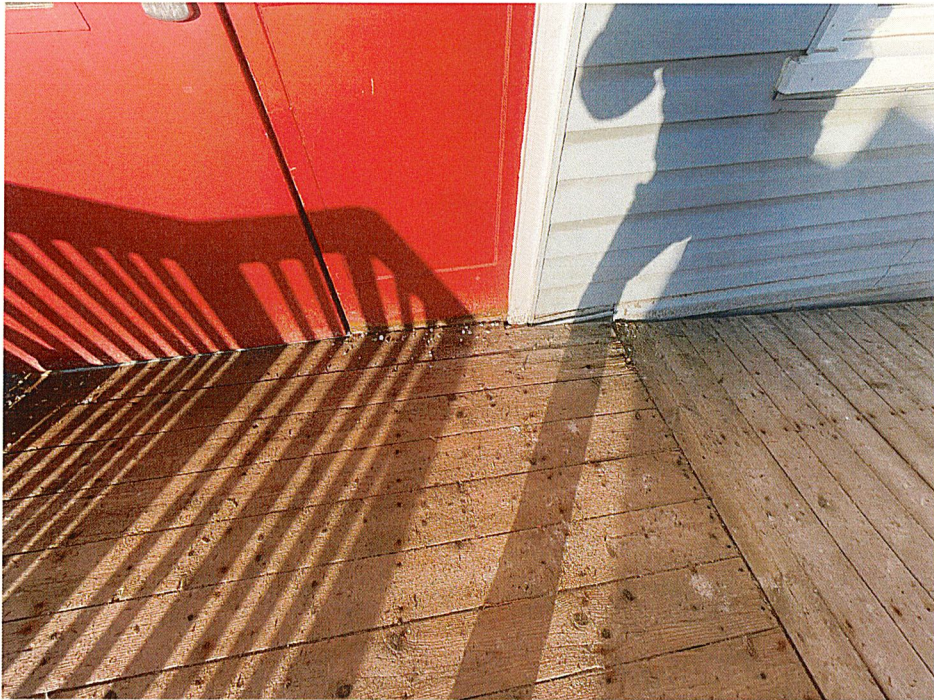
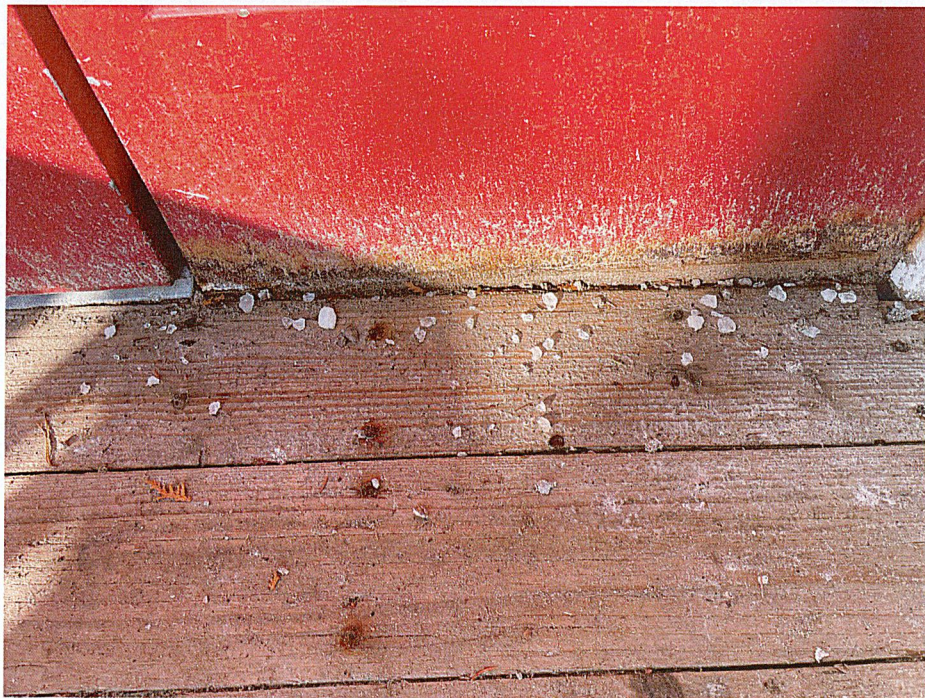
6. At main entrance door, sand and prime corroded hollow metal door and repaint to protect door (See Photograph 3.1.12 and 3.1.13).

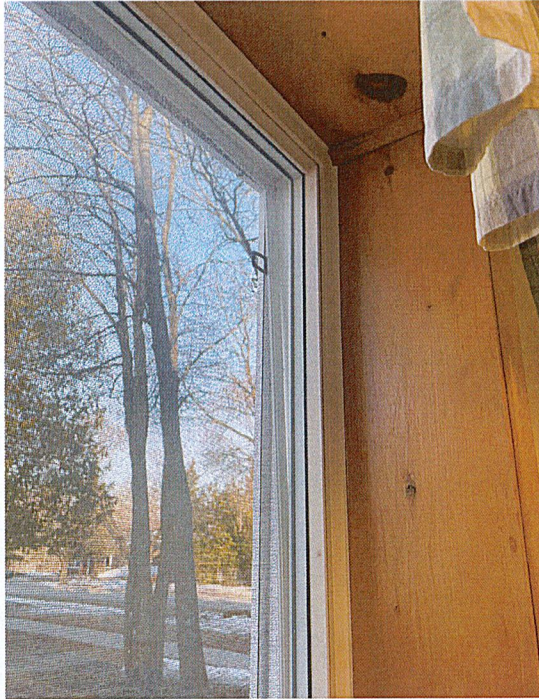
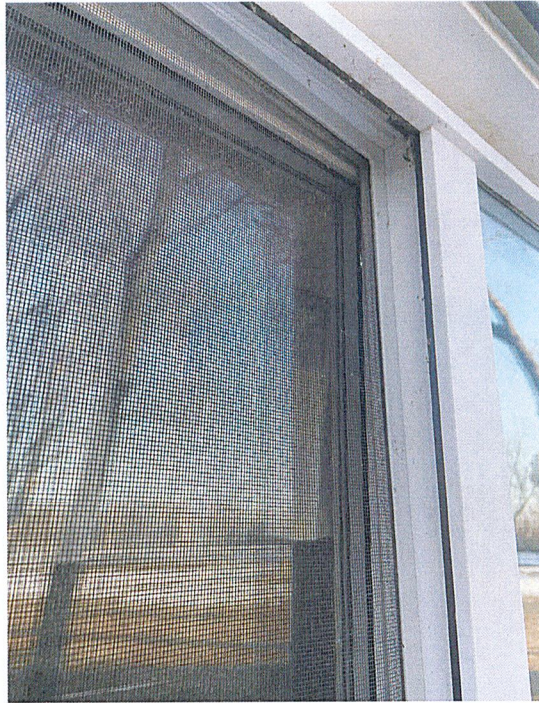
7. We observed dislodged or damaged window screens. We recommend that all windows are reviewed and screens replaced as required, particularly in food preparation areas (see Photographs 3.1.14 and 3.1.15).

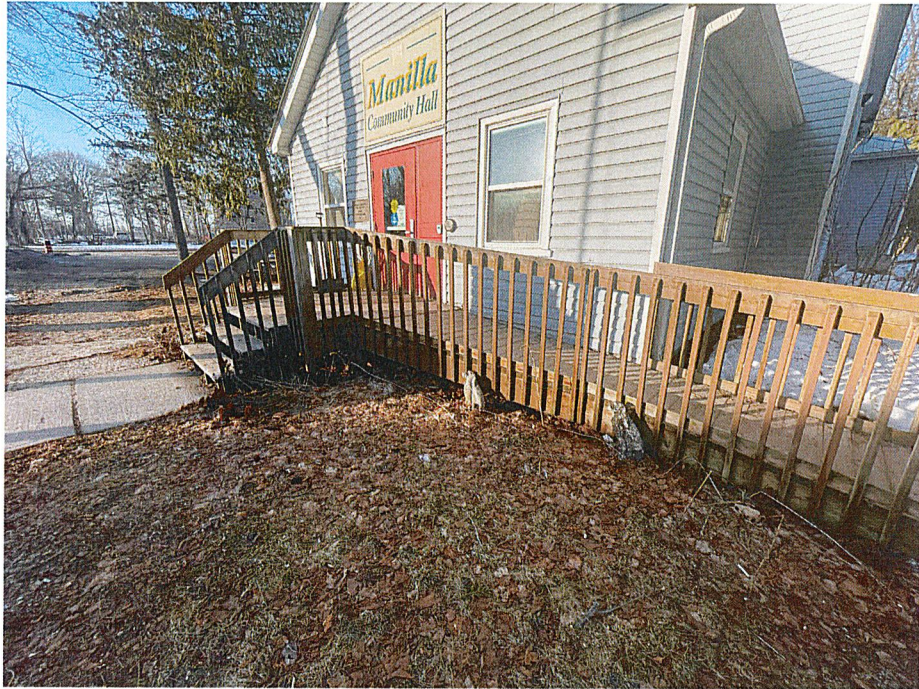
Photograph 3.1.16

8. Existing timber entrance ramp does not meet current OBC and AODA requirements (see Photograph 3.1.16). We recommend the wood entrance be removed and replaced with a concrete entrance ramp complete with proper wear surface and guards.

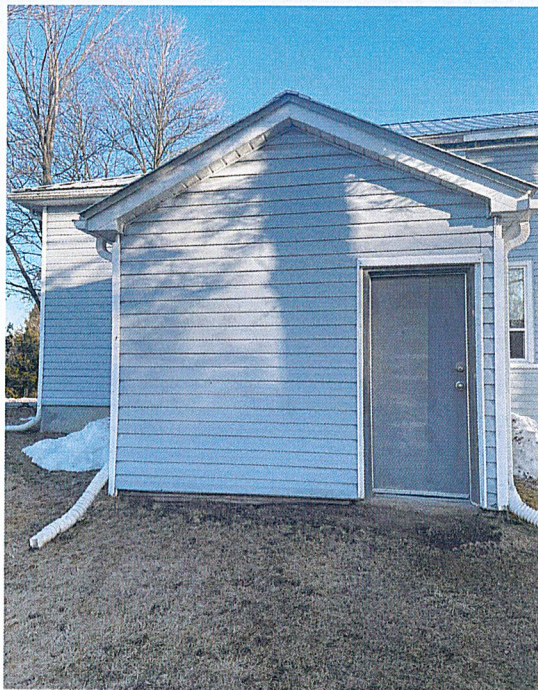
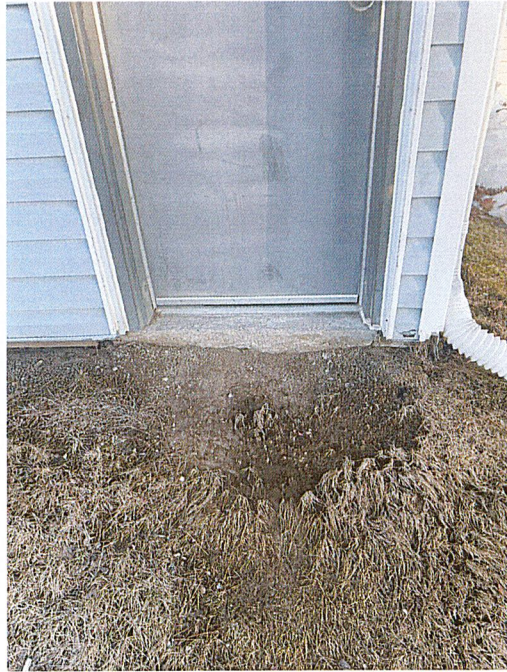
9. We recommend a landing be provided at the base of the existing exterior door on the south elevation (see Photograph 3.1.17 and 3.1.18).
10. Repair damaged GWB and apply new paint finish to match (see Photograph 3.1.19 and 3.1.20).

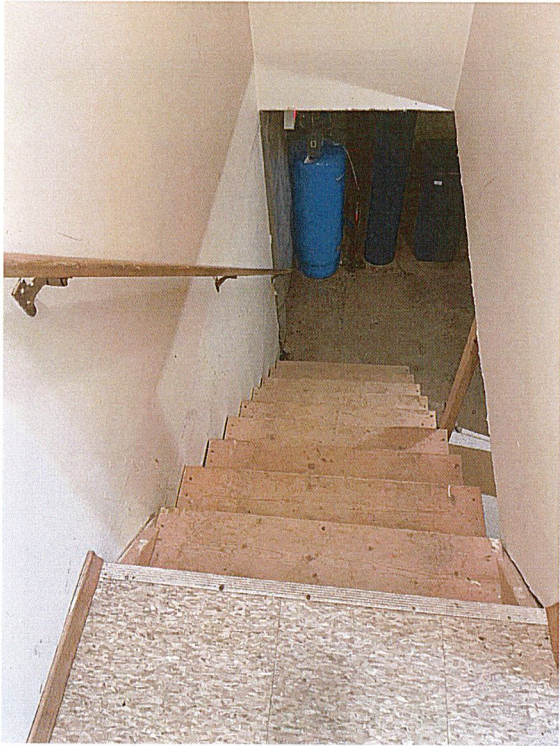
Photograph 3.1.21

11. Provide handrails on both sides of the basement exit stairs in accordance with OBC requirements (see Photograph 3.1.21).
12. We recommend exposed basement structural elements be reviewed for adequacy by a structural engineer. This includes a review of block foundation walls to determine if unit replacements and repointing is required for structural considerations (see Photograph 3.1.22). Moreover, although we did not observe signs of distress, the existing block piers are slender and they should be reviewed to confirm they can carry the intended loads as per OBC Part Four requirements (see Photograph 3.1.23). Lastly, the 2x10 wood joists have relied on notched connections into the existing 10x10 timber beams (see Photograph 3.1.24). This connection detail should be reviewed to ensure it meets current code structural requirements.
