File 421442

August 18, 2021

Re: Rick MacLeish Memorial Community Centre, Cannington  
Roof Deck Assessment

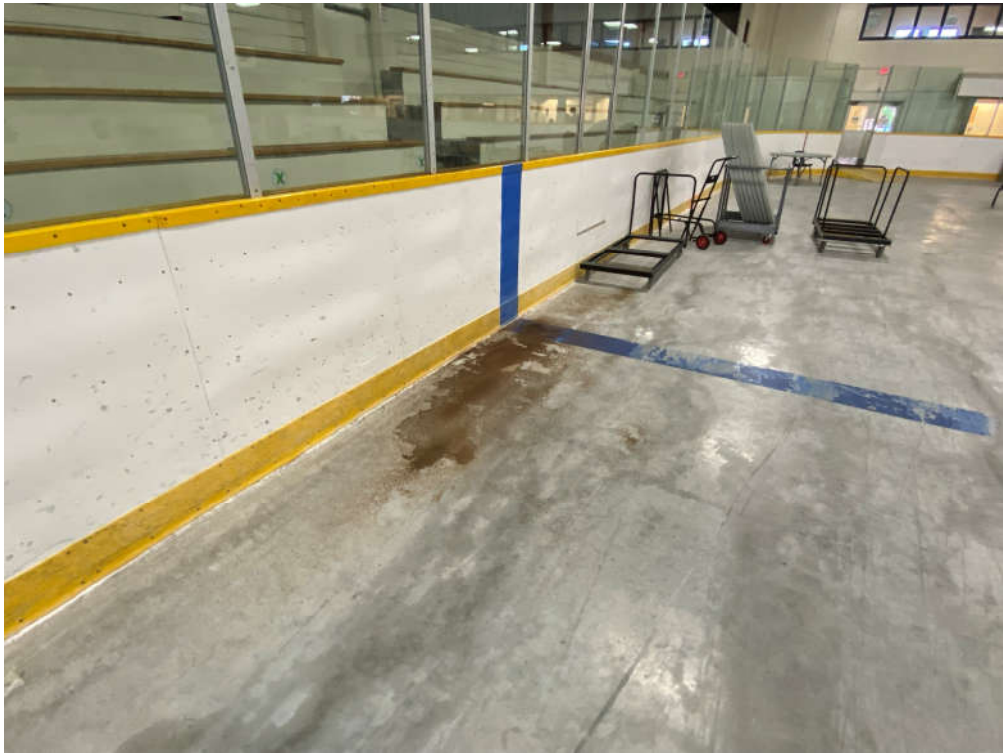
We understand the residue and carpenter ants have only been observed on the floor of the arena in one location. We met with the community centre staff while on site and they advised no signs of wood residue

Photograph 1: Wood residue on the arena floor due to ant damage above

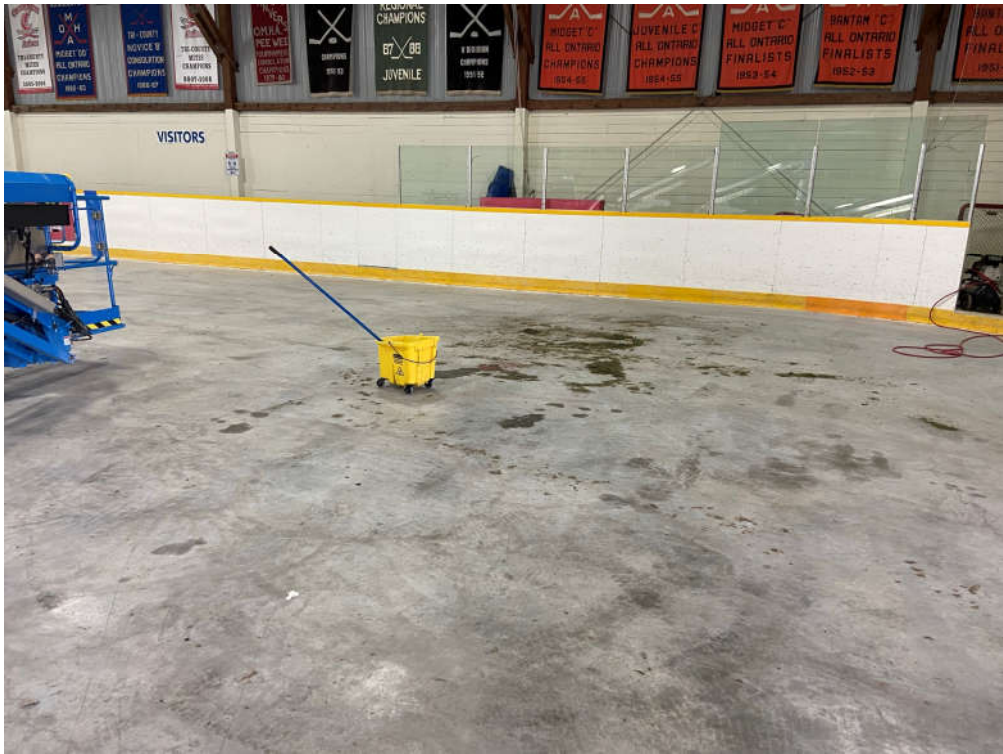
or carpenter ants have been observed other than the area previously identified. Community centre staff did note that one area of the roof at the south-east corner of the building has recently been actively leaking (Photograph 2). We understand active leakage has been an ongoing issue in the building.

Photograph 2: Reported roof leak at south-east corner of the building

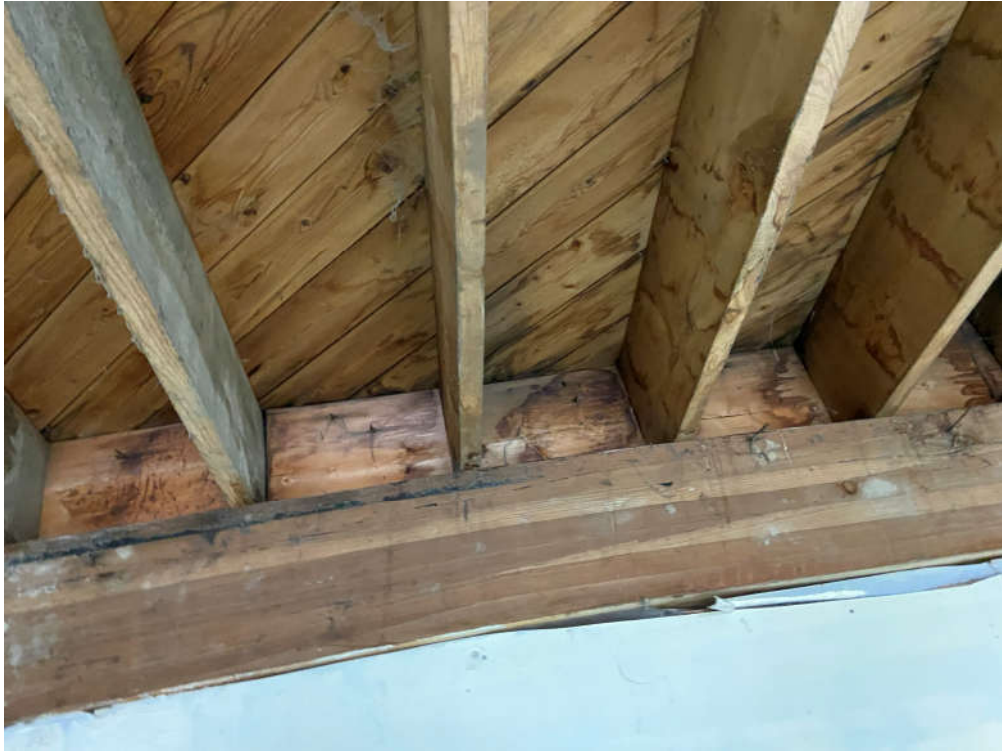
**Photograph 3: Area of water staining at north end of arena**

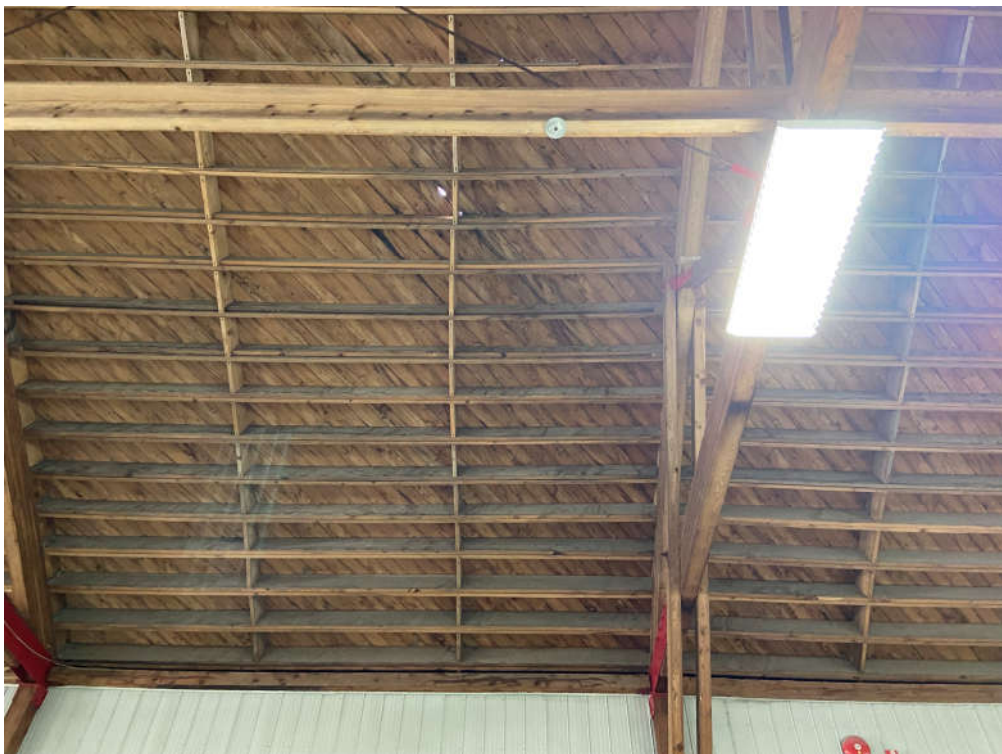
**Photograph 4: General area of ant damage seen from below**

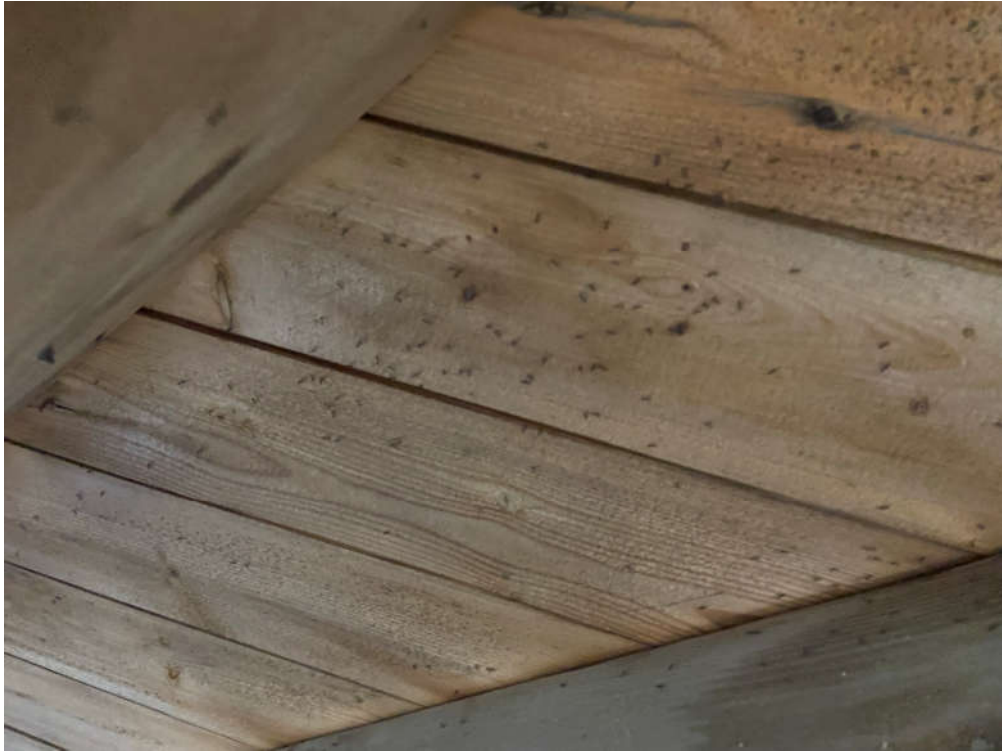
**Photograph 5: Ants observed at underside of roof deck**

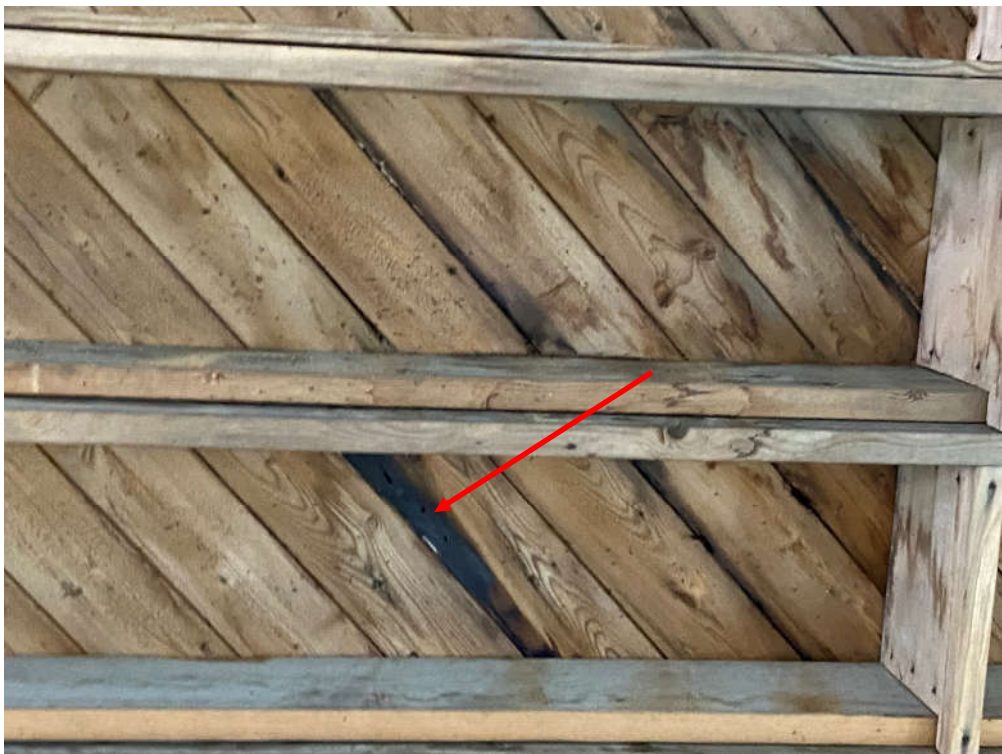
**Photograph 6: Area of deck deterioration where instrument fully penetrated roof deck**

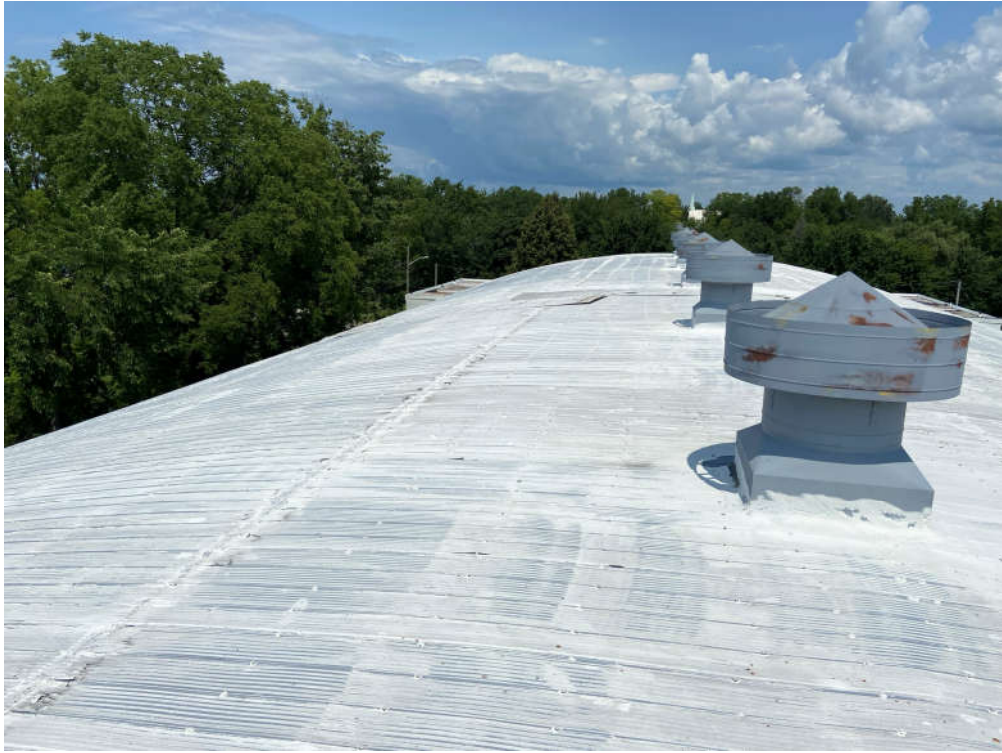
The existing metal roofing consists of corrugated sheets with exposed fasteners, fastened to the deck below. Each panel is approximately 3'-0" wide by 18'-0" to 20'-0" long and the panels have a profile that matches the curve of the barrel roof (Photograph 7). There are a total of five rows of panels across the width of the roof. It appears the metal roof has been painted in the past, possibly more than once, likely to prolong the life of the metal roof. Below the metal roofing is a bituminous built-up waterproofing membrane with a layer of roofing paper between the deck and the waterproofing. The waterproofing membrane had deteriorated (cracked) at various locations and the deck was visible through the waterproofing joints in localized areas.

- The existing metal roofing and waterproofing membrane is in poor condition and requires replacement, as previously noted in our 2020 assessment report.

Photograph 7: Overview of existing metal roof

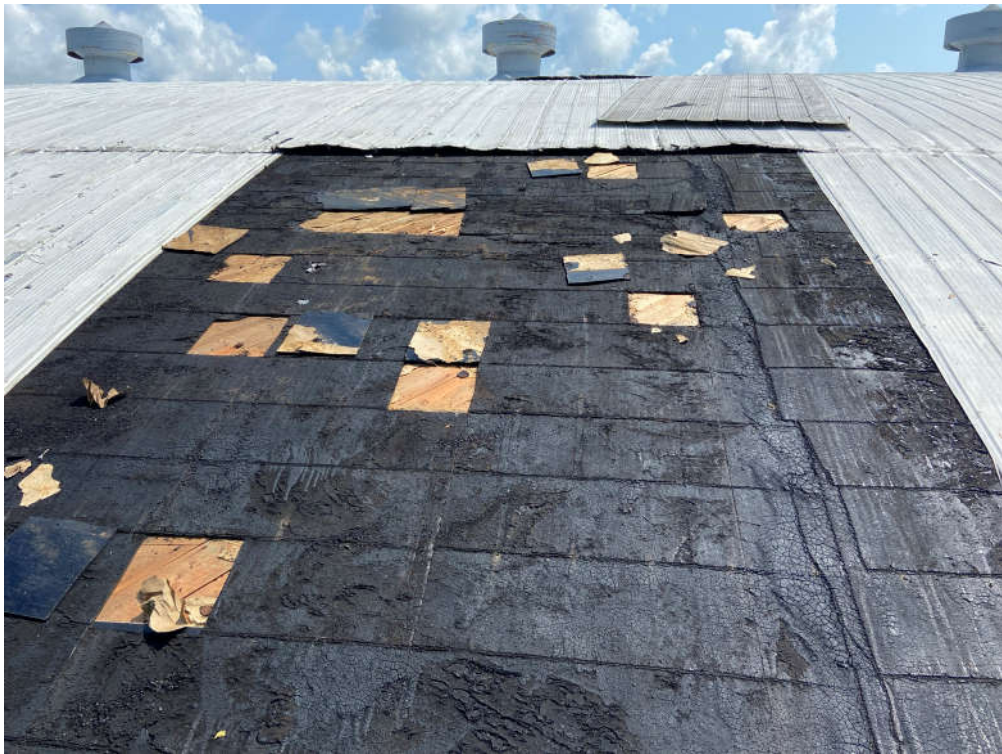
In the area where the ants were present, six panels at the eaves were removed. Ants were present on top and within the joints of the decking. The roof deck was prodded from above and the areas of deterioration appeared to mirror the results of the investigation at the underside of the deck (Photograph 8). The extent

of the ants and the deteriorated deck is within approximately a 10'-0" by 10'-0" area. The moisture content measured was approximately 30%.

- The wood deck in the area where the ants were observed has significantly deteriorated and must be replaced.
- The remainder of the wood deck was found to be generally in satisfactory condition.

Photograph 8: Area of ant damage and deteriorated roof deck from above

The estimated quantity of deck removal and replacement is 100 square feet. If the Township proceeds to procure a contractor to replace the roofing materials, we recommend a quantity of 250 square feet of deck replacement be carried to account for any hidden deterioration that may be discovered during construction and for the replacement of any excessively wet areas that are found during construction. We estimate the cost to replace this area of deck to be \$30,000 to \$35,000 assuming the work is completed as part of a larger roofing replacement project.

- Expose and assess the roof deck to verify the extents of repair with the contractor and determine if any other areas of the wood deck have deteriorated and require decking replacement.
- Hire an insect extermination service to confirm the extent of the ants and remove the ants as required.
- For the ice and water shield to properly adhere to the roof deck, the deck must be dry. Therefore, once the deck is exposed, sufficient time must be provided to allow the deck surface to completely dry prior to installation of a new ice and water shield. After a reasonable amount of time has elapsed, any areas of the roof deck that still contain excessive moisture should be removed and replaced to facilitate the installation of a new ice and water shield.

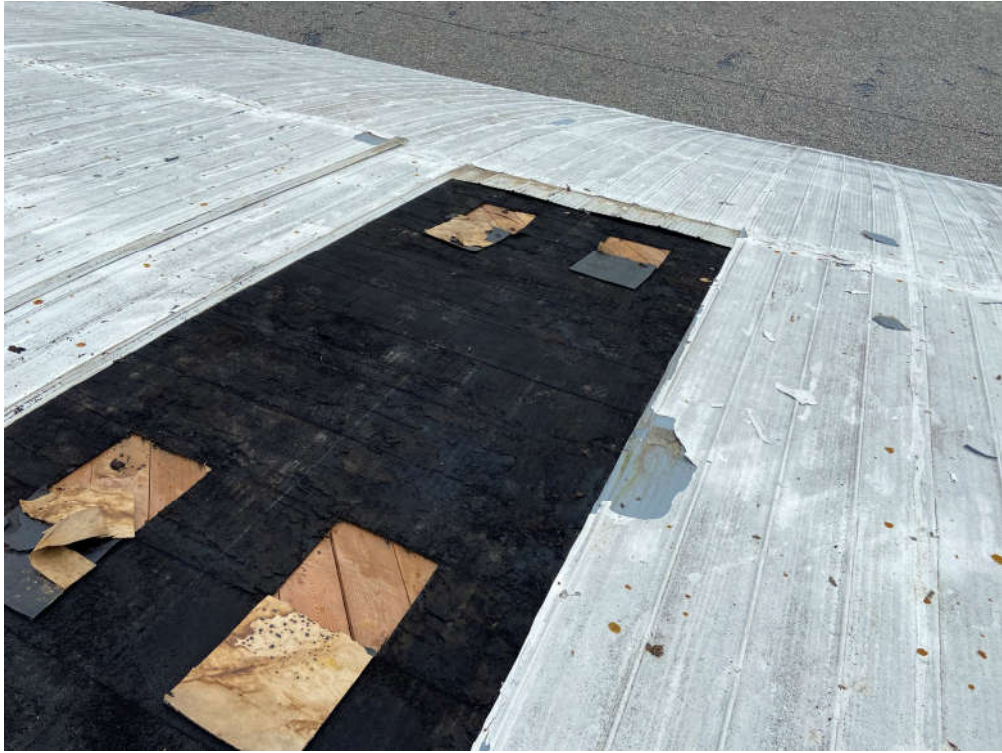
Above the location where the arena staff reported the leak, two adjacent roof panels at the second row above the eaves were removed (Photograph 9) and the waterproofing was removed at various locations. No ants were present, and no signs of deck deterioration were noted. The wood moisture content measured was approximately 30% in the areas of water staining.

**Photograph 9: Roof deck exposed at reported roof leak at south-east corner of building**

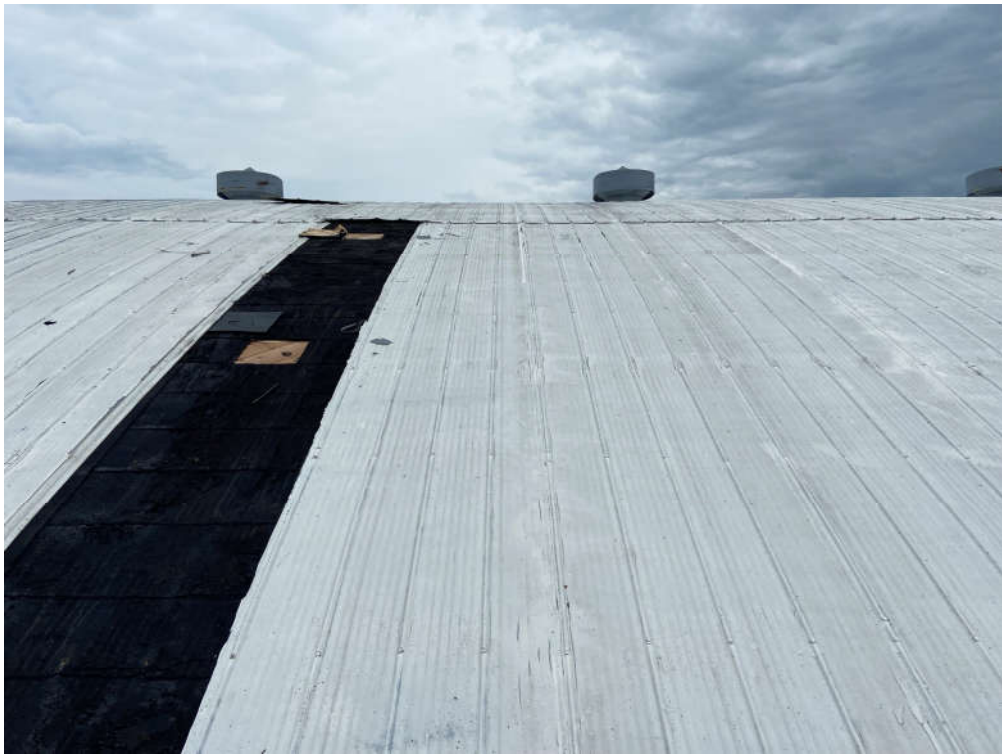
One panel was removed at two other locations selected at random; one on the west side of the building at the eaves (Photograph 10) and one at the north end of the building on the top of the roof (Photograph 11 & Photograph 12) At both locations, no signs of deck deterioration were noted, and no signs of water leakage were noted. The moisture content measured was between 5%-10%.

**Photograph 10: Exposed roof deck at randomly selected location at west side of building**

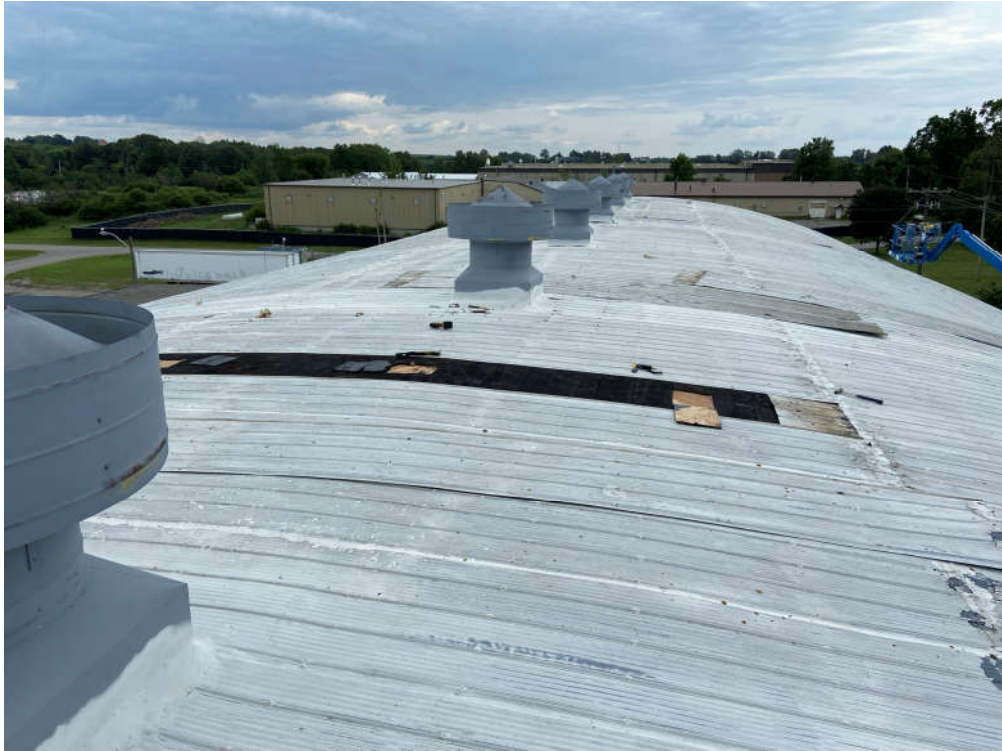
Photograph 11: Overview of exposed roof deck at randomly selected location at north end of building

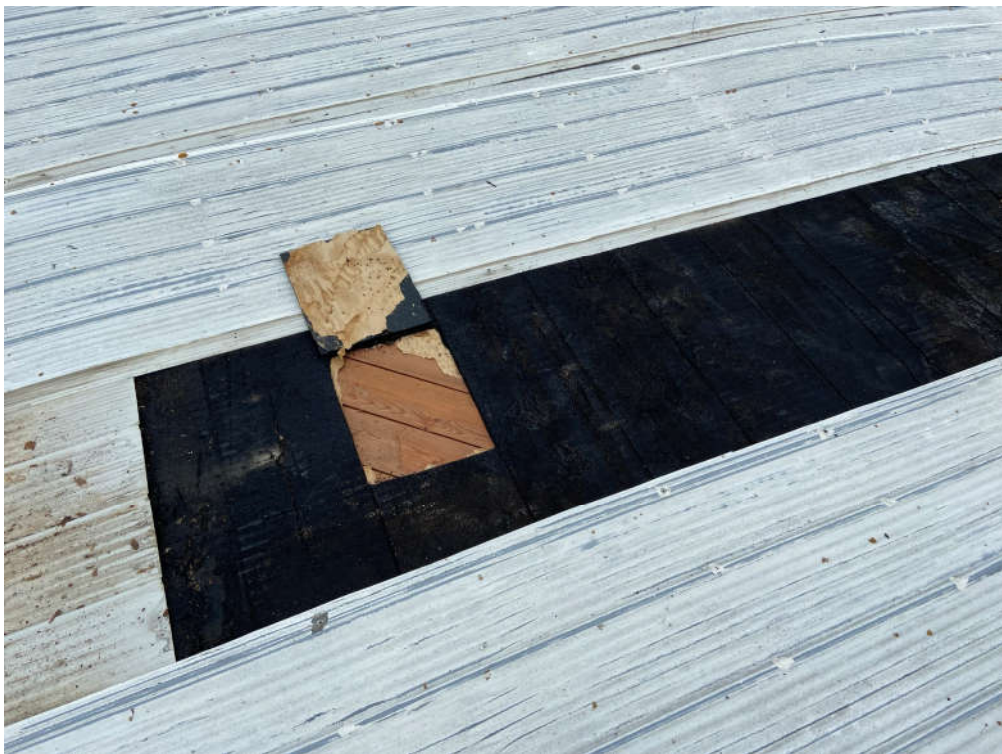
Photograph 12: Close-up of exposed roof deck at north end of building
