Structural Condition Investigation, Report and Review for
Rick MacLeish Memorial Community Centre
91 Elliot Street, Cannington, ON
The Corporation of the Township of Brock

BBA PROJECT NO. 22124

SEPTEMBER 14, 2022

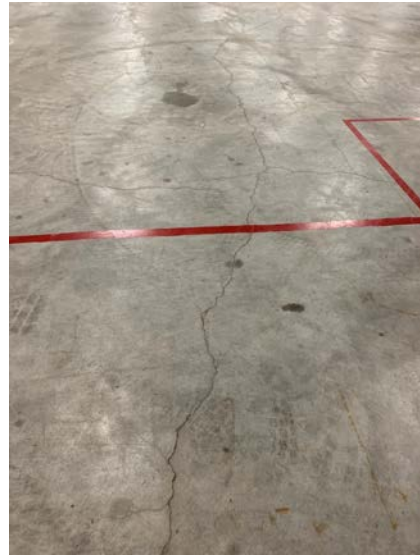
Photo 10

- Hairline surface cracks were observed throughout the rink slab. These are not a structural concern at this time however should continue to be monitored for further propagation.
- More significant cracking was observed at the south end of the rink slab (Photo 10). These cracks should be repaired to protect against continued deterioration.

1. Repair or replace concrete slab-on-grade at ice-resurfacers room.
2. Repair or replace concrete housekeeping pads.
3. Repair cracks in rink slab.
4. Rout out and repoint deteriorated/open/cracked mortar joints.
5. Repair damage to landscaping concrete retaining/stair structures.
6. Clean staining/efflorescence from concrete block walls.

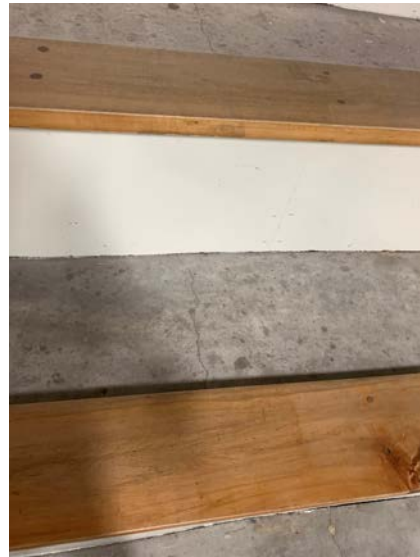
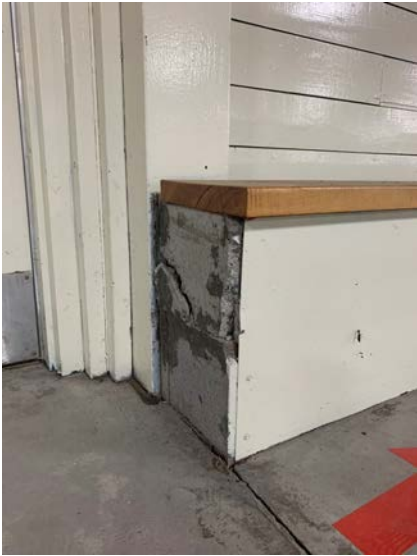
- Minor cracks were observed throughout the concrete bleachers, however these are not structural concerns at this time (Photo 12).
- Spalling and delaminating concrete were observed at a single location on the southernmost stair (Photo 13). This area requires to be repaired.

1. Complete an analysis of the figure skating support hoist system and support framing, if not previously complete.
2. Repair concrete at bleacher stairs.
3. Extend short erection bolts at roof framing connections.
4. Provide proper support of exterior stair posts.

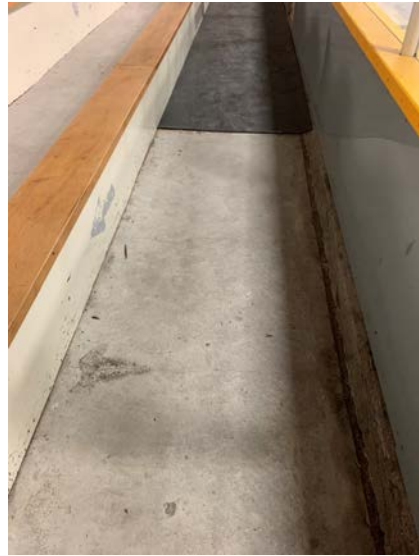
Photo 14

- Minor hairline/shrinkage cracks were observed on the surface of the apron slab (Photo 14). This surface cracking is typical of slab-on-grade and is not currently a structural concern. These should continue to be monitored for further deterioration.
- Concrete ramps around the apron slab appeared to be in good condition with no notable deterioration or damage.

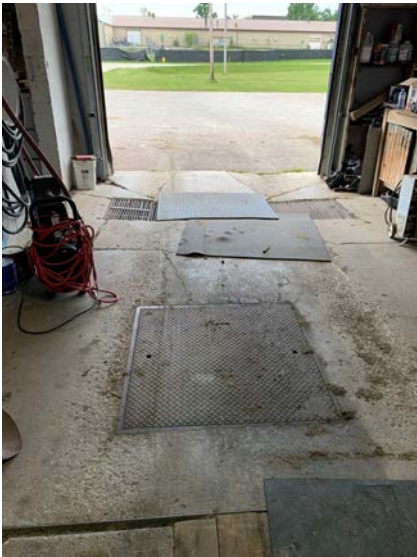
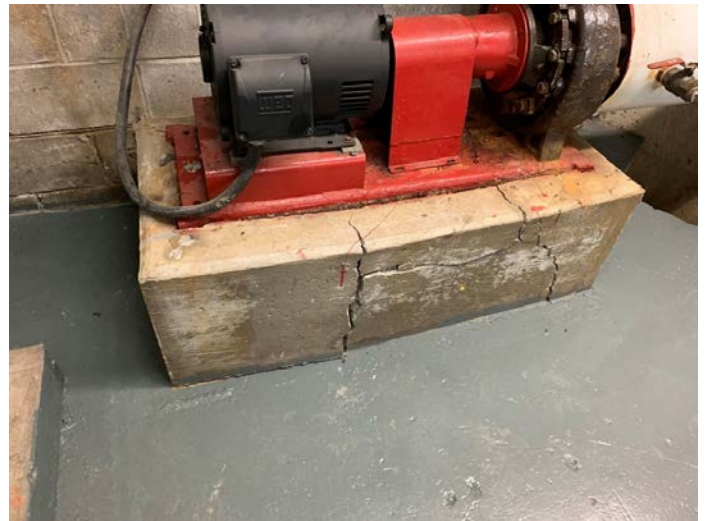
- Significant damage, deterioration and rutting was observed in the ice-resurfacer room (Photo 15). Localized areas of settlement may have also occurred around trench drains. Given the current condition, we recommend that the ice-resurfacer room slab be repaired or replaced.
- In the ice-making plant, the slab-on-grade appeared to be in good condition, with only minor hairline cracks observed. These cracks are not a structural concern at this time.
- Damage to the housekeeping pads within the ice-making plant was observed (Photo 16). We recommend these areas to be repaired.

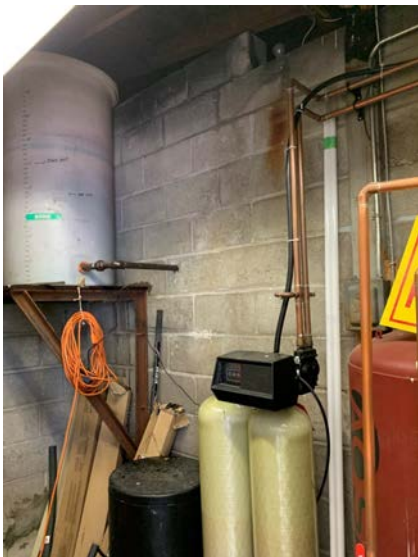
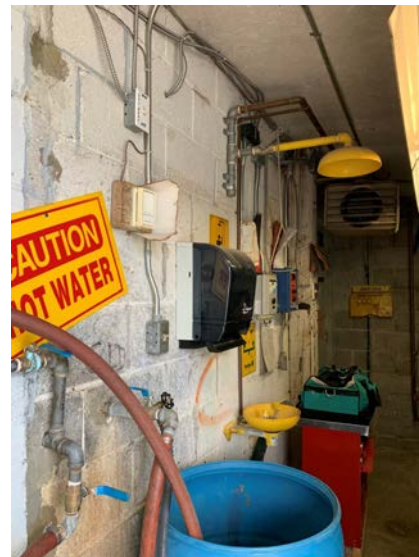
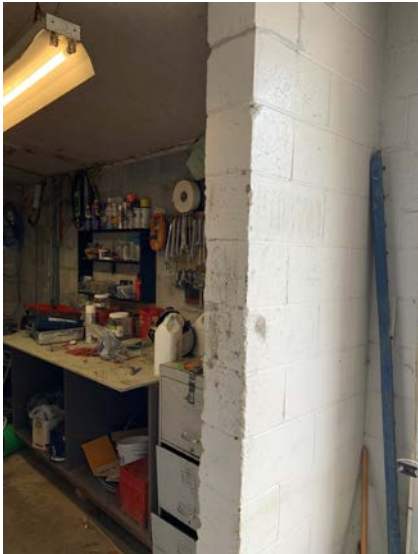
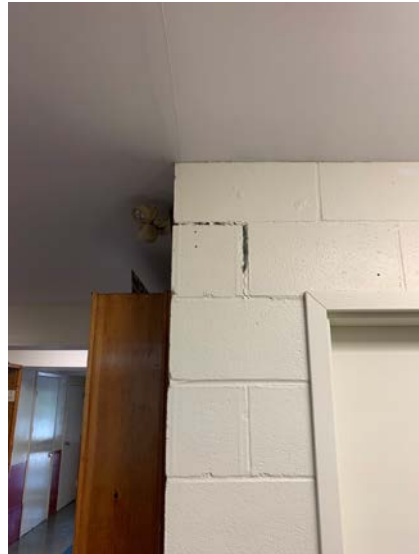
- Staining and efflorescence were observed on the interior face of the concrete block masonry walls in the ice-making plant, indicating the presence of moisture (Photo 17, 18). These areas should be cleaned and monitored for worsening conditions.
- Minor cracking, deteriorated mortar joints and other damage were observed in the ice-resurfer and mechanical rooms (Photo 19, 20, 21). These areas should be cleaned and monitored for worsening conditions.
- Deteriorated mortar joints were observed at some locations throughout the partition walls at the ground floor (Photo 22). It is recommended that these be routed and repointed with appropriate repair mortar.

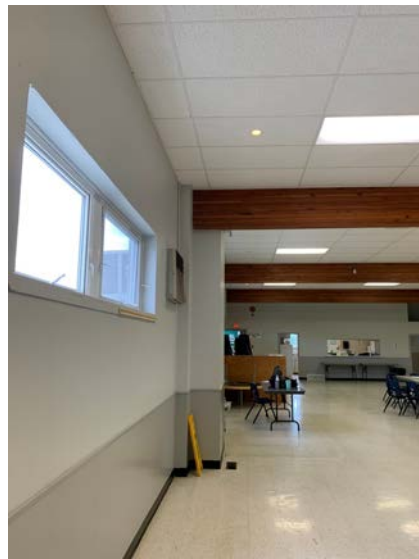
The roof framing consists of steel deck on 2x12 joists at 16" c/c, supported by 7"x30-7/8" glulam beams that bear on 7"x13" glulam columns and masonry piers (Photo 23, 24). Observations are as follows:

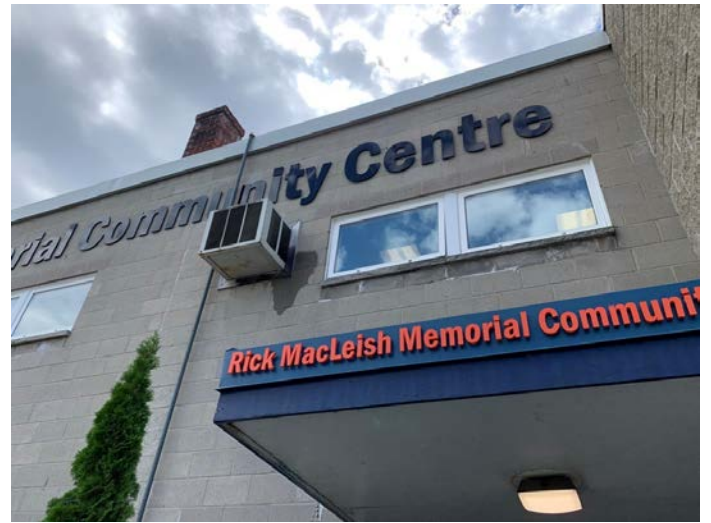
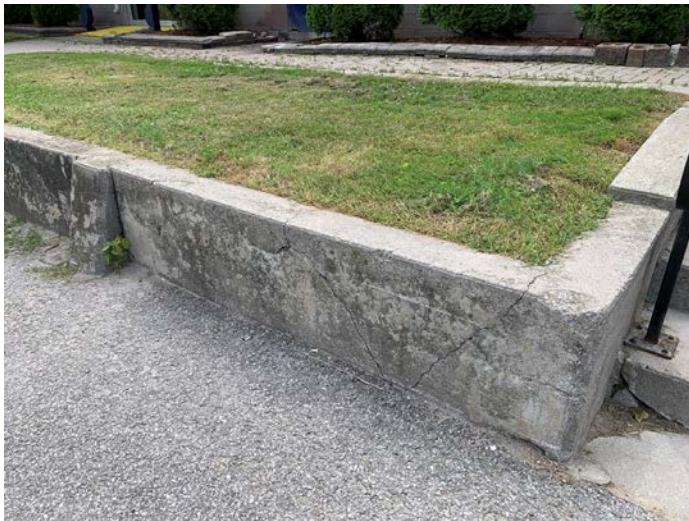
- Minor deterioration and staining were observed on the split-face block at the elevator room roof down spout location; it appears that the downspout has been removed (Photo 29).
- Deteriorated mortar joints, damage and staining were observed below the windows (Photo 30). It is recommended that cracked joints be routed and repointed with appropriate repair mortar.
- Significant cracking was observed in the concrete landscaping retaining walls and stairs (Photo 31). Repair is recommended as to avoid further damage and deterioration from water penetration and freeze-thaw action.

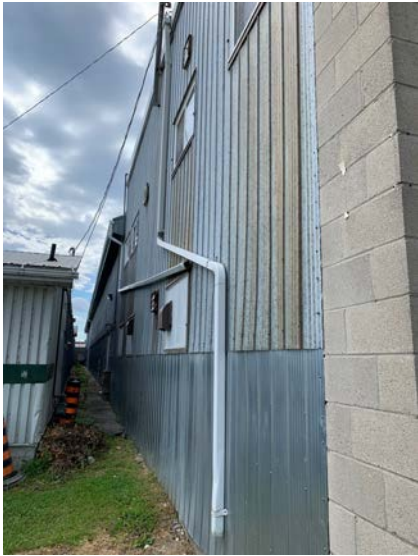
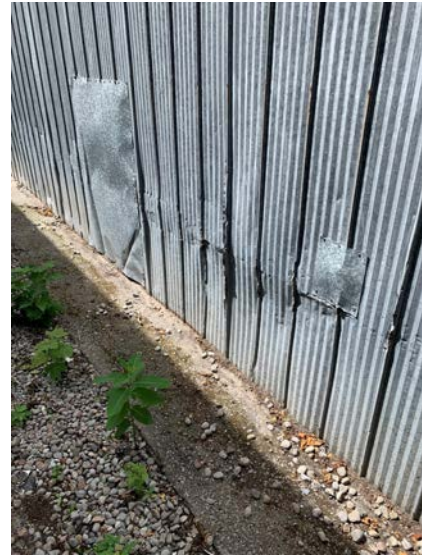
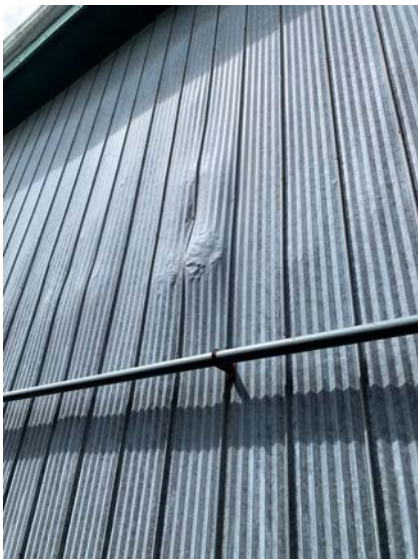
- Minor corrosion was observed on the metal cladding below windows (Photo 33). These areas should continue to be monitored for further degradation.
- Damaged and deformed metal cladding observed at various locations (Photo 34, 35).

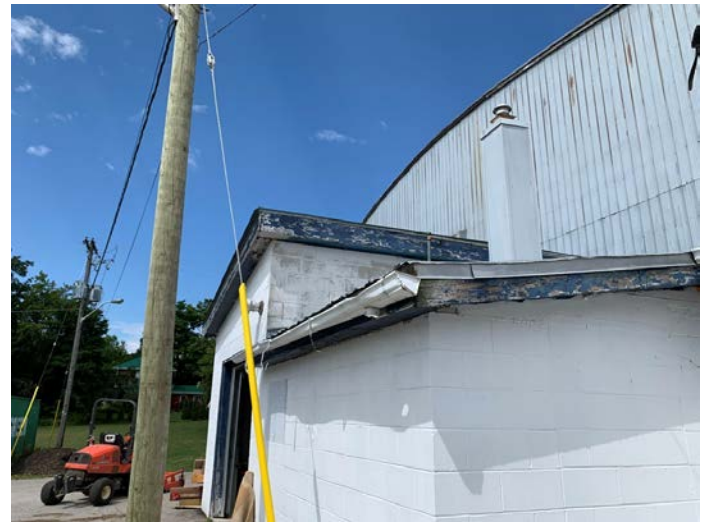
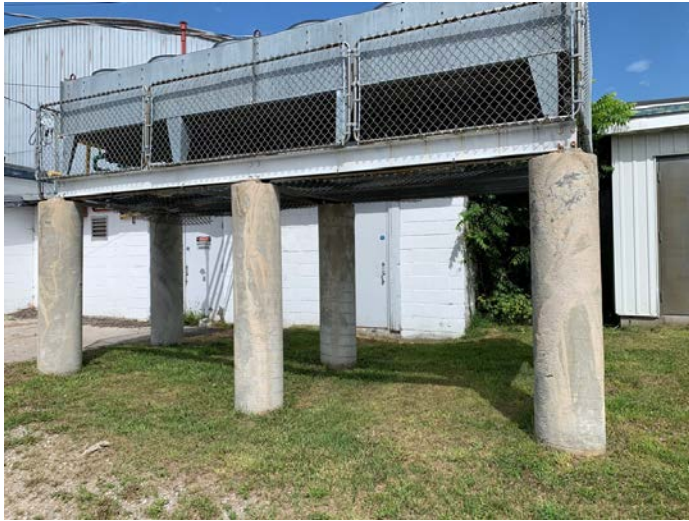
The south elevation generally consists of concrete masonry block walls with pre-finished metal cladding above (Photo 36). Located on the south elevation is the ice-resurfacer and ice-making plant extensions, as well as a mechanical unit support structure (Photo 37). Observations are as follows:

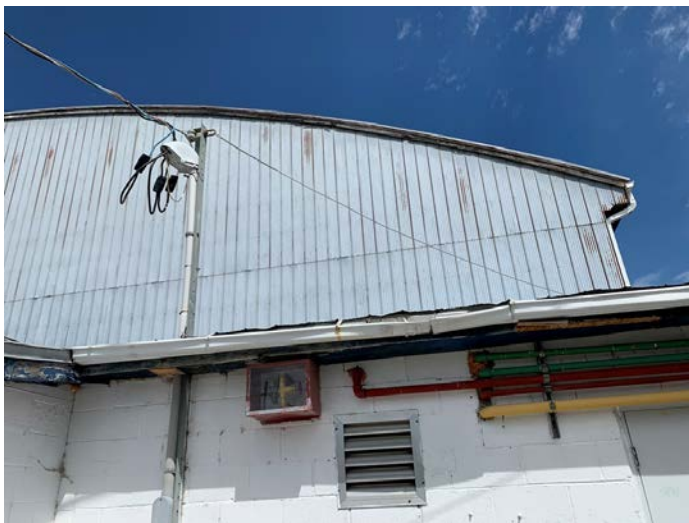
- Paint peeling and deterioration were observed along timber roof framing at the ice-resurfacer and mechanical rooms. Any areas of rot should be removed and replaced. Other areas should be re-painted.
- Concrete block masonry walls appear to be in fair condition (Photo 38).
- Minor surface corrosion was observed throughout original metal cladding (Photo 39). Corrosion should continue to be monitored.
