**Structural Condition Investigation, Report and Review for
Sunderland Brock Memorial Arena
20 Park Street, Sunderland, ON
The Corporation of the Township of Brock**

BBA PROJECT NO. 22124

SEPTEMBER 9, 2022

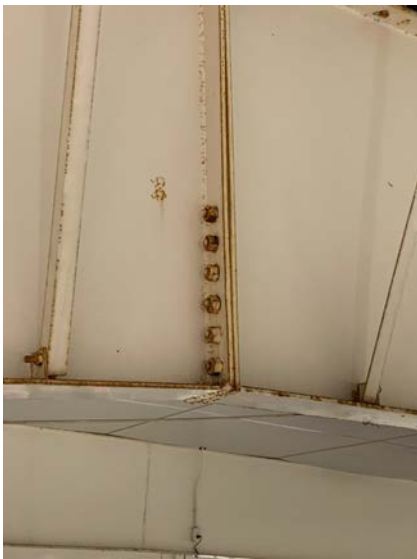
Photo 03

- Minor surface corrosion and peeling paint was observed throughout the pre-engineered frames, most notably on the bottom flange members and at connections/bolts (Photos 003). These areas should be cleaned to bare metal and prime painted to prolong the service life of the steel framework.

1. Rout out and repoint deteriorated/open/cracked mortar joints.
2. Repair cracks in rink slab or consider full replacement.
3. Clean corrosion and repaint pre-engineered framing.
4. Repair damage to concrete foundation wall on east elevation.
5. Replace sealant at external expansion joints.
6. Replace guards on west wall louvres.

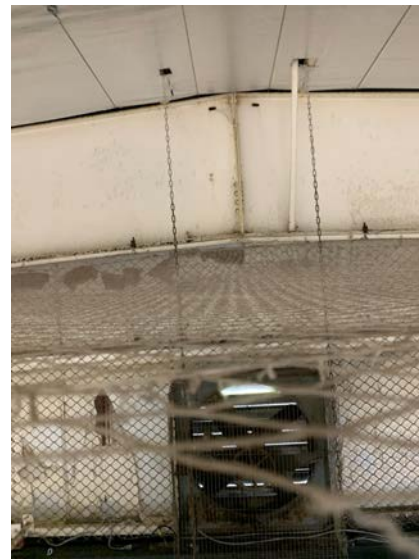
Photo 04

- Missing and/or damaged lateral support braces and bolts were observed at several locations throughout the pre-engineered steel frames. (Photos 004, 005, 006, 007). These must be replaced to reinstate the structural integrity of the frame.

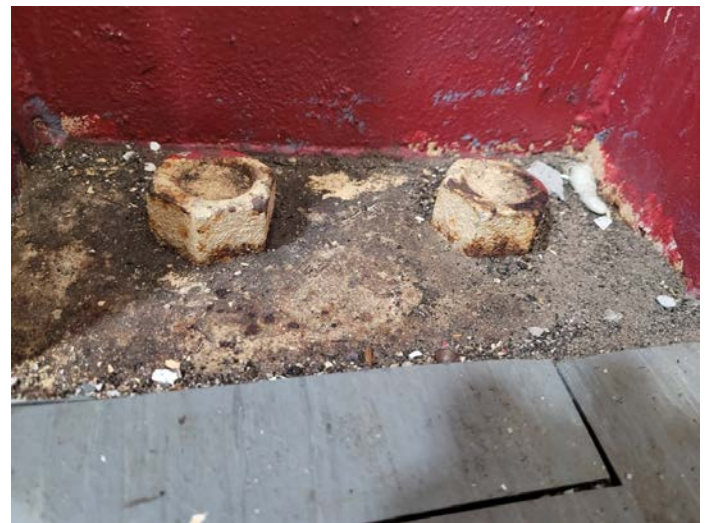
Photo 08

- Short thread extensions were observed on several of the column baseplate anchor bolts and should be extended (Photo 008, 009, 010). Further review is required to determine the specific requirements and options for repair.

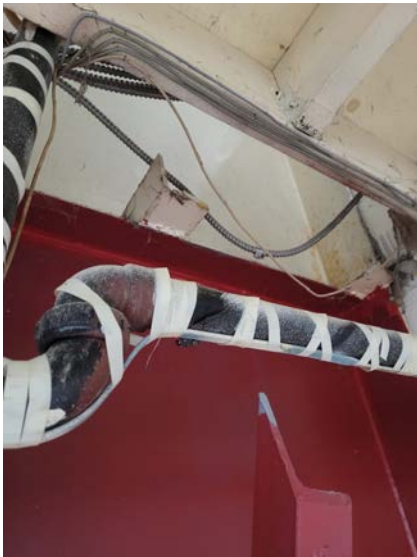
Photo 11

- Lateral support bracing has been removed to accommodate platform at the column in the northeast corner of the arena (Photo 011). Missing bracing components must be replaced to reinstate the structural integrity of the frame.

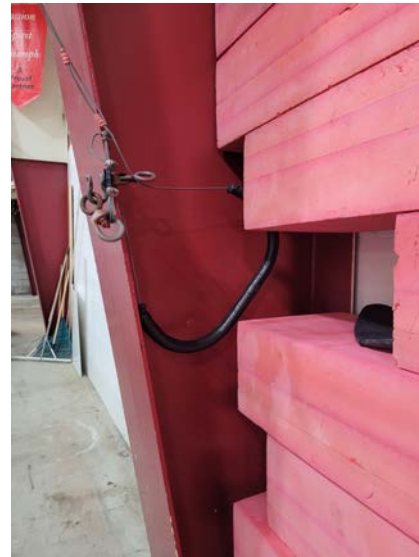
Photo 12

- It appears that a figure skating support hoist has been installed along one of the frames near the south end of the arena. It is unclear whether the hoist connections or supporting framing have been engineered (Photo 012, 013). Further review is required to determine whether the existing system is sufficient to support the necessary loading conditions.

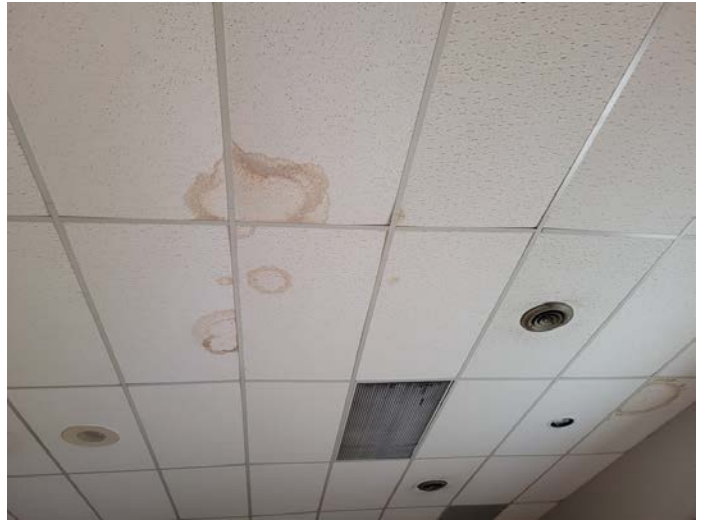
Photo 14

- Localized staining at suspended ceiling tiles was observed within the second floor community room, indicating potential areas of roof leaks (Photo 014). Further investigation is required to determine the source and severity of any moisture infiltration.

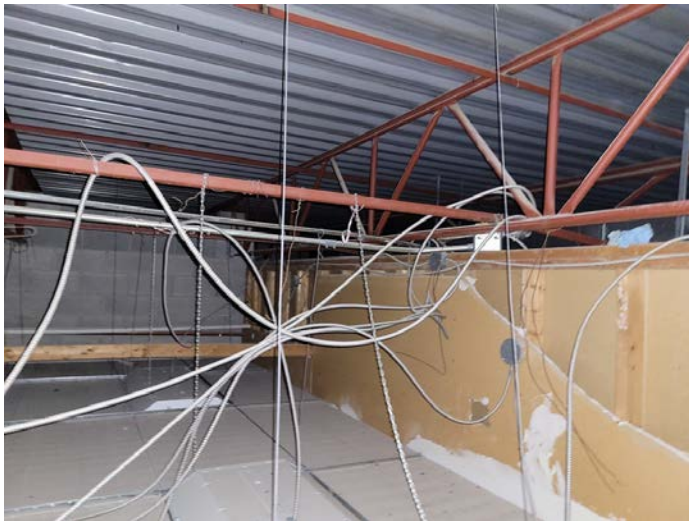
Photo 15

- The OWSJ and metal roof deck appear in good condition with no signs of damage or deterioration (Photo 015).

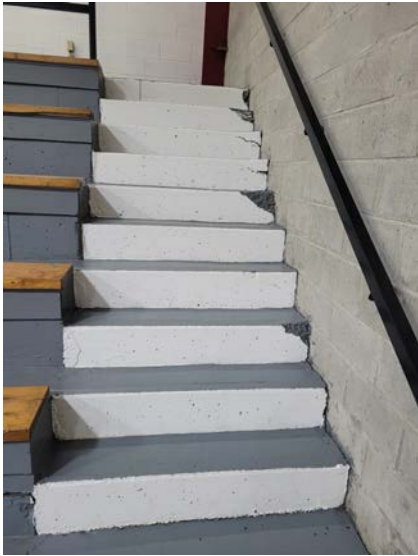
Photo 17

- Concrete damage was observed through the northmost stairs (Photo 017, 018). It is recommended that this damage be repaired to prohibit further structural degradation and eliminate the potential tripping hazard that currently exists.
- Minor cracking and damage was observed throughout (Photo 019, 020). These cracks are not currently a structural concern however, they should continue to be monitored for further deterioration.
- On the underside of the bleachers, minor honeycombing was observed. As the honeycombing is not significant, and no spalling or delamination was observed, no structural action is required. It is recommended that these areas continue to be monitored.

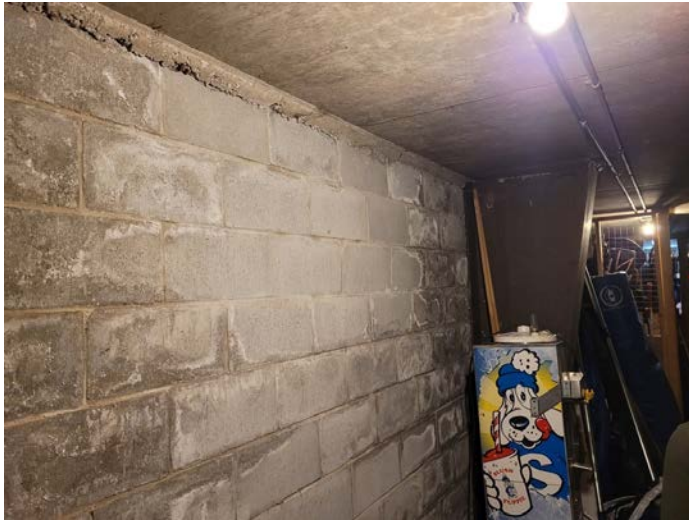
Photo 21

- Step cracking, peeling paint, staining, evidence of moisture and deteriorated mortar and control joints were observed along each of the perimeter concrete block walls, including at the ice-resurfacers room (Photo 021, 022, 023, 024). In many areas the block wall is unprotected from the elements and is uninsulated.

Continued exposure to the elements and freeze-thaw cycles will lead to more significant structural deterioration in time. Deteriorated mortar joints should be routed and repointed while areas of minor staining, peeling paint, etc. should continue to be monitored for further deterioration. Consideration should be given to painting/sealing the exterior block to add further protection should installation of a proper rainscreen not be viable.

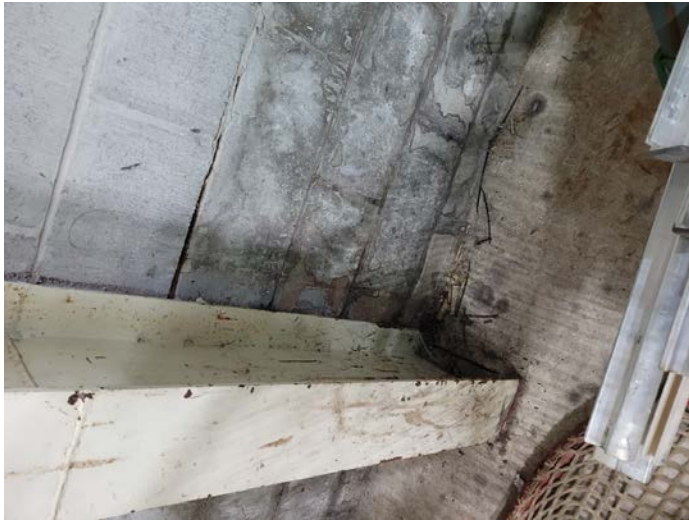
Photo 25

- Significant staining and evidence of moisture was observed on the interior side of the base of the north concrete block wall (Photo 025). The exterior grade in this area appears to be higher than the apron slab, which is likely contributing to the higher moisture levels.

Continued exposure to moisture and freeze-thaw cycles could result in significant damage to the exterior wall. Damaged block should be repaired or replaced and consideration given to improving exterior drainage or adjusting the grade to suit.

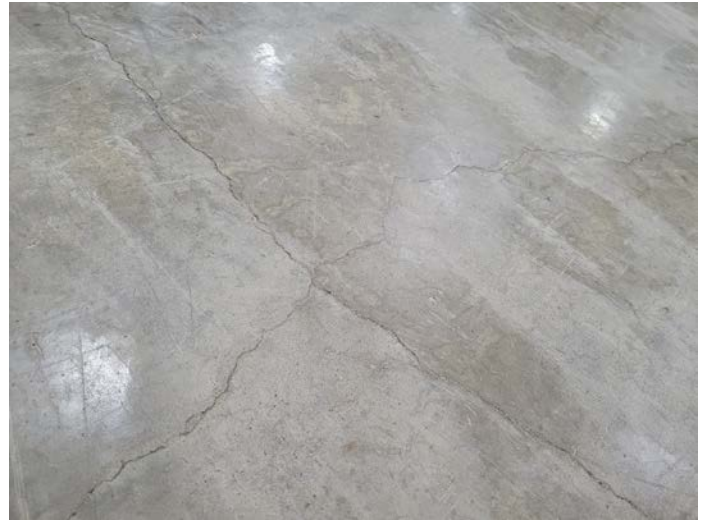
Photo 26

- Cracks were observed throughout the rink slab (Photo 026). These should be repaired to prevent further degradation.
- Previous repairs have been completed to other more substantial areas of cracking (Photo 027). Some areas of repair appear to have performed while others appear to have worsened. Worsening slab conditions may indicate a larger issue at hand. Further investigation and review should be completed to determine a reasonable timeframe for replacement.
- Various areas of damage around concrete inserts were observed (Photo 028). These areas should be repaired.

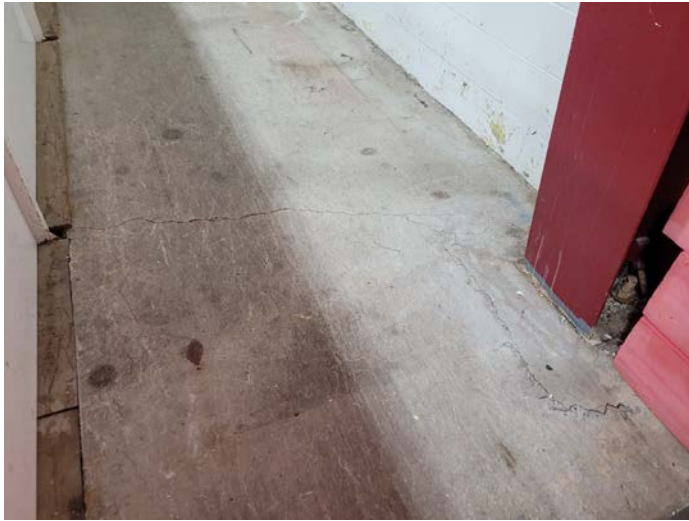
Photo 29

- Cracks were observed throughout the apron slab (Photo 029). While not a structural concern at this time, we recommend that these areas continue to be monitored and eventually repaired.
- Minor surface wear and damage were observed at some locations (Photo 030, 031). These areas should continue to be monitored for further deterioration.

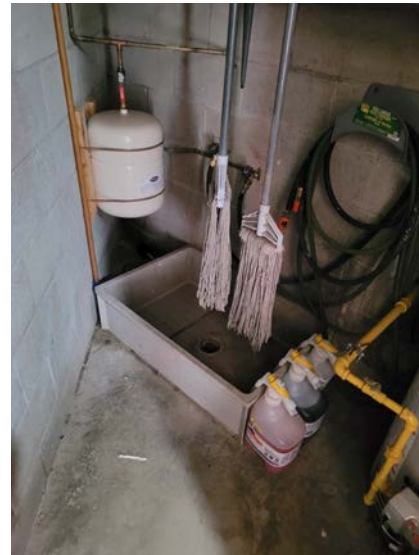
Photo 32

- Minor to moderate staining and damage were observed at the slab on grade and housekeeping pads within the mechanical pump room and janitor's closet (Photo 032).
- Minor cracking was observed throughout the basement slab on grade.

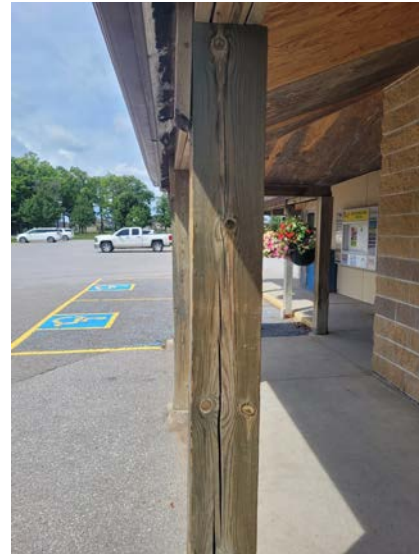
Photo 34

- Significant checking was observed in most timber columns (Photo 034, 035). Further investigation is required to determine the severity of the checking and to confirm whether there has been any reduction in column capacity.

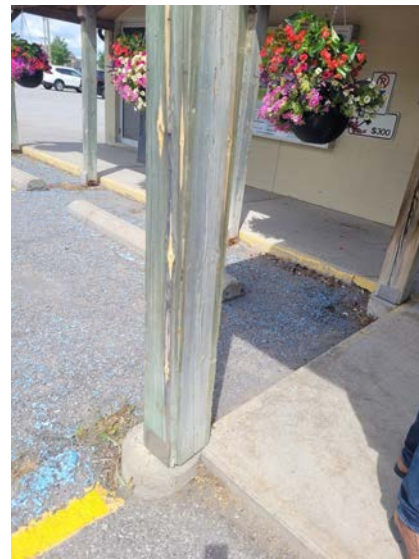
Photo 36

- It appears that one (1) wood column has been impacted, likely from a vehicle, is damaged/skewed and has shifted off the supporting foundation (Photo 036, 037). This column and associated connections must be replaced or repaired to replaced.

The existing structures along the south elevation generally appeared to be in fair condition. However, the wood canopy framing requires to be repaired as various structural components are damaged and have shifted, presumably from vehicular impact loading. Consideration should be given to construction of new exterior bollards to protect against future impacts once the repairs are made.

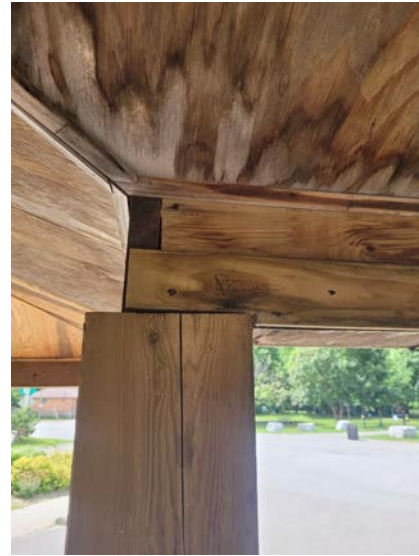
Photo 38

- Various columns appear to have shifted and are no longer centered along the main canopy support beam (Photo 038, 039). Repairs to this area are required to ensure proper connection between the beam and columns.

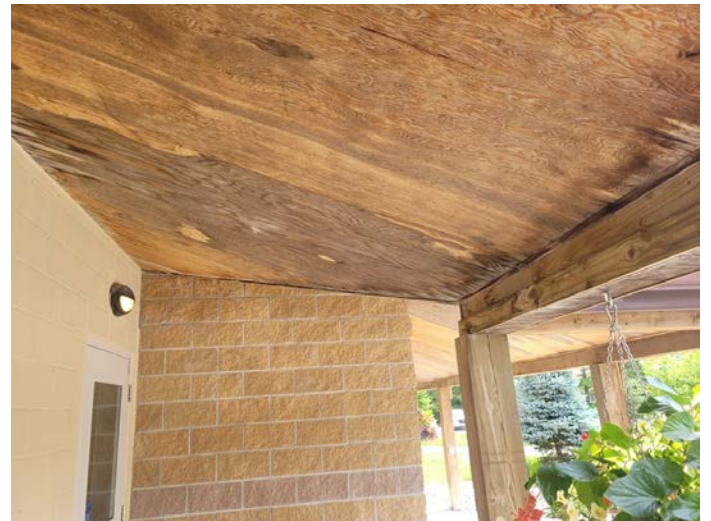
Photo 40

- Evidence of moisture and staining was observed at the underside of the plywood liner below the canopy framing (Photo 040). Further intrusive investigation is required to confirm the condition of the canopy framing system and whether moisture has adversely affected the structural system.

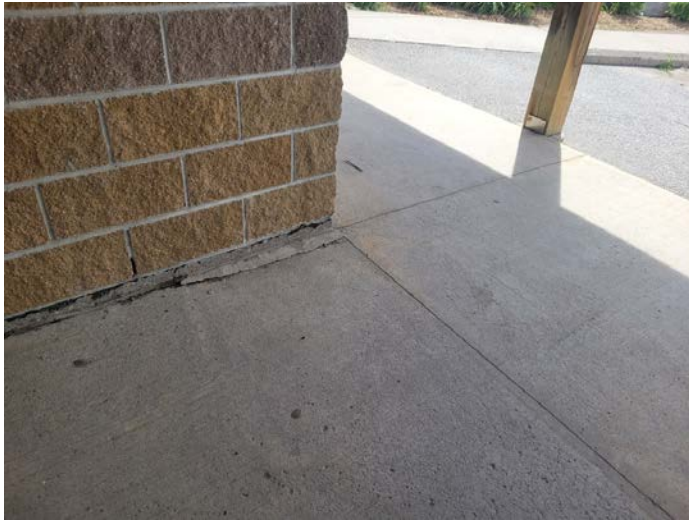
Photo 41

- Concrete spalling was observed at various locations on the exterior concrete sidewalk (Photo 041, 042). While not a structural concern, loose concrete and void in the slab should be removed and repaired to prevent further degradation and to eliminate potential tripping hazards.

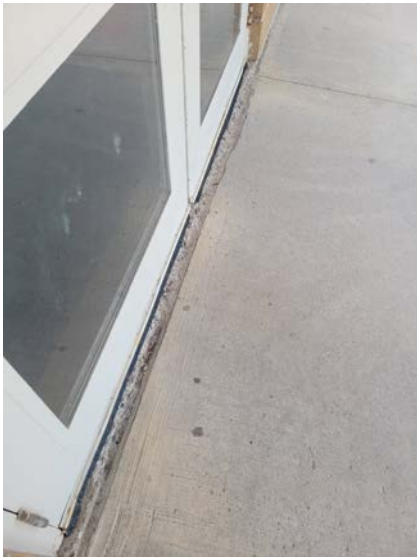
Photo 43

- Various damage was observed at the entryway thresholds (Photo 043, 044). These areas should continue to be monitored for further deterioration.
- Deteriorated mortar joints were observed at some locations along the south elevation. These should be routed and repointed.

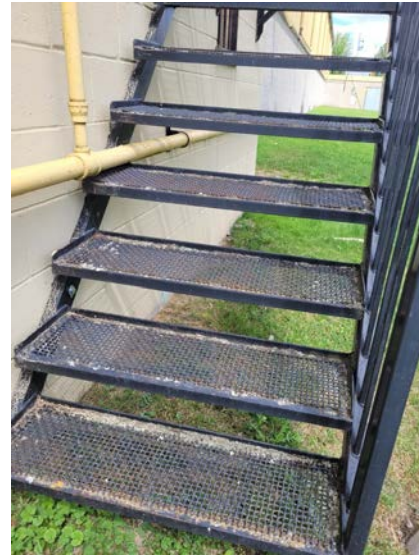
Photo 46

- Minor surface corrosion and paint peeling was observed on the steel stair (Photo 046). This condition should be monitored, and the stair eventually repainted to protect against more significant corrosion.
- The existing stair acts as an exit from the second floor community room however does not appear to be structurally stable to support the required loading currently prescribed by the Ontario Building Code. While this is an existing condition and may not require upgrade by code, we recommend that this stair be further reviewed for potential upgrades to landing grating and support connections.

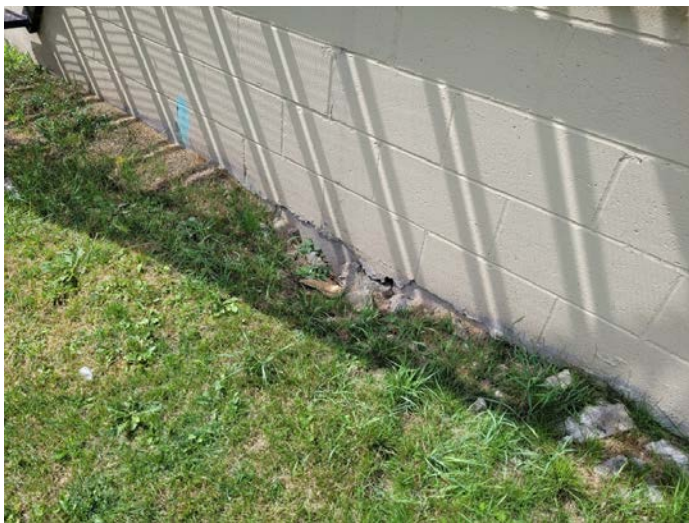
Photo 47

- Various areas of damage were observed at the base of the concrete masonry block wall throughout the wall, particularly at downspout discharge locations (Photos 047, 048, 049). Block wall damage and staining should be repaired and consideration given to modifying the downspouts to direct water away from the building structure.
- Caulking at expansion joints was cracked, damaged, or missing in several locations (Photo 050). It is recommended that the caulking be replaced to avoid further damage from water penetration and freeze-thaw action.
- Deteriorated mortar joints were observed at some location along the east elevation, including at the arena plant (Photo 051, 052, 053). It is recommended that cracked joints be routed and repointed with appropriate repair mortar.

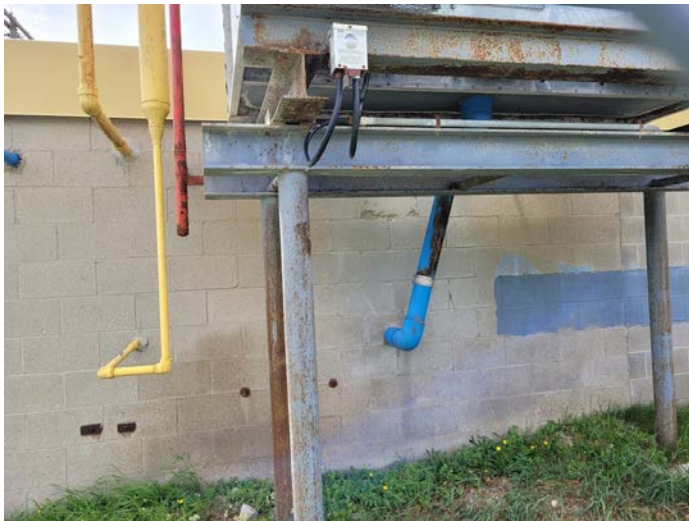
Photo 55

- Surficial corrosion was observed on the mechanical unit support structure (Photo 055). This structure should continue to be monitored.
- Minor deterioration and staining were observed at various locations along the base of the concrete masonry block wall on the north elevation (Photo 056, 057). Recommendations regarding exterior concrete block walls are discussed previously.
- Deteriorated mortar joints were observed at some locations along the block wall (Photos 058, 059, 060). It is recommended that cracked joints be routed and repointed with appropriate repair mortar.
- Damage to the metal roof flashing was observed at the northwest corner of the ice-resurfer room (Photo 061). This damage should be repaired to protect against further moisture infiltration.

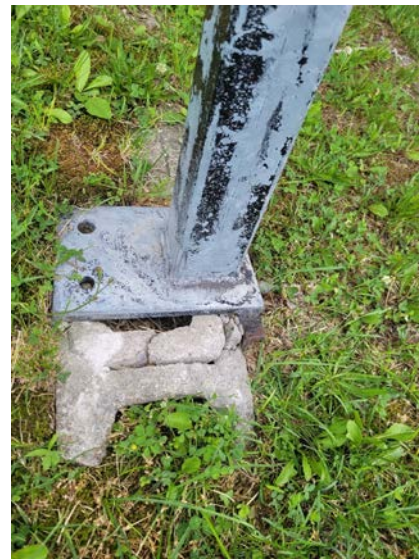
Photo 68

- The posts for the steel stair are not properly connected to the supporting concrete block structure (Photo 068). Further, the concrete block is not an acceptable foundation. New base connections and foundation structures are required for support of this stair.
- The existing stair acts as an exit from the second floor however does not appear to be structurally stable to support the required loading currently prescribed by the Ontario Building Code. While this is an existing condition and may not require upgrade by code, we recommend that this stair be further reviewed for potential upgrades to landing grating and support connections.

The west elevation generally appeared to be in fair condition. However, the existing second floor exit stair requires to be upgraded or replaced.
