**Structural Investigation and Report**  
**BEAVERTON-THORAH COMMUNITY CENTRE**

**Township of Brock**

**BBA PROJECT NO. 17176**  
**NOVEMBER 23, 2021**

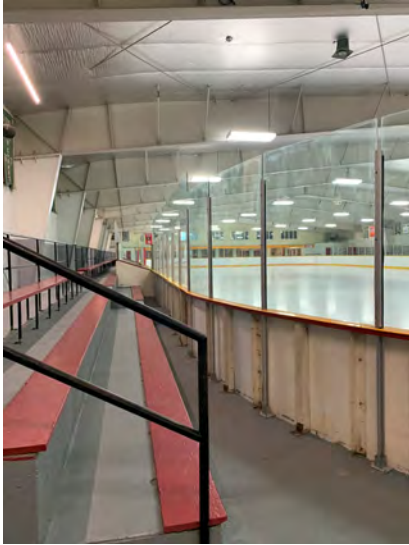
The main structure of the arena consists of a pre-engineered structural frame system with tapered steel girders supporting the steel purlins. The steel frames span approximately 100'-0" and are spaced at approximately 25'-0" centre to centre. We were unable to complete a detailed review of the entire extents of the tapered girders as this framing was enclosed by the existing insulation system (Photo 001). Our observations are as follows:

Photo 01 - Pre Engineered Frames

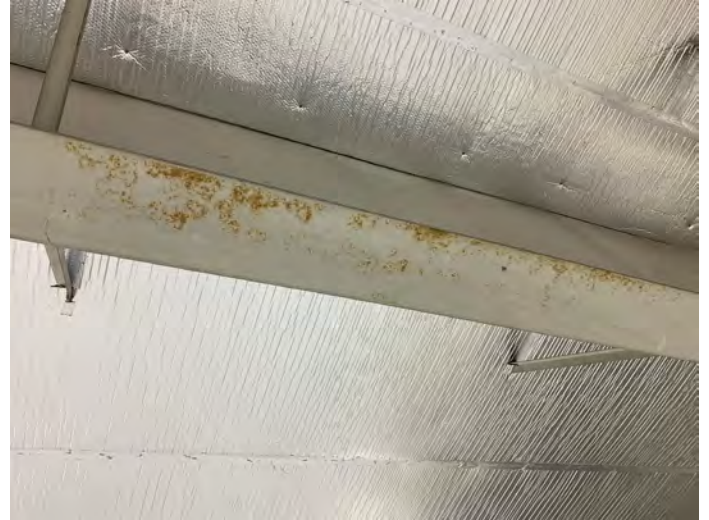
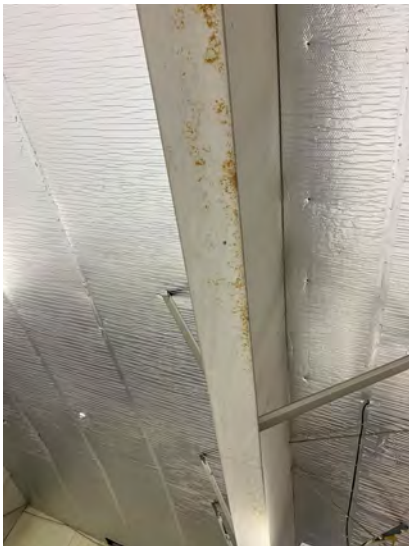
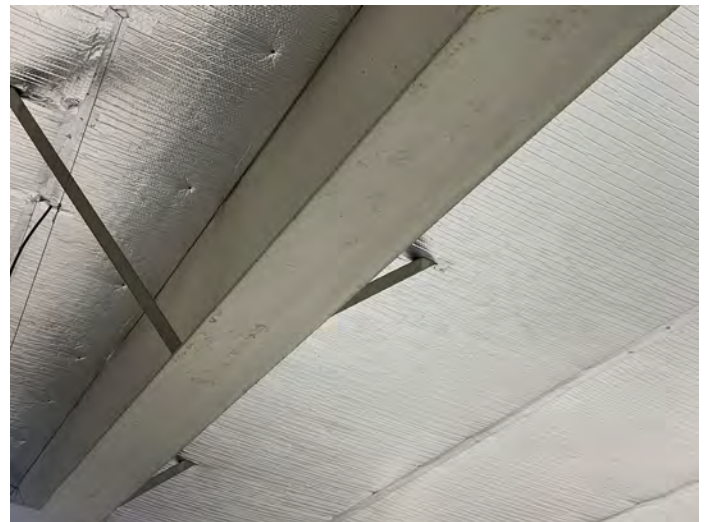
- Minor localized surface corrosion and peeled paint was observed on the bottom flange of the frames at several locations (Photos 002-004). This is likely due to condensation and high humidity during occupancy. We recommend for the corroded areas to be wire brushed clean to bare metal and an epoxy protective coating is applied.

Photo 02 - Pre Engineered Frame Bottom Flange Corrosion

Photo 03 - Pre Engineered Frame Bottom Flange Corrosion

Photo 04 - Pre Engineered Frame Bottom Flange Corrosion

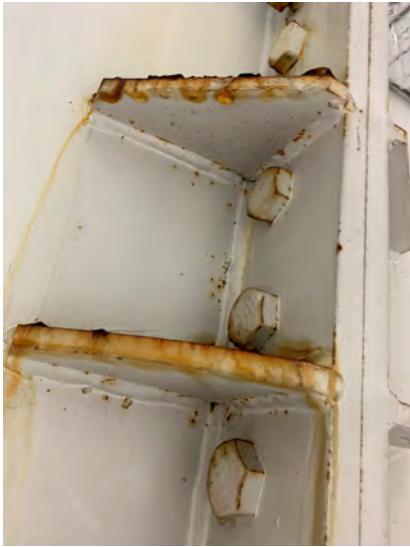
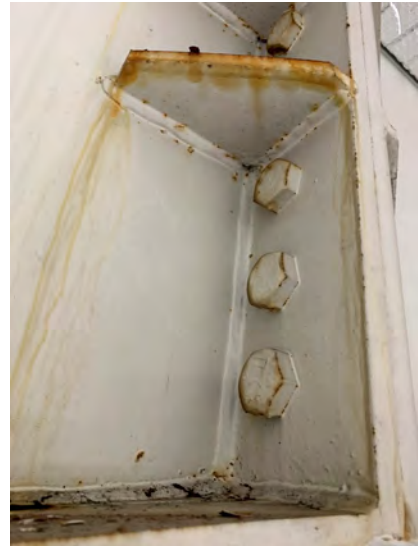
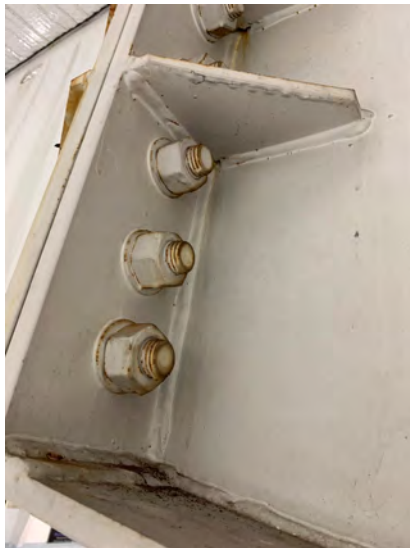
- The bolted connection of the pre-engineered frame web appeared to be experiencing localized minor corrosion (Photos 005-007). This is likely due to condensation and high humidity during occupancy. We recommend for the corroded areas to be wire brushed clean to bare metal and an epoxy protective coating is applied.

Photo 05 - Pre Engineered Frame Bolted Connection Corrosion

Photo 06 - Pre Engineered Frame Bolted Connection Corrosion

Photo 07 - Pre Engineered Frame Bolted Connection Corrosion

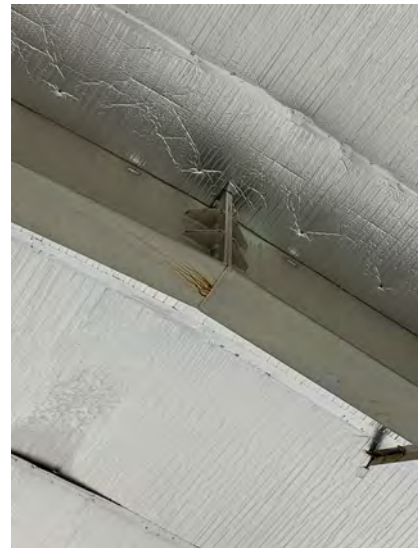
- The pre-engineered steel frame at the south wall elevation appeared to have moisture staining along the bottom flange (Photo 008 & 009). This is likely due to condensation and high humidity during occupancy. We recommend for the corroded areas to be wire brushed clean to bare metal and an epoxy protective coating is applied.

Photo 08 - Pre Engineered Frame Moisture Staining

Photo 09 - Pre Engineered Frame Moisture Staining

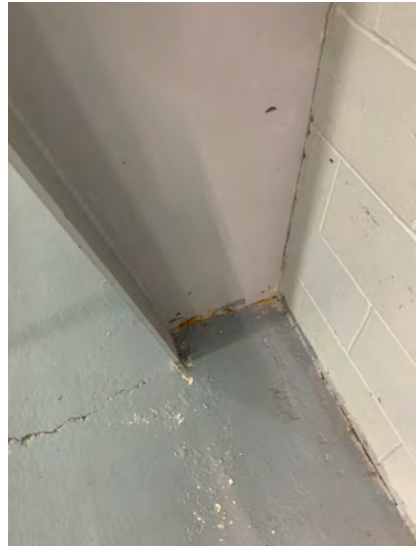
- The base of several frames appeared to not consist of a protective epoxy coating and appears to have experienced minor surface rusting (Photo 010 & 011). We recommend for the rusted areas to be wire brushed clean to bare metal and a protective coating is applied.

Photo 10 - Pre Engineered Frame Base Corrosion

Photo 11 - Pre Engineered Frame Base Corrosion

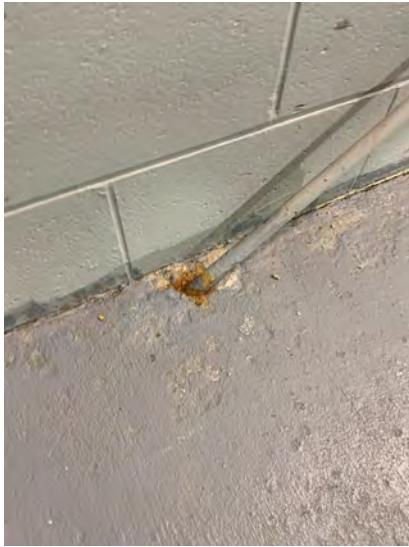
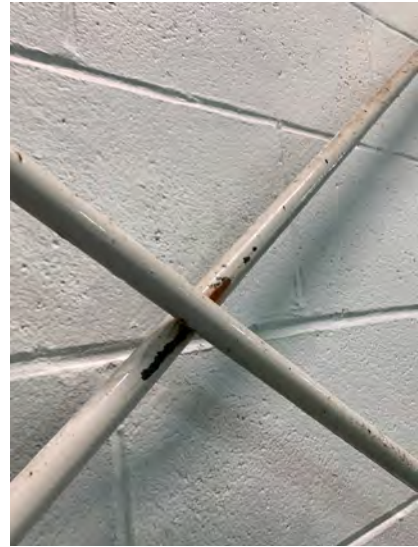
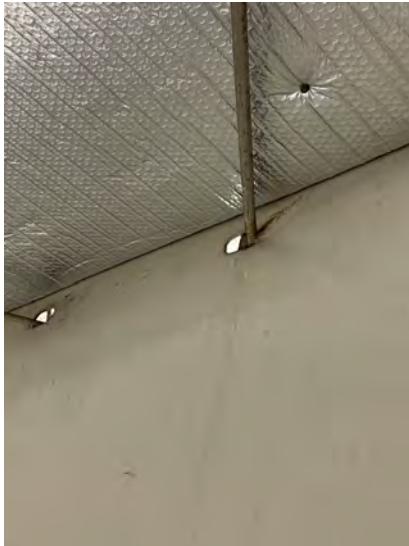
- The pre-engineered frame bracing located along the east and west perimeter walls and the

bracing at roof level appeared to be experiencing localized minor corrosion (Photo 013-015). We recommend for the corroded areas to be wire brushed clean to bare metal and an epoxy protective coating is applied.

Photo 13 - Pre Engineered Frame Bracing Corrosion

Photo 14 - Pre Engineered Frame Bracing Corrosion

Photo 15 - Pre Engineered Frame Bracing Corrosion

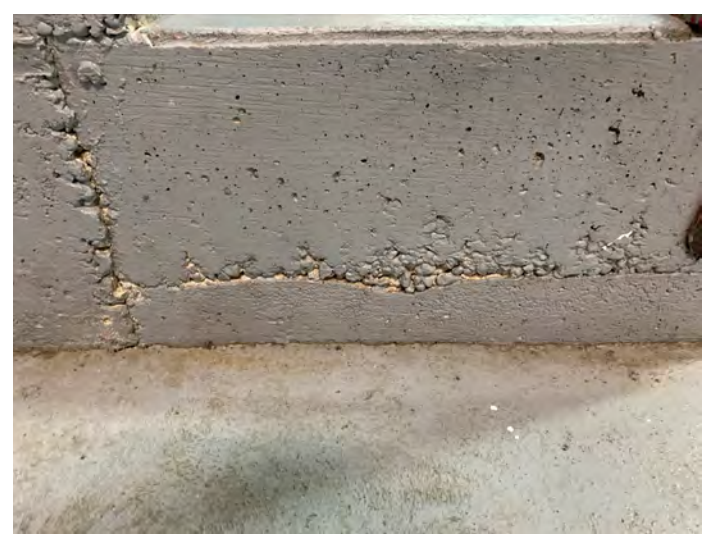
- There appeared to be localized honeycombing at the exposed sides of the bleacher seating (Photo 016). This appears to be an existing condition and is not a structural concern at this time.
- Minor cracking was observed on the vertical face of the bleachers (Photo 017). These cracks are not a structural concern at this time however we recommend that they be monitored over a five (5) year period for continued propagation.
- Minor cracking was observed at the base of the pre-engineered frames (Photo 018 & 019). These cracks are not a structural concern at this time however we recommend that they be monitored over a five (5) year period for continued propagation.
- Minor deterioration was observed along the bleacher seating (Photo 020). We recommend that this area be cleaned, and a non-slip industrial coating be applied.

Photo 16 - Bleacher Seating Honeycombing

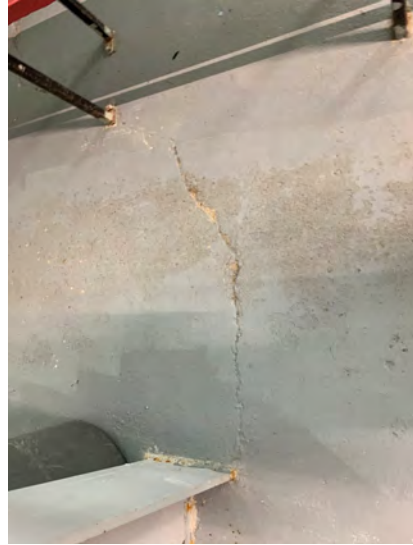
Photo 18 - Bleacher Seating Cracking

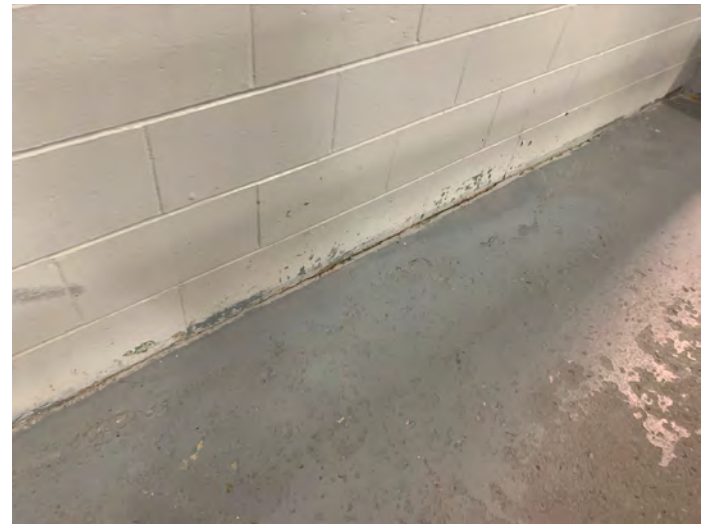
Photo 20 - Bleacher Seating Deterioration

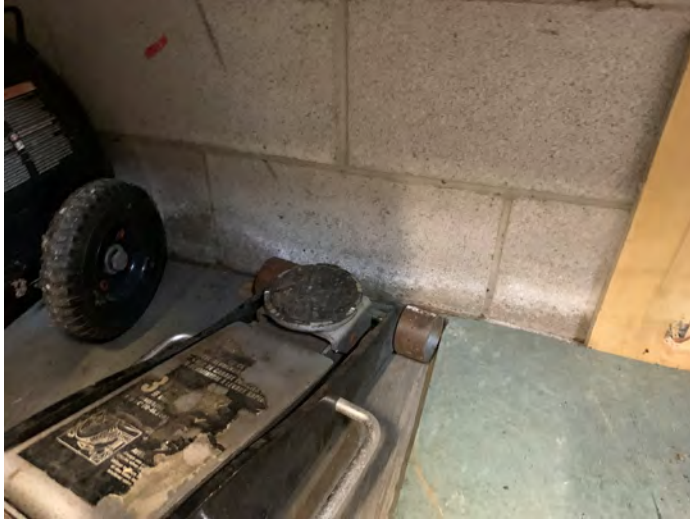
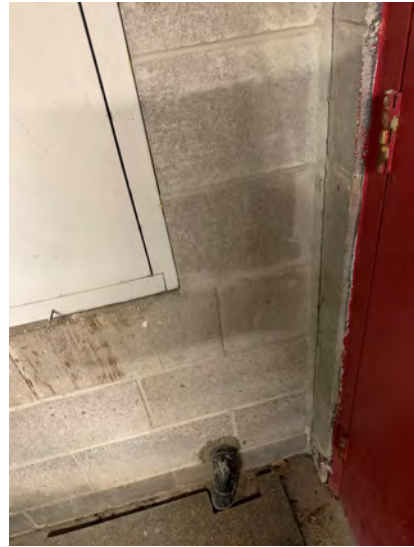
- Efflorescence accumulation was observed along the base of the concrete block walls in the Zamboni room (Photo 021 & 022). The efflorescence accumulation is likely due to moisture absorption through the wall system. We recommend for the area to be cleaned and coated with a protective coating.

Photo 21 - Masonry Block Wall Efflorescence

Photo 22 - Masonry Block Wall Efflorescence

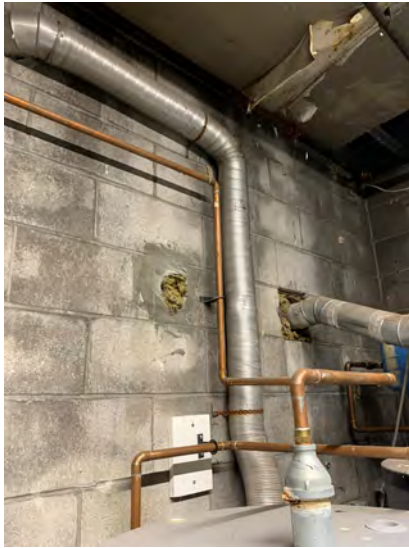
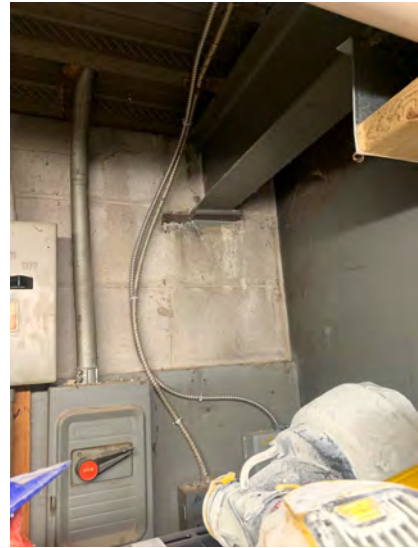
- Efflorescence accumulation was observed along the concrete block walls in the Ammonia room and Mechanical room (Photo 023 & 024). The efflorescence accumulation is likely due to high humidity in the room with poor ventilation. We recommend for the area to be cleaned and coated with a protective coating.

Photo 23 - Masonry Block Wall Efflorescence

Photo 24 - Masonry Block Wall Efflorescence

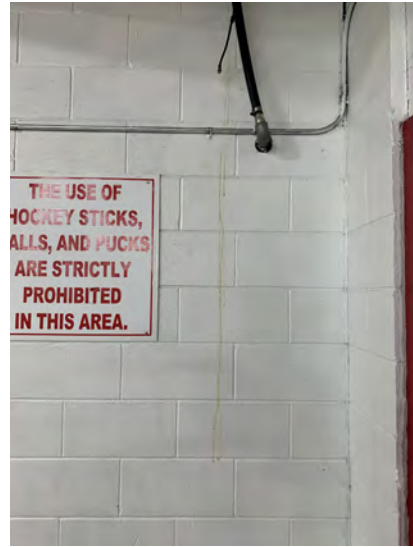
- Water staining on the masonry block walls was observed beneath the condensing unit in the northeast corner of the arena (Photo 026). This is likely a result of moisture from the condensing unit causing water staining on the walls. We recommend the walls be cleaned and a new protective coating applied.
- Minor localized cracking was observed in the mortar joints (Photo 027). We recommend this crack be repaired with a suitable repair mortar.

Photo 26 - Masonry Block Wall Staining

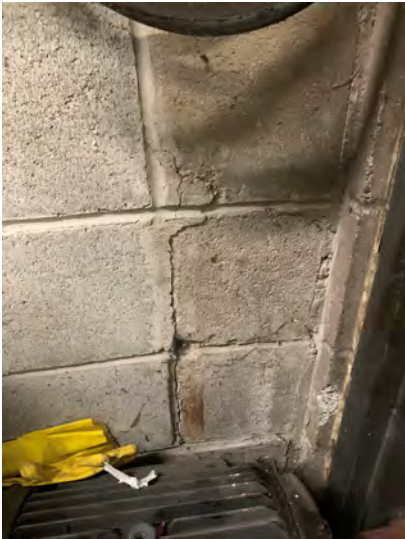
Photo 27 - Masonry Block Wall Cracking

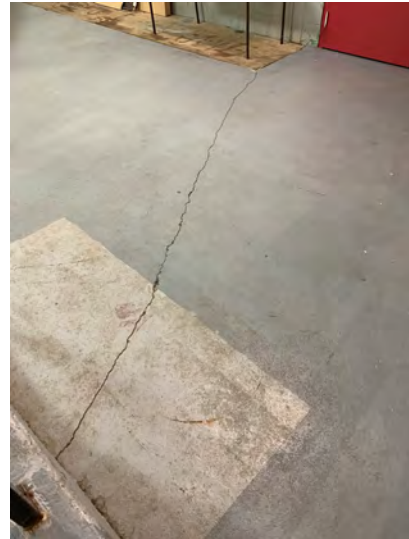
- Localized cracking at the apron slab surface was observed at the corner of the floor drain location extending towards the rink slab (Photo 028). The cracking is likely a result of concrete shrinkage and is not a structural concern.
- Efflorescence accumulation was observed at multiple areas on the exposed concrete apron slab (Photo 029 & 030). The efflorescence accumulation is likely due to high moisture content due to the nearby ice. We recommend for the area to be cleaned and coated with a protective coating.
- Larger cracking at the apron slab surface was observed in the southeast corner of the arena (Photo 031). This crack should be epoxy injected to try and extend the long-term serviceability of the pad.
- Surface deterioration was observed along the bleacher seating (Photo 032 & 033). We recommend that this area be cleaned, and a non-slip industrial coating be applied.

Photo 28 - Concrete Apron Slab Cracking

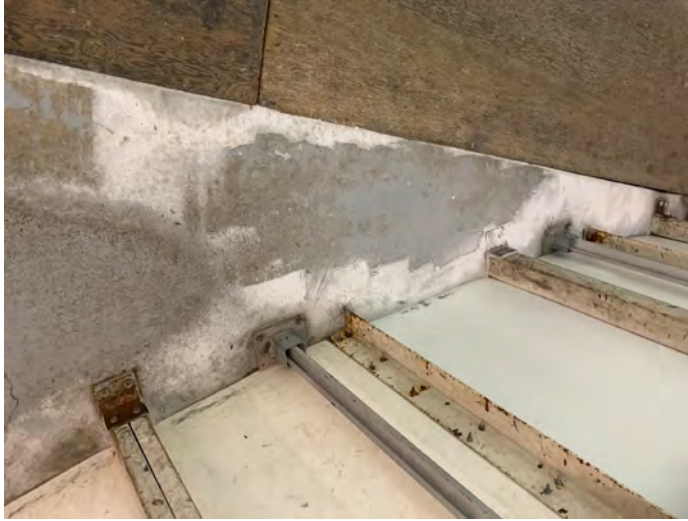
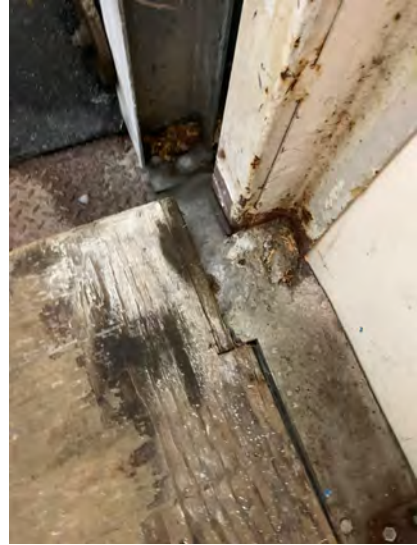
Photo 29 - Concrete Apron Slab Efflorescence

Photo 30 - Concrete Apron Slab Efflorescence

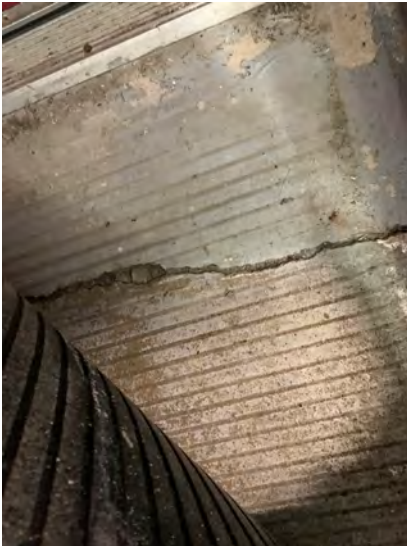
Photo 31 - Concrete Apron Slab Bigger Cracking

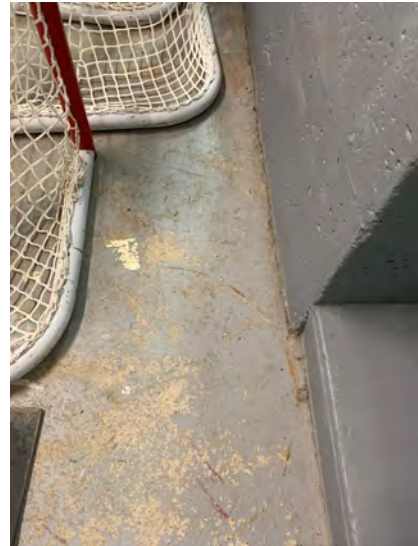
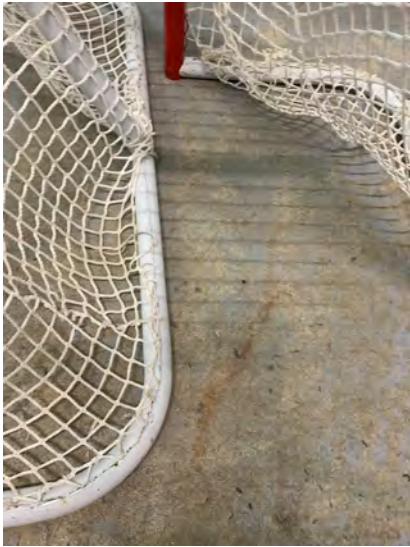
Photo 32 - Concrete Apron Slab Deterioration

Photo 33 - Concrete Apron Slab Deterioration

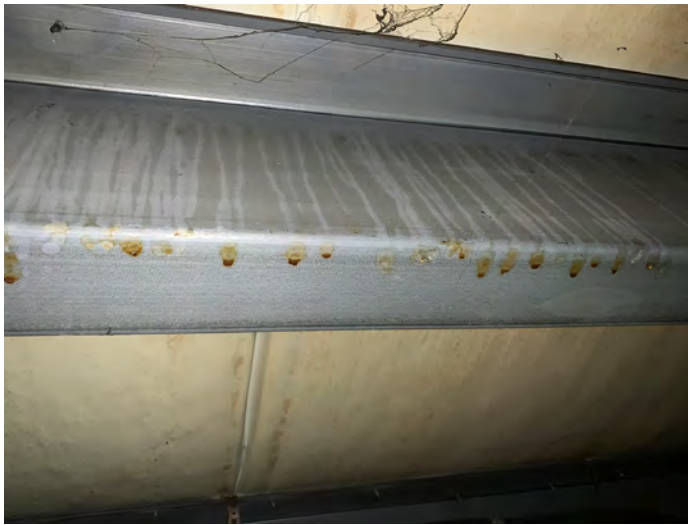
- There appeared to be some water staining on the underside of the Z girts (Photo 035). We recommend these stains be removed and a protective coating be applied.

Photo 35 - Partial Second Floor Z Girt Water Staining

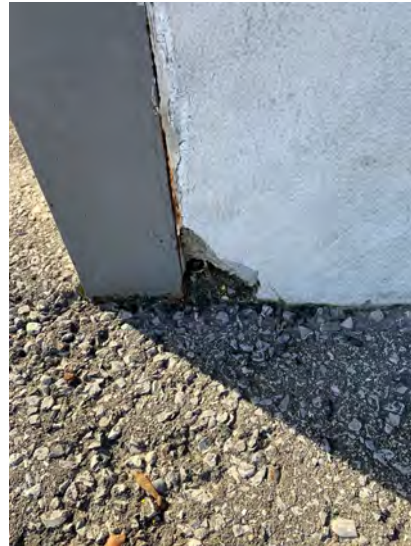
- There appears to be an opening beneath the metal cladding at ground level (Photo 036). This opening will allow moisture to enter the building and should be repaired by a suitable repair mortar the exposed portion.

Photo 36 - South Elevation Opening

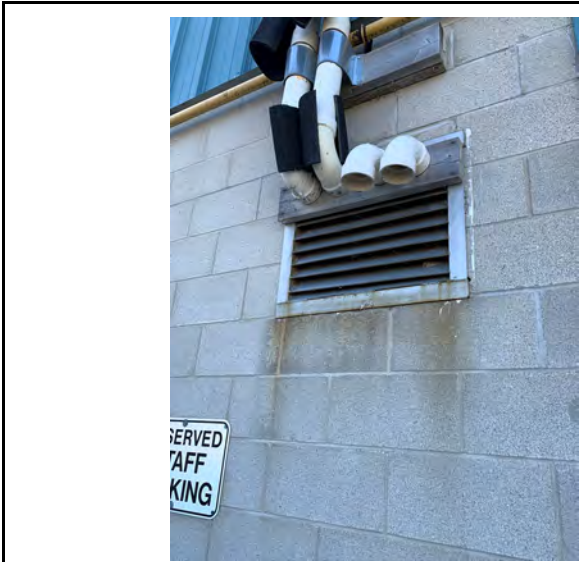
- The block wall was observed to be corroded around a mechanical unit (Photo 037). This is most likely due to leaks from the mechanical unit. We recommend for the corroded areas to be cleaned and an epoxy protective coating is applied.

Photo 37 - South Elevation Block Wall Corrosion

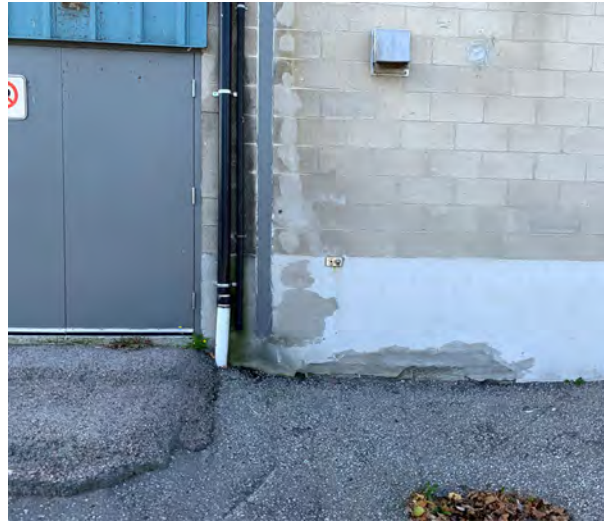
- Vegetation growth on the concrete masonry block wall was observed behind a gutter (Photo 038). This is likely due to the moisture from gutter. We recommend this area be cleaned and a protective coating be applied.

Photo 38 - South Elevation Block Wall Vegetation

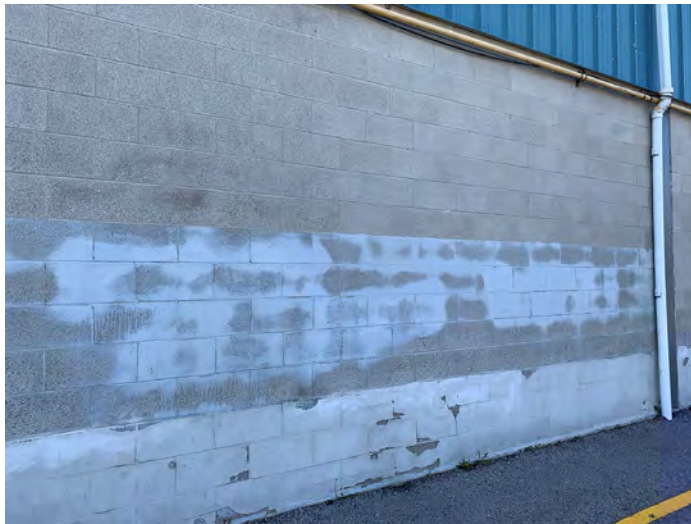
- Efflorescence accumulation was observed along the block wall (Photo 039). We recommend for the area to be cleaned and coated with a protective coating.

Photo 39 - South Elevation Block Wall Efflorescence

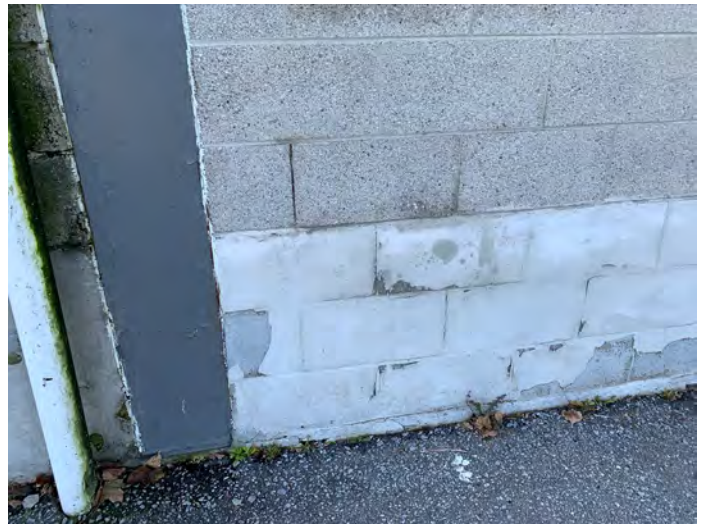
- Parging at the base of the block wall appeared to be deteriorating (Photo 040). This is likely due to de-icing salts and snow accumulation against the wall. We recommend a protective coating be applied and this area be re-parged to prevent further deterioration.

Photo 040 - South Elevation Block Wall Parging

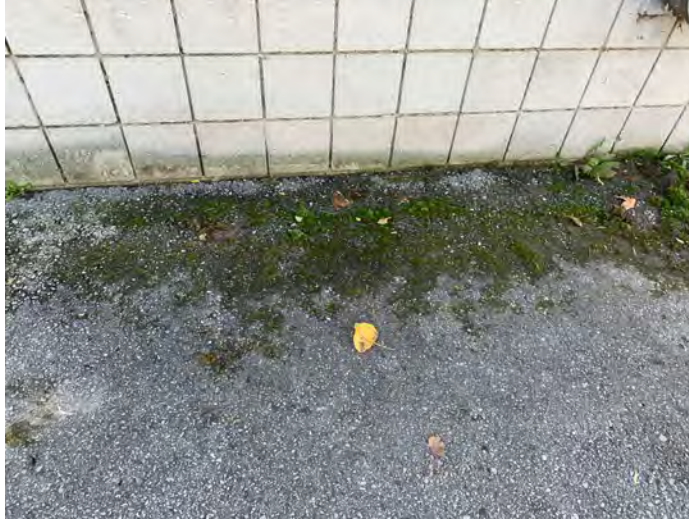
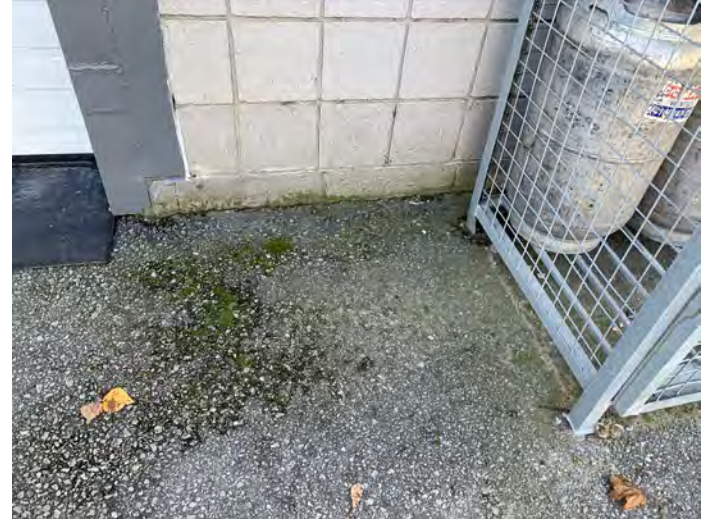
- Vegetation growth on the concrete masonry block wall was observed at the base of the wall (Photos 041 & 042). The walls should be cleaned and coated with a suitable protective coating.
- The metal cladding was observed to be corroded around a mechanical unit (Photo 043). This is most likely due to leaks from the mechanical unit. We recommend for the corroded areas to be wire brushed clean to bare metal and an epoxy protective coating is applied.
- Efflorescence accumulation was observed along the block wall (Photo 044). We recommend for the area to be cleaned and coated with a protective coating.

Photo 41 - East Elevation Vegetation

Photo 42 - East Elevation Vegetation 2

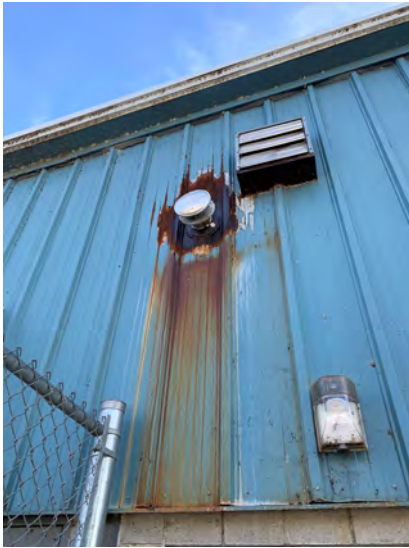
Photo 43 - East Elevation Corroded Cladding

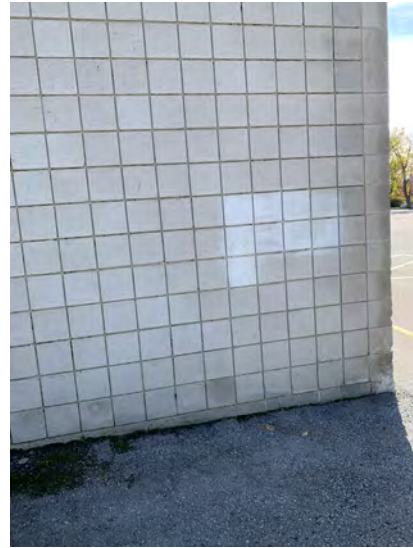
Photo 44 - East Elevation Block Wall Efflorescence

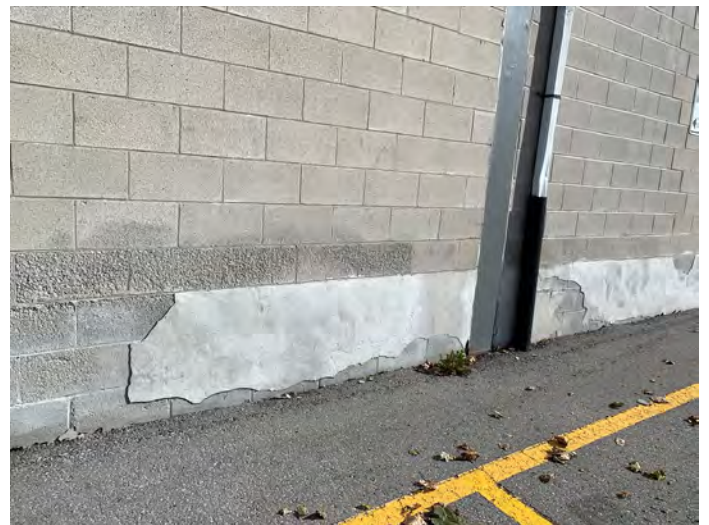
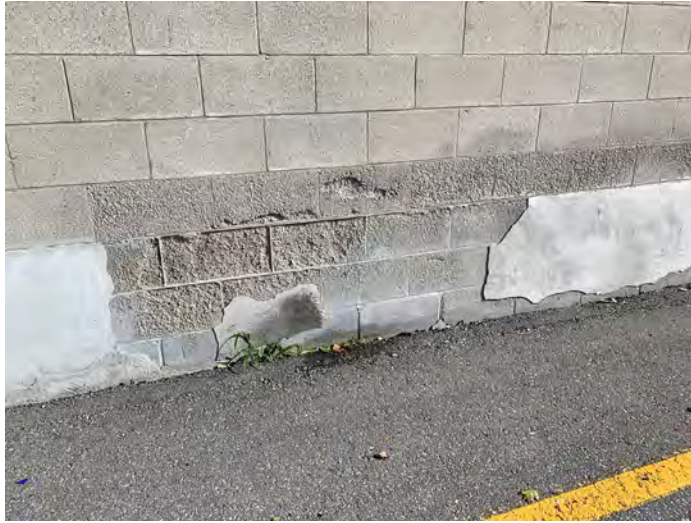
- Parging at the base of the block wall appeared to be deteriorating and in return the block wall was observed to be deteriorating (Photo 048 & 049). This is likely due to de-icing salts and snow accumulation against the wall. We recommend a protective coating be applied and this area be re-parged to prevent further deterioration.

Photo 48 - North Elevation Parging

Photo 49 - North Elevation Parging2

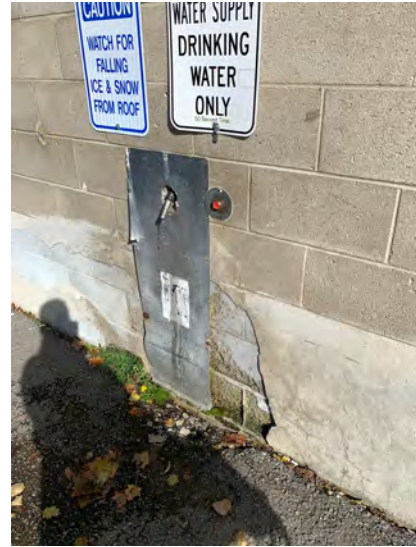
- Vegetation growth on the concrete masonry block wall was observed at the base of the wall below a water supply (Photos 050). This is likely due to the moisture from the water supply. We recommend this area be cleaned, a protective coating be applied and this area be re-parged to prevent further deterioration.

Photo 50 - North Elevation Vegetation and Deteriorated Parging

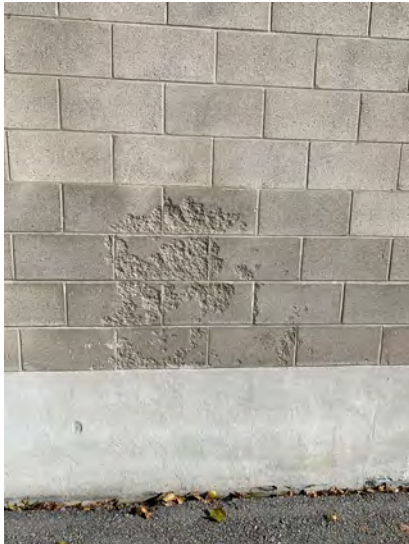
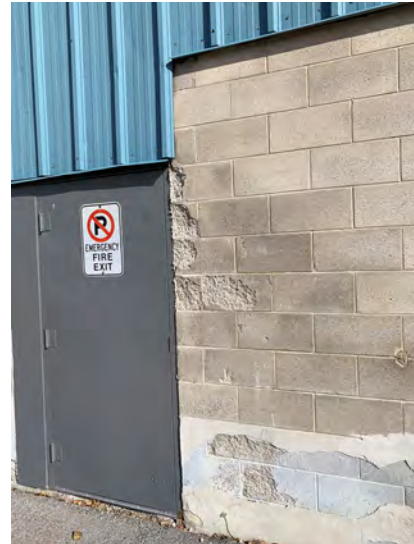
- Localized deterioration of the block was observed (Photo 051 & 052). We recommend for the deteriorated concrete to be repaired with a suitable repair mortar and protective coating to prevent further deterioration of the exterior wall.

Photo 51 - North Elevation Deterioration

Photo 52 - North Elevation Deterioration 2

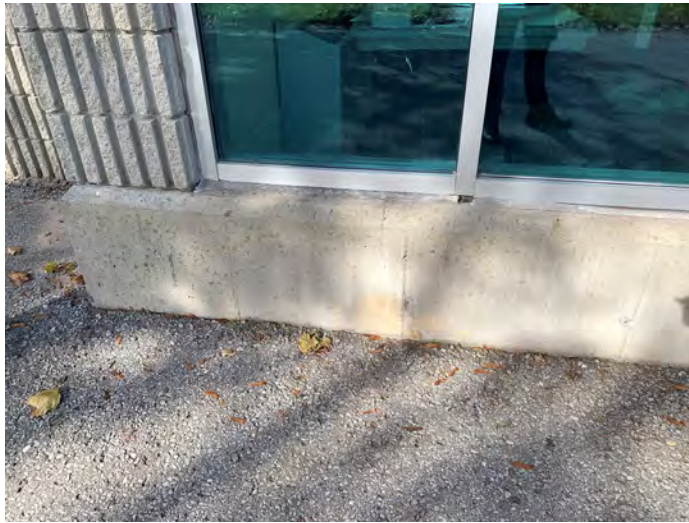
Photo 55 - West Elevation Foundation Wall Vegetation and Efflorescence

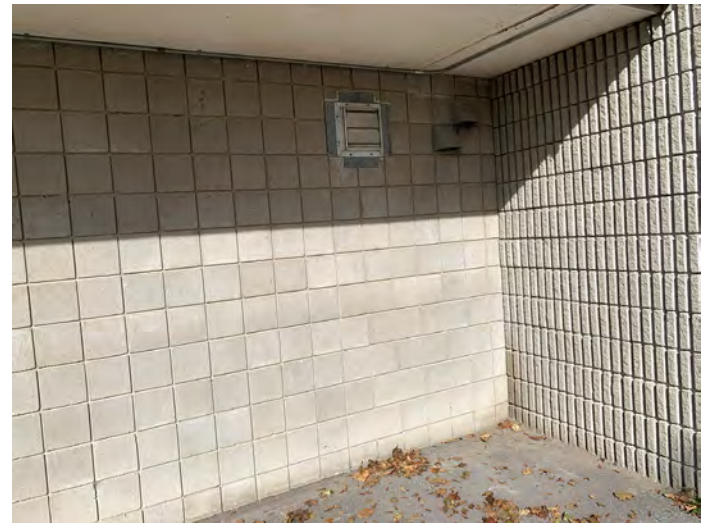
Photo 56 - West Elevation Block Wall Efflorescence

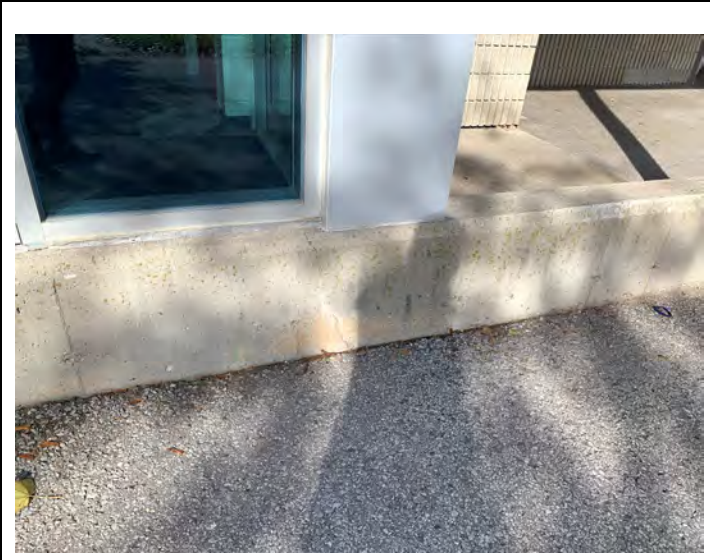
- The base of the exterior column supporting the partial second floor appeared to be experiencing localized minor corrosion (Photos 053 & 054). This is likely due to condensation and high humidity during occupancy. We recommend for the corroded areas to be wire brushed clean to bare metal and an epoxy protective coating is applied.
- Vegetation growth and efflorescence on the concrete foundation wall was observed at the base of the wall (Photos 055 & 056). We recommend this area be cleaned and a protective coating be applied.
- Minor cracking was observed on the concrete foundation wall (Photo 057). We recommend the wall be repaired with a suitable repair mortar.

Photo 57 - West Elevation Foundation Wall Minor Cracking
