Chloride in the Lake Simcoe Watershed

Presented to: Township of Brock

September 22, 2025

Lake Simcoe Region
conservation authority

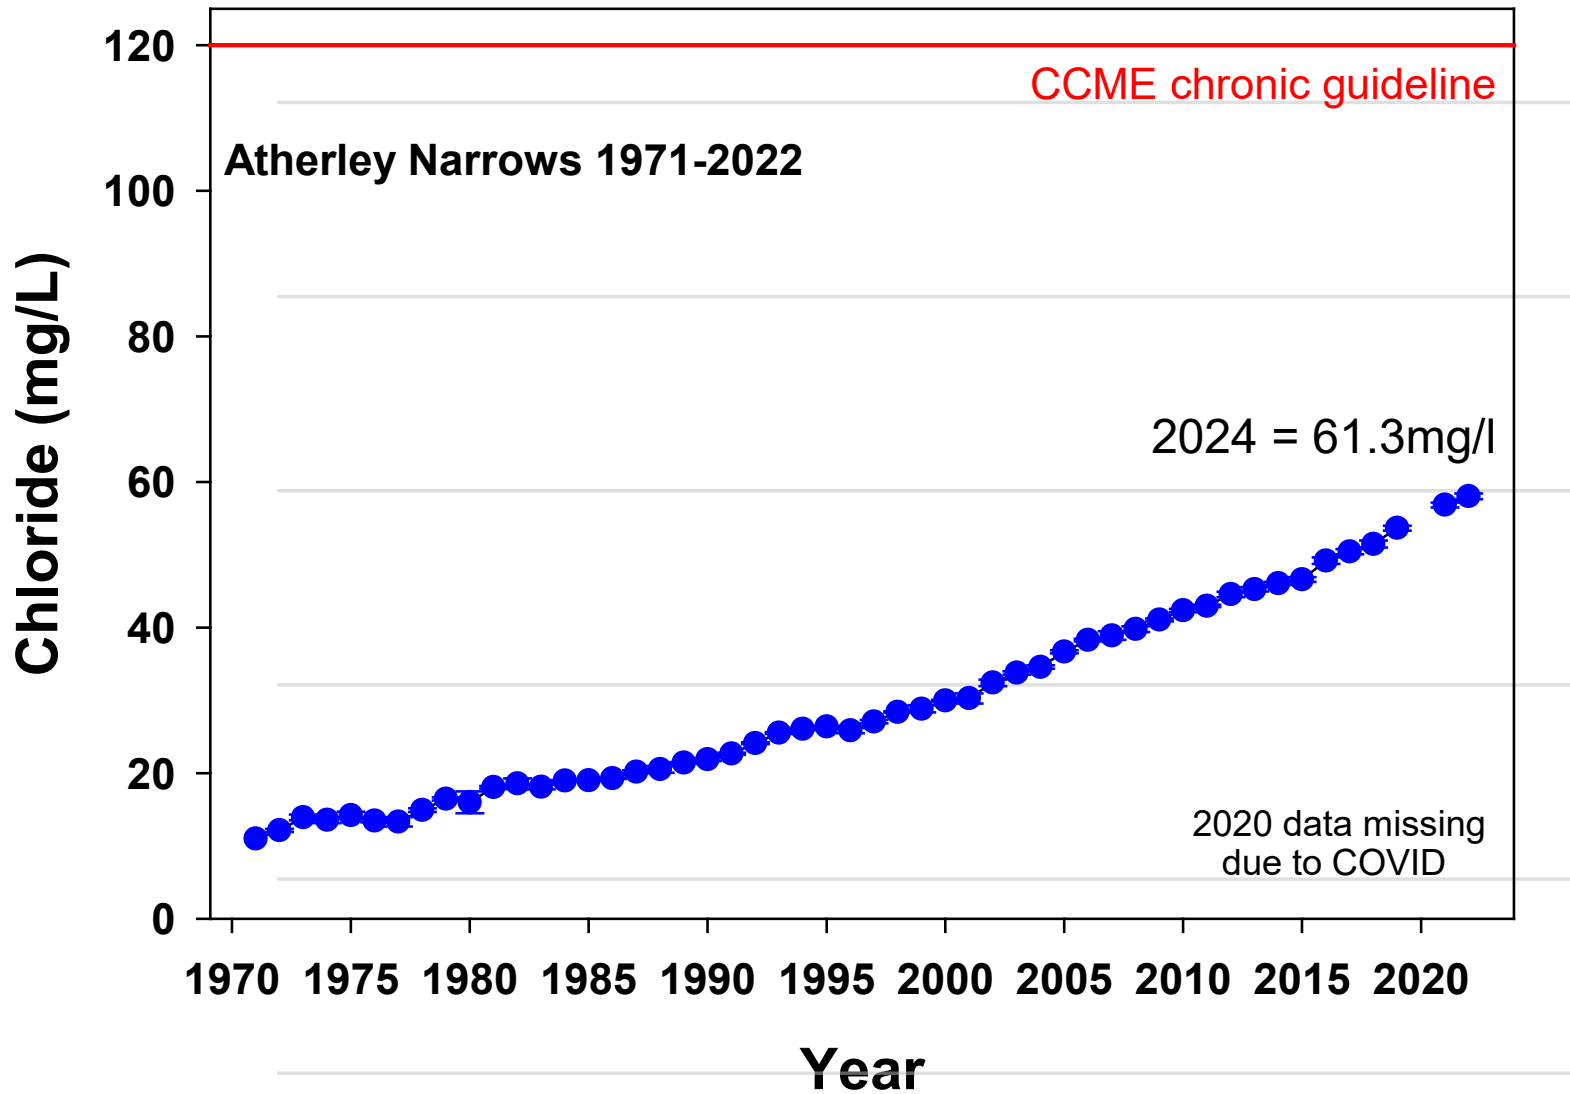
Winter Salt Concentration in Lake Simcoe

Most recent sample result:
64.2mg/l March 20th 2025

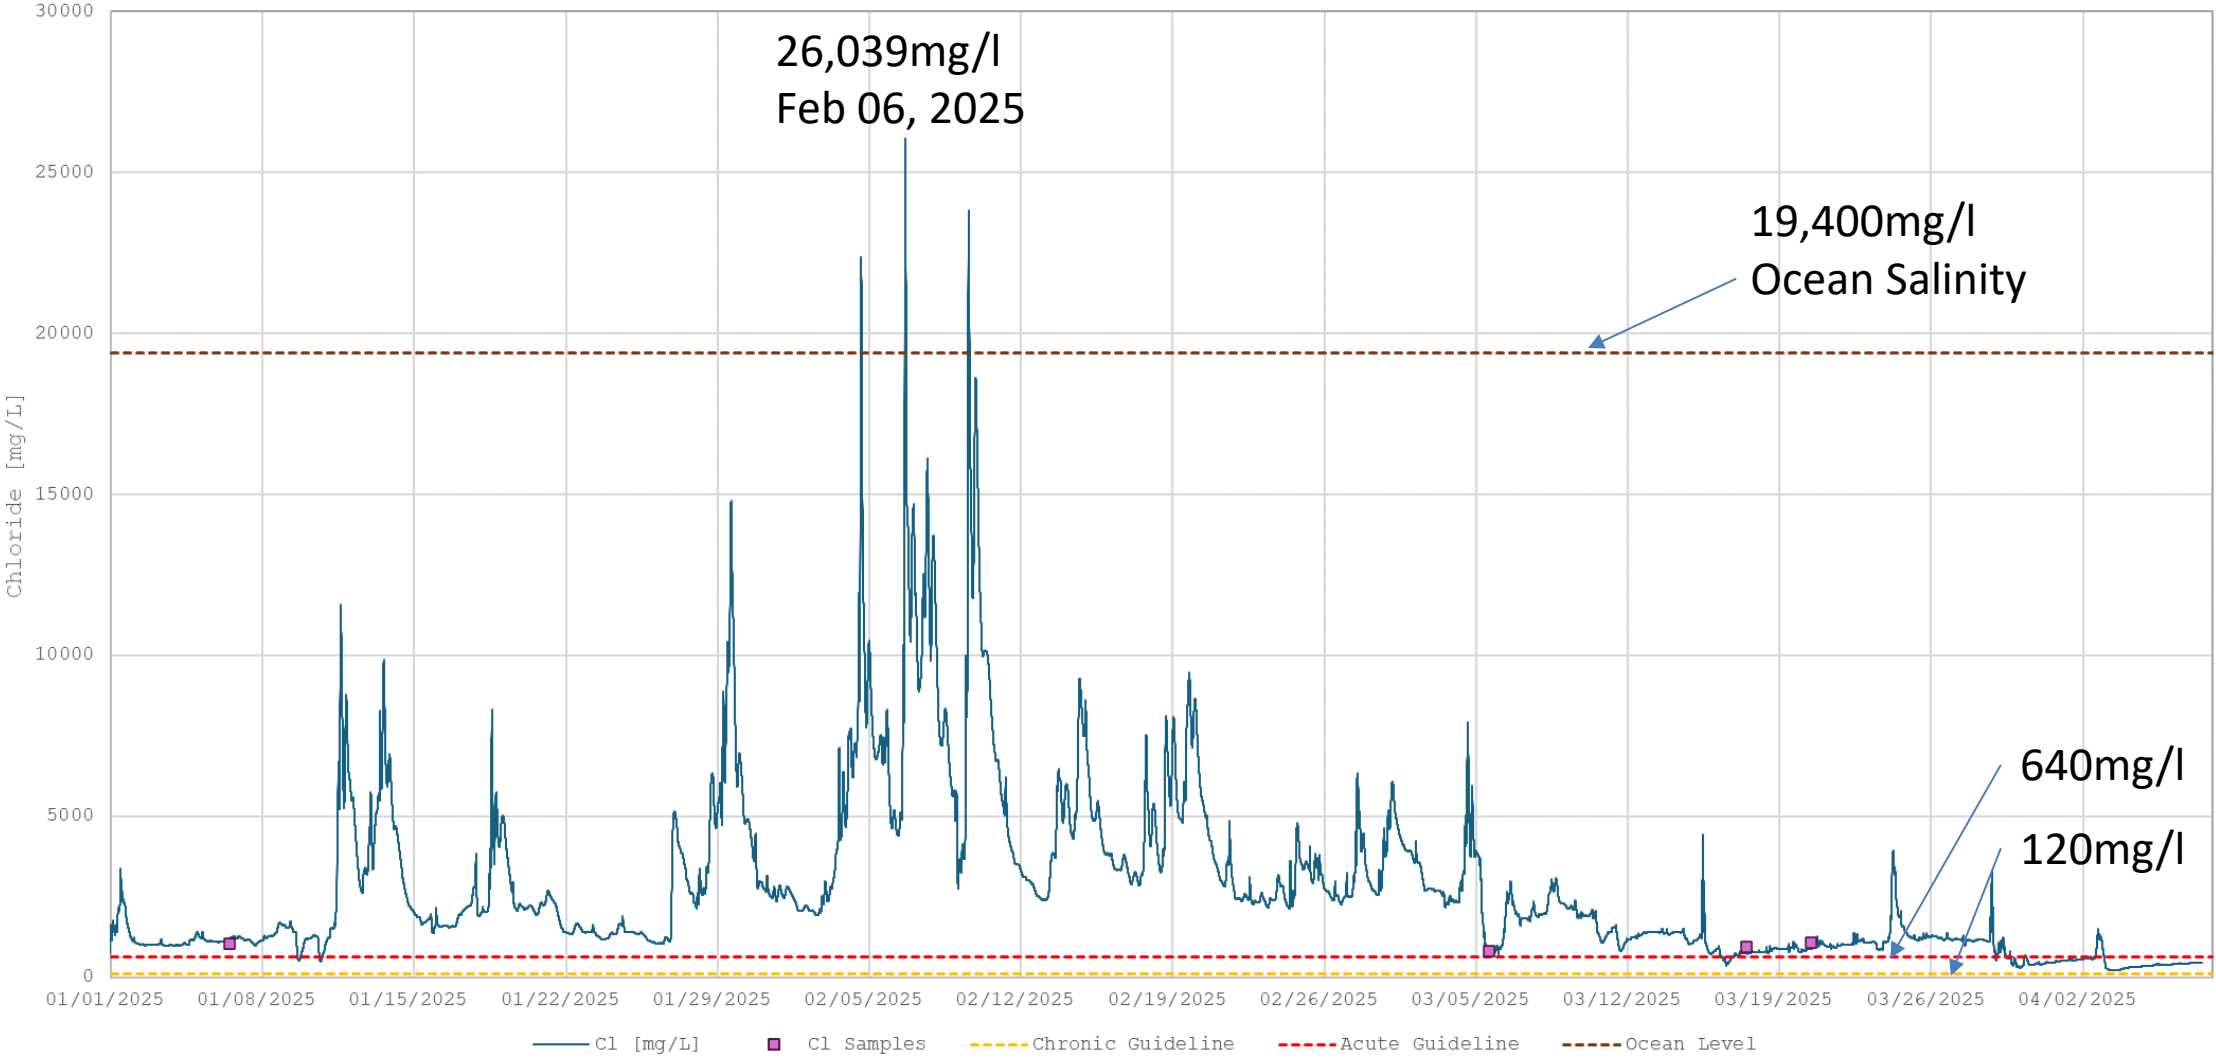
Continuous Chloride Concentrations in Western Creek

January 2025 to April 2025

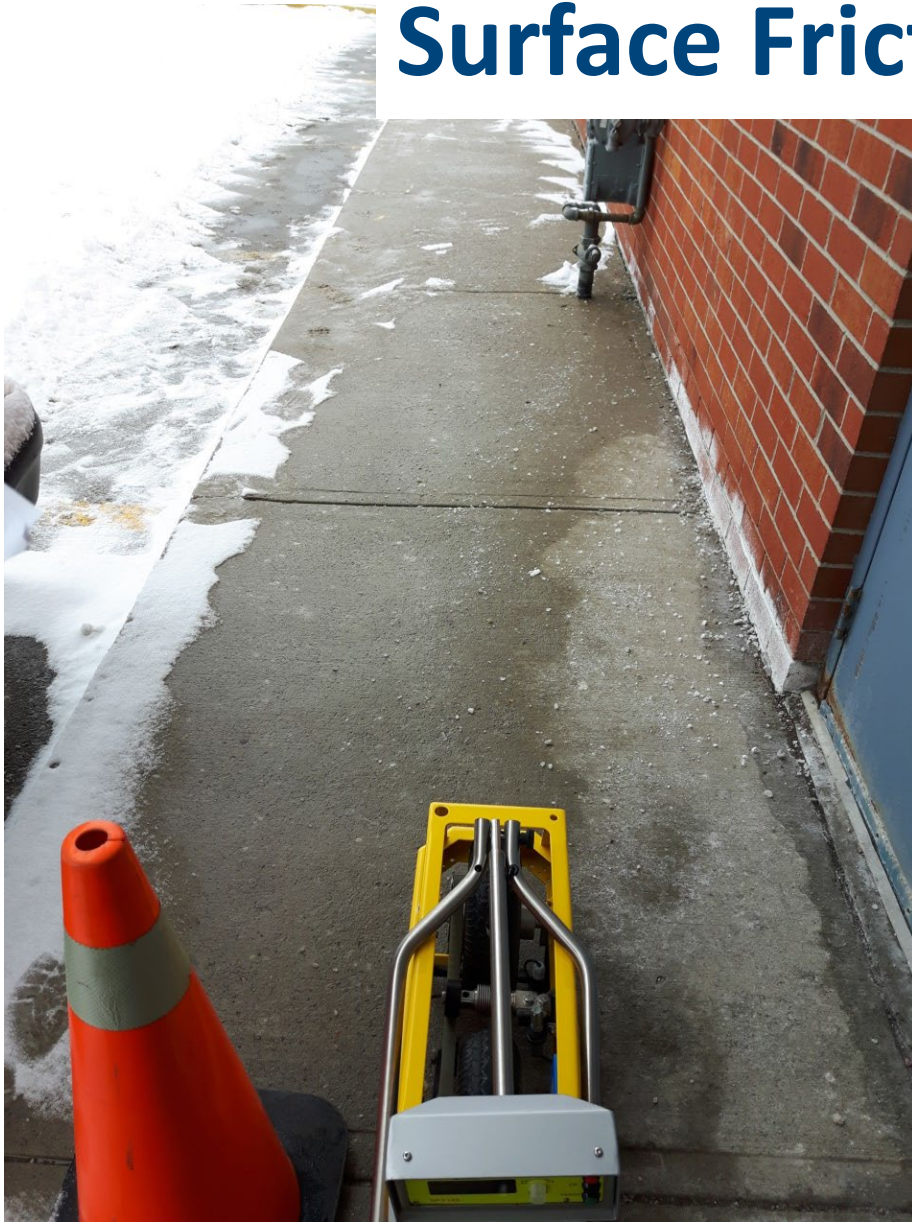
Surface Friction Testing

$\text{Mu} = 0.63$

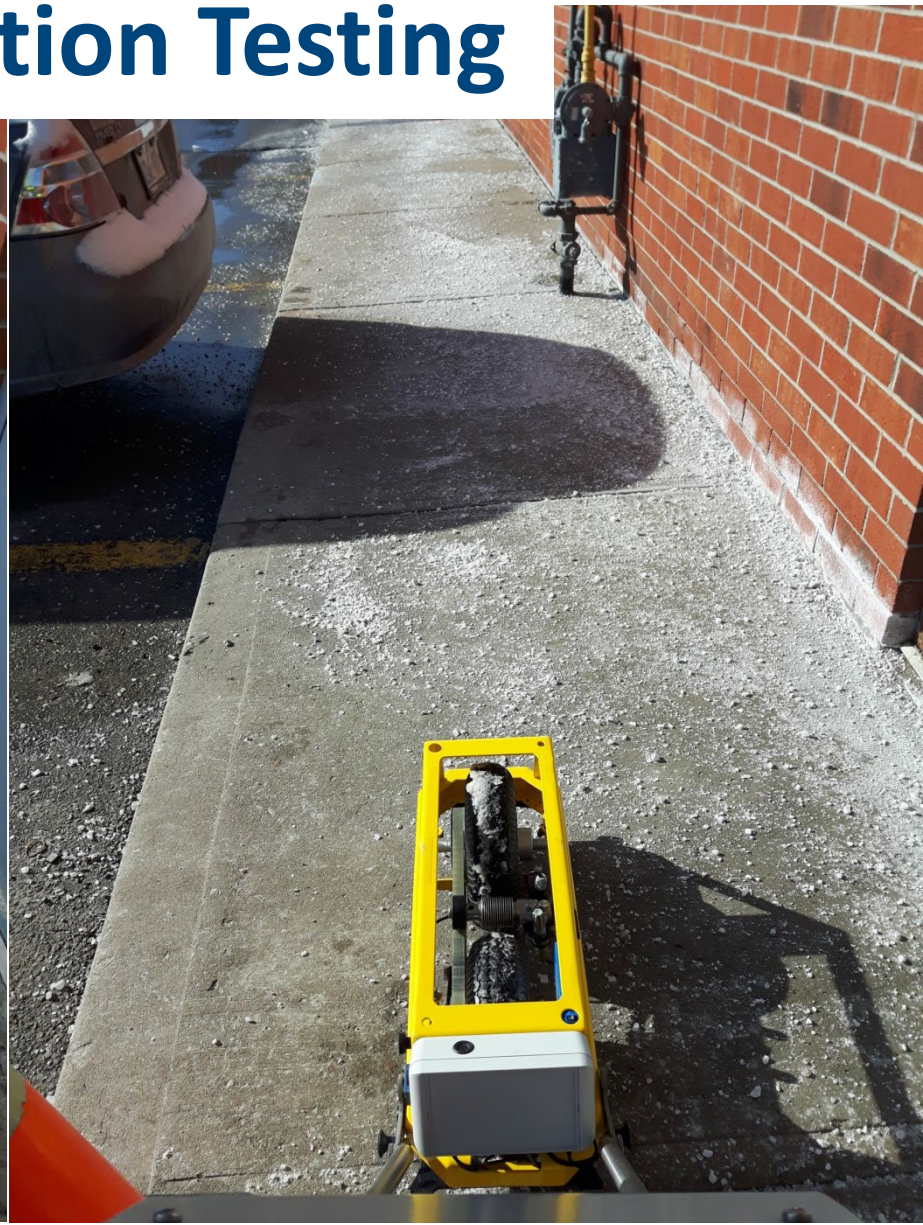
$\text{Mu} = 0.26$

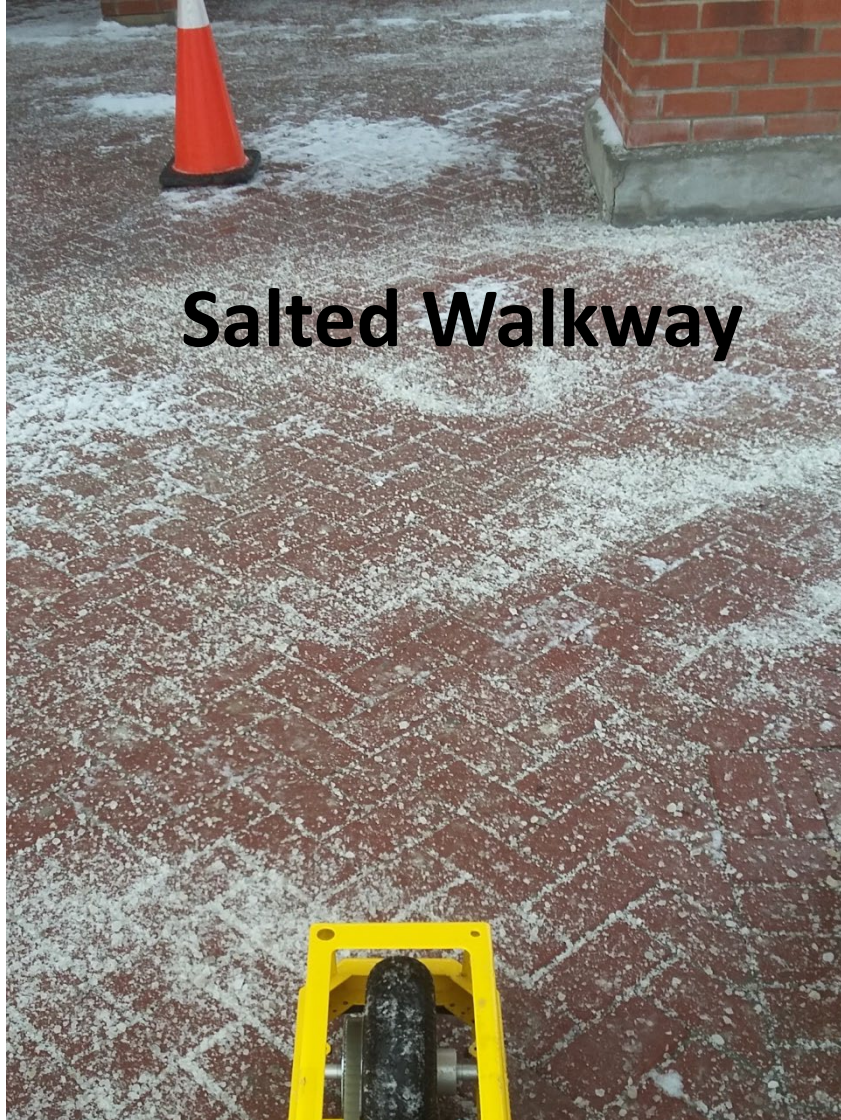
Salted Walkway

$\mu = 0.22$

Application Rate = 969g/m²

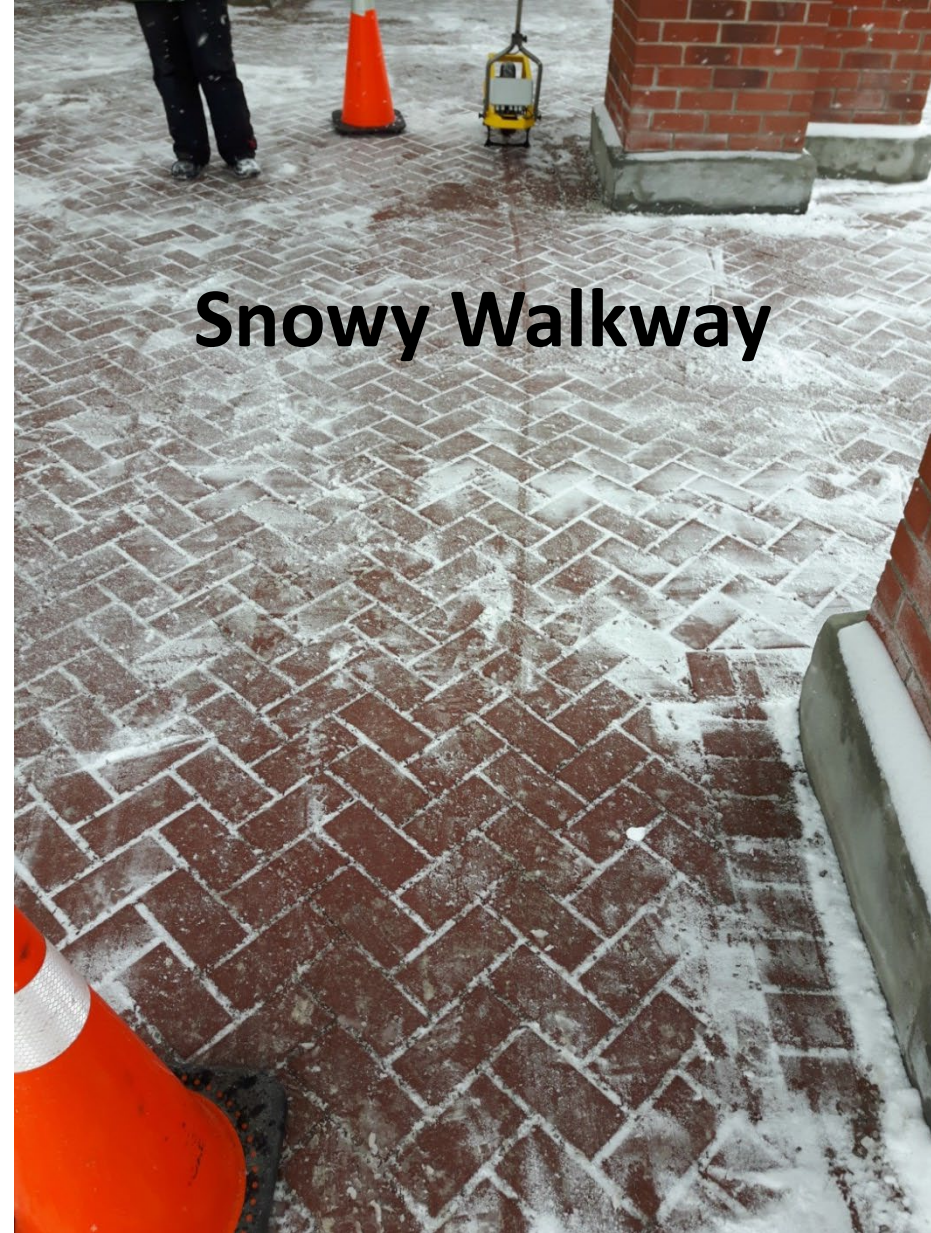
Snowy Walkway

$\mu = 0.21$

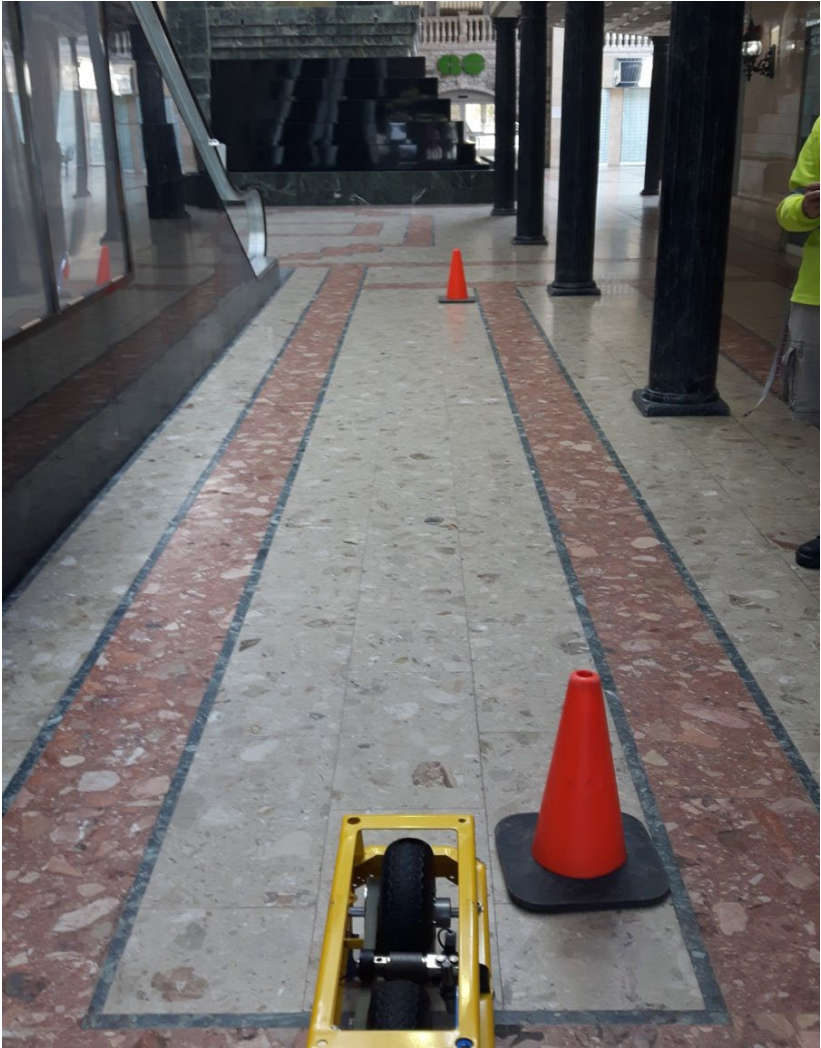
$\mu = 0.34$

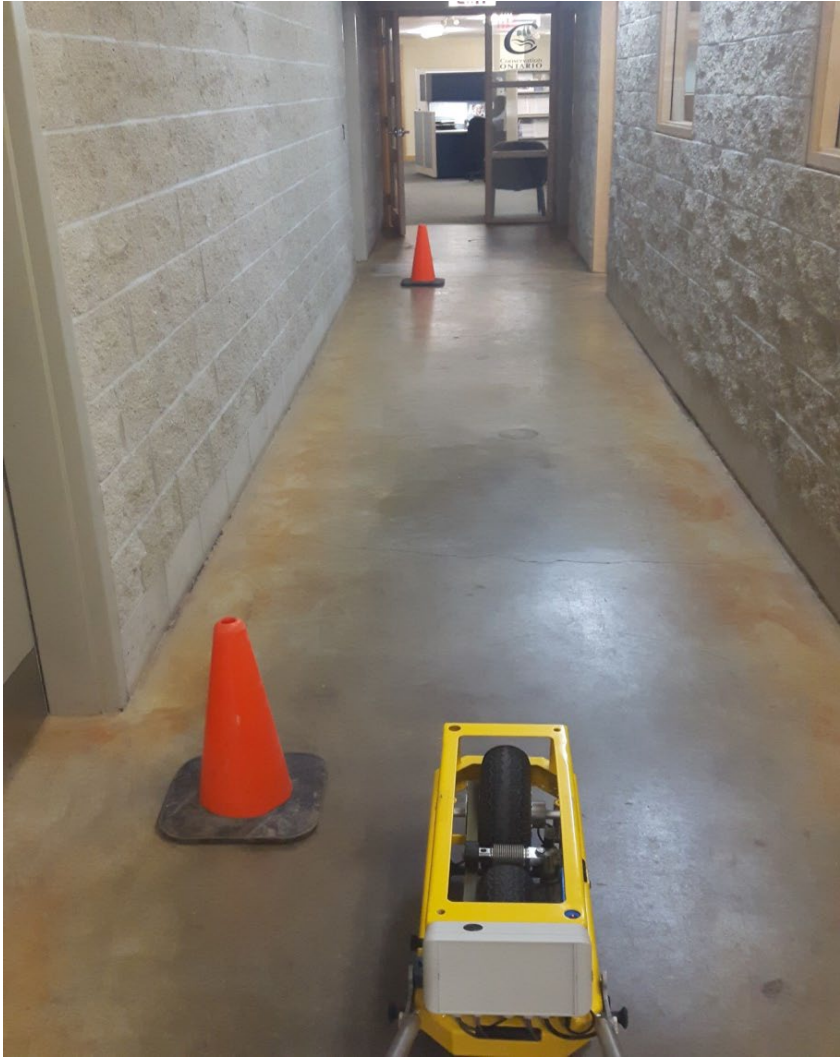
$\mu = 0.32$

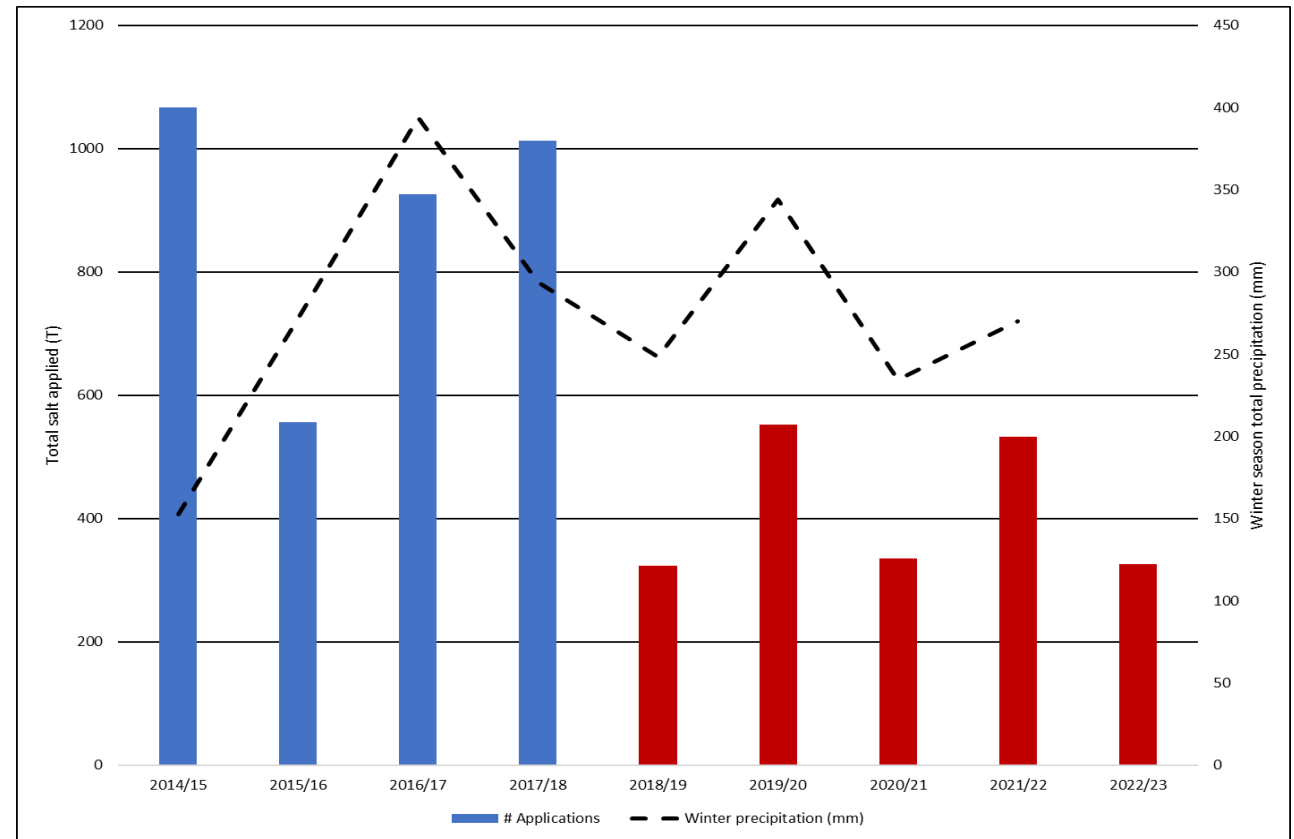
Case study: commercial parking lot

- Average applications/season:
 - Contractor A: 66
 - Contractor B: 43
- Average application per event:
 - Contractor A: 12 tonnes
 - Contractor B: 10 tonnes
- Both contractors were claim-free for the duration of the study
- Contractor B realized approx. \$40k in material cost savings/year
