**ROSE WINDOW**

# Estimate for the replication of the rose window in the second storey of the Town Hall in Sunderland Ontario

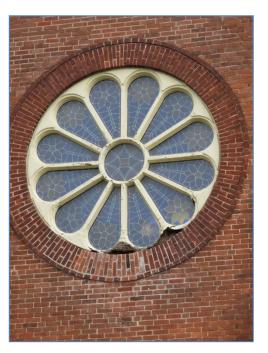
## **Photos**

It is unknown what the condition will be of the brick, lath and plaster where the window is to be removed as water has been running inside the exterior wall during the last number of years because the bottom of the wooden window has rotted out. This estimate does not include any cost for repairs of the brick or the interior lath and plaster. This can be discussed further once the window has been removed.

Skyhigh Restoration is to erect scaffolding outside of the town hall for safe removal of the rose window. A small amount of scaffolding is also required inside the hall to safely remove the associated stained glass panels.
