The Corporation of the Township of Brock  
Committee of the Whole Agenda

Monday, January 30, 2023, 10:00 a.m.  
Virtual Meeting

**Structural Condition Investigation, Report and Review for  
Rick MacLeish Memorial Community Centre  
91 Elliot Street, Cannington, ON  
The Corporation of the Township of Brock**

**Structural Condition Investigation, Report and Review for  
Sunderland Brock Memorial Arena  
20 Park Street, Sunderland, ON  
The Corporation of the Township of Brock**

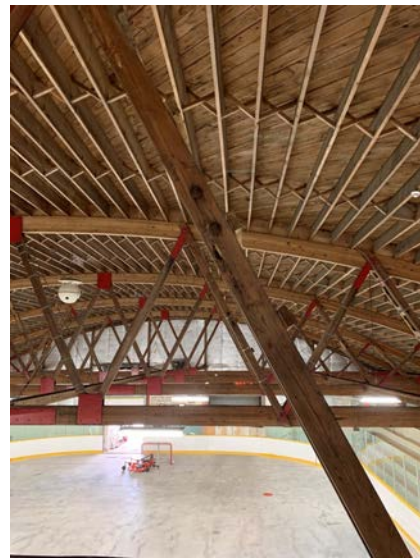
Photo 04

- Checking, delamination, and damage was observed at additional, unaddressed, bowstring truss elements, girts, and columns (Photo 04, 05). We recommend these areas be repaired to maintain the structural integrity of these elements.

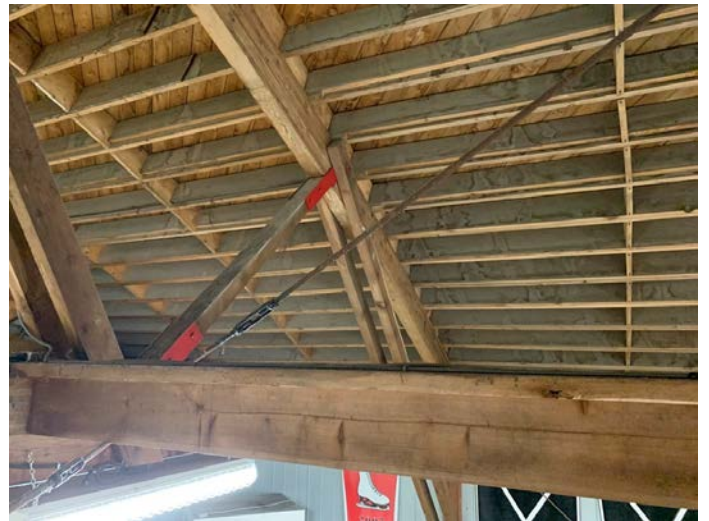
Photo 08

- Surficial corrosion was observed on most bracing rods (Photo 08). The corrosion levels appear minor at this time, however they should continue to be monitored for continued degradation.

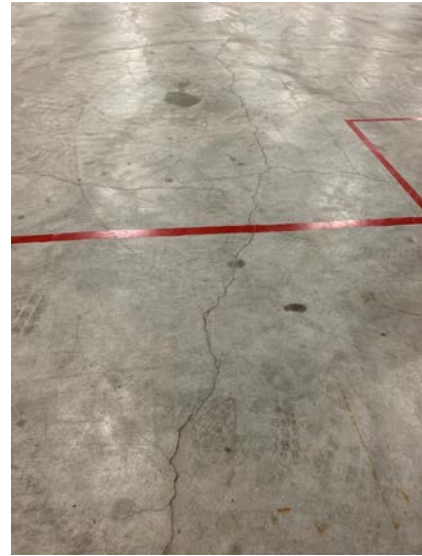
Photo 10

- Hairline surface cracks were observed throughout the rink slab. These are not a structural concern at this time however should continue to be monitored for further propagation.
- More significant cracking was observed at the south end of the rink slab (Photo 10). These cracks should be repaired to protect against continued deterioration.

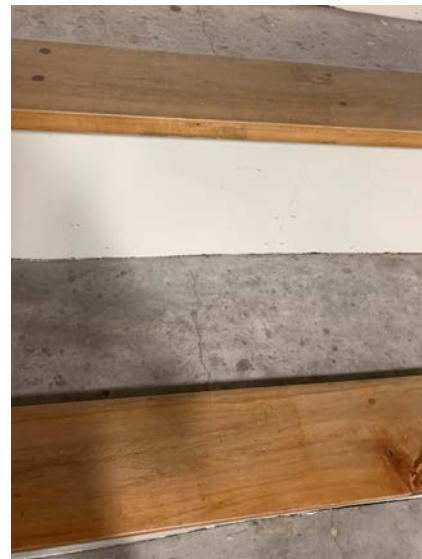
Photo 12

- Minor cracks were observed throughout the concrete bleachers, however these are not structural concerns at this time (Photo 12).
- Spalling and delaminating concrete were observed at a single location on the southernmost stair (Photo 13). This area requires to be repaired.

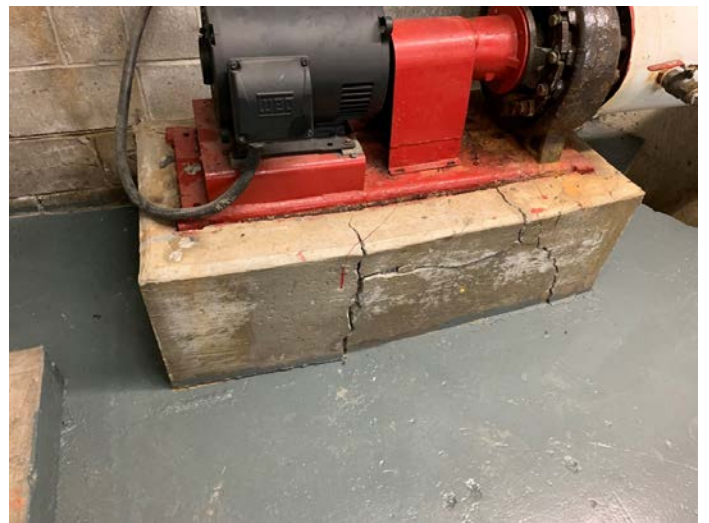
Photo 16

- Significant damage, deterioration and rutting was observed in the ice-resurfacer room (Photo 15). Localized areas of settlement may have also occurred around trench drains. Given the current condition, we recommend that the ice-resurfacer room slab be repaired or replaced.
- In the ice-making plant, the slab-on-grade appeared to be in good condition, with only minor hairline cracks observed. These cracks are not a structural concern at this time.
- Damage to the housekeeping pads within the ice-making plant was observed (Photo 16). We recommend these areas to be repaired.

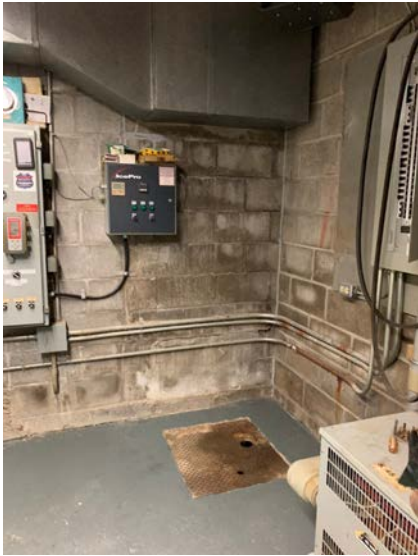
Photo 17

- Staining and efflorescence were observed on the interior face of the concrete block masonry walls in the ice-making plant, indicating the presence of moisture (Photo 17, 18). These areas should be cleaned and monitored for worsening conditions.
- Minor cracking, deteriorated mortar joints and other damage were observed in the ice-resurfer and mechanical rooms (Photo 19, 20, 21). These areas should be cleaned and monitored for worsening conditions.
- Deteriorated mortar joints were observed at some locations throughout the partition walls at the ground floor (Photo 22). It is recommended that these be routed and repointed with appropriate repair mortar.

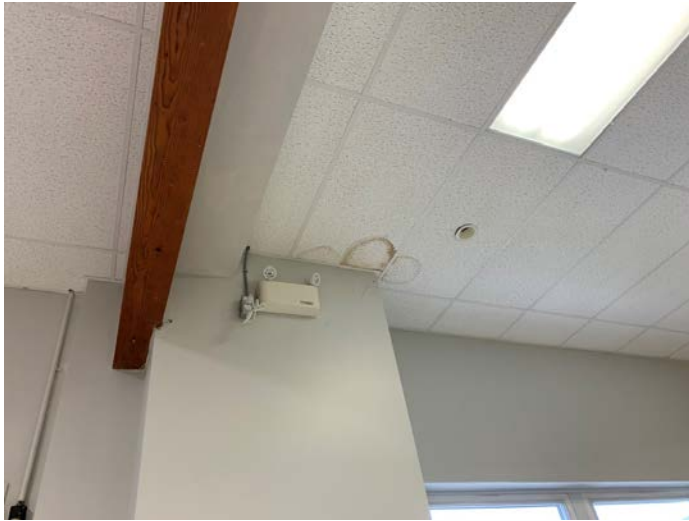
Photo 25

- Staining on suspended ceiling tiles indicate presence of moisture (Photo 25, 26, 27). Further investigation is required to determine the source and severity of moisture infiltration.
- Glulam beams and columns appeared to be in good condition with no notable damage or deterioration.

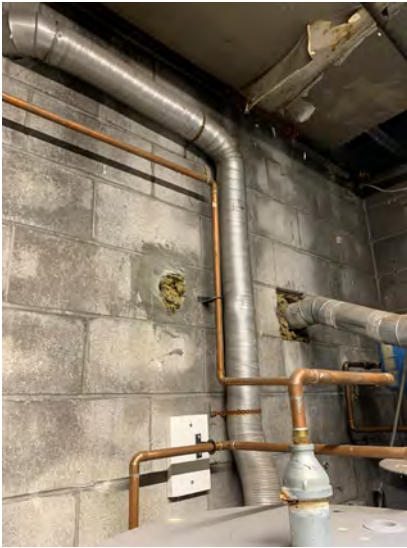
Photo 22 - Masonry Block Wall Efflorescence

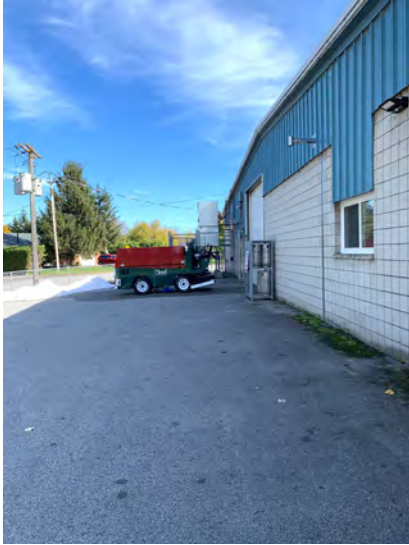
Photo 44 - East Elevation Block Wall Efflorescence
