SUNDERLAND TOWN HALL BUILDING CONDITION ASSESSMENT REPORT

TOWNSHIP OF BROCK

LARKIN ARCHITECT LIMITED

SEPTEMBER 2023

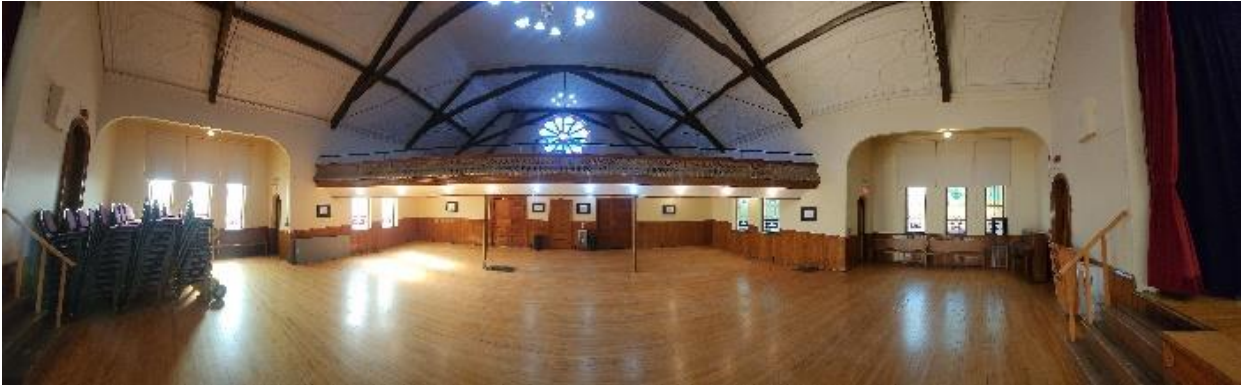
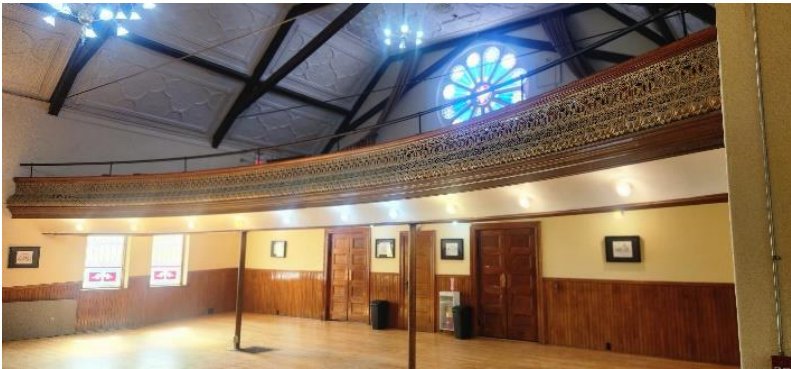
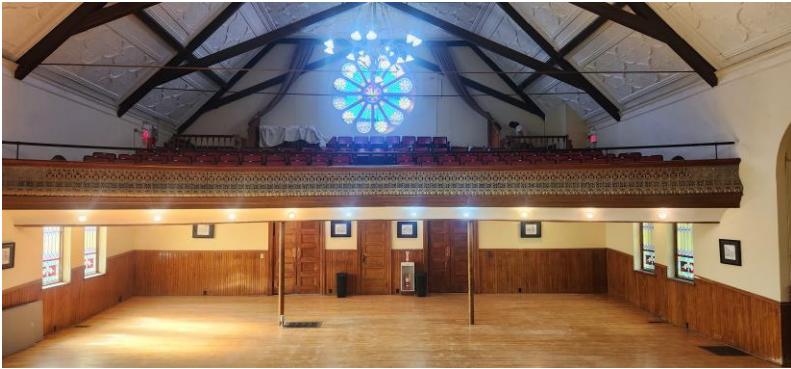
In general, the Sunderland Town Hall has been well maintained and appears to be in good shape (Refer to Fig.'s div. 1.1 to 1.3 inclusive) except for a few minor masonry issues, non-compliant protection of exits, and the desire to meet AODA accessibility standards. A detailed spreadsheet identifying required maintenance, priorities/timeframes, and estimated budgets in 2023 dollars can be found in the appendices. It should be noted that actual costs are subject to market conditions at time of tendering and any changes in the scope of work. In addition, relevant photographs referenced in the report have been included in the appendices. This building assessment report represents observations of existing conditions noted on July 14, 2023. Regular maintenance and monitoring of the items noted should be carried out on an annual basis as a minimum and addressed when required to avoid significant replacement costs.

FIG. Div.1. 1 –Auditorium Panorama

FIG. Div.1. 2–View of Auditorium Towards Lobby

FIG. Div.1. 3–View of Auditorium From Stage

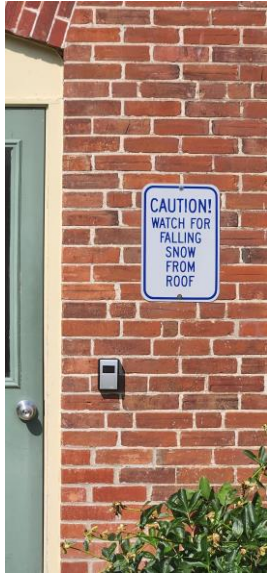
Generally, the Town Hall grounds appear to be well maintained. There are three parking spaces provided on site including one that is barrier-free. There is a sign adjacent to the door from the rear meeting room that warns the public to “watch for falling snow from the roof”. It would be prudent to assess the situation during freeze thaw cycles in the winter to determine if a canopy is necessary to protect the building users. (Refer to Fig. Div. 2.1). This item has not been included in the costing spreadsheet for that reason. The freestanding signage for the facility has deteriorated to the point where it requires replacement. (Refer to Fig. Div.2.2). The supporting post is deteriorating at grade and represents the potential for failure. (Refer to Fig. Div. 2.3). It should be monitored on a regular basis for stability and removed or replaced if deemed unstable. A French drain was installed in the rear yard to accept roof run-off via connected downspouts as well as surface water in the area. We were advised that the buried drainpipe connecting the downspout to the French drain remains free flowing during freezing weather. It was also noted that the grades on the west side of the property were adjusted to accommodate grade changes on the adjacent property. It was advised that the French drain appears to be dealing with the storm water, so no work is anticipated at this time. (Refer to Fig. Div. 2.4). The concrete and unit paver walkways on the property appear to be in serviceable condition.

FIG. Div.2. 1- Falling Snow Warning Sign

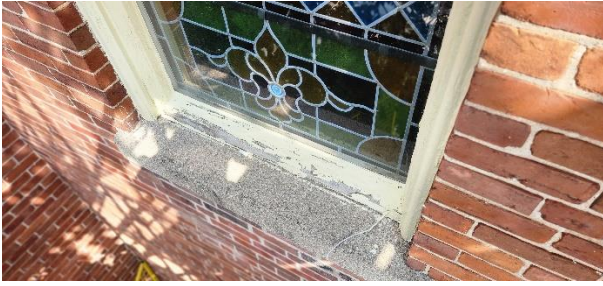
FIG. Div.3. 1 – Front Window Sill

The building has decorative windowsills, keystones, and buttress caps which appear to be limestone but are in fact made of an early form of precast concrete commonly referred to as “Roman Stone” as produced by a local Toronto manufacturer of the same name owned by Sir Henry Pallett, who used the product in lieu of limestone for his own home, Casa Loma. The material is showing signs of age with hairline cracks appearing. It should be noted that one on the east façade appears to have already been replaced with a new precast concrete sill. The pieces with horizontal surfaces should be monitored on a regular basis and eventually replaced or protected with LCC flashings to prevent further deterioration. (Refer to Fig.’s Div. 3.1 to 3.7 inclusive) Due to the fact that the keystones are vertically oriented, they appear to have little or no deterioration. (Refer to Fig. Div. 4.1)

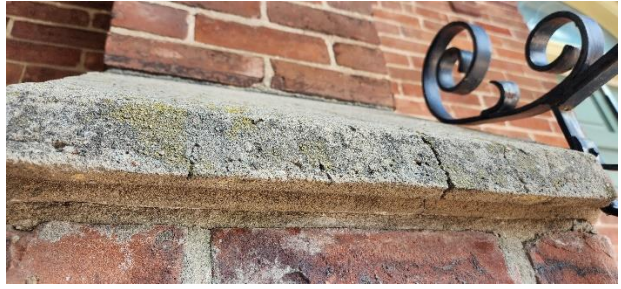
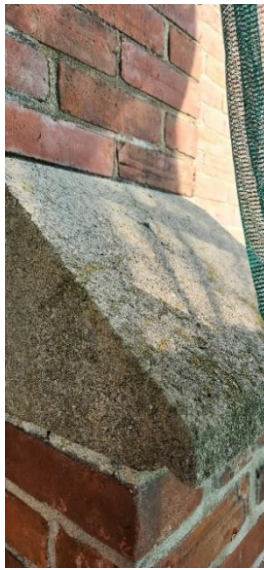
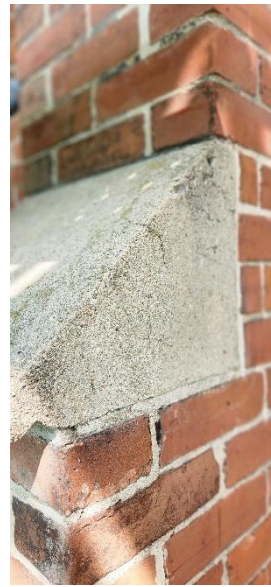
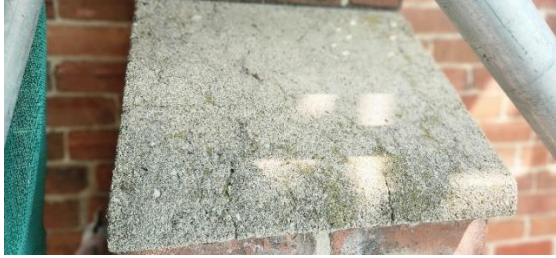
FIG. Div.3. 2 – Front Buttress Cap Stone.

FIG. Div.3. 3 – Front Buttress Cap Stone 2

FIG. Div.3. 4 – Front Buttress Cap Stone 3

FIG. Div.3. 5 – Front Buttress Cap Stone 4

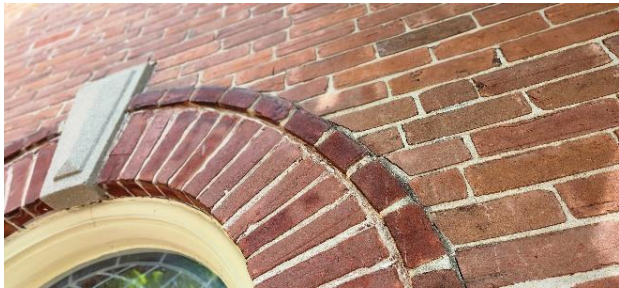
FIG. Div.4. 1 – Front Window Arch

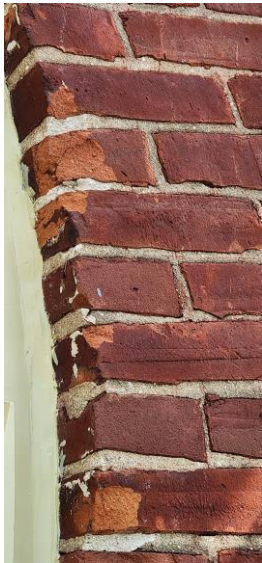
repaired as soon as possible to prevent further deterioration. Fig. Div. 4.3 indicates some chipped masonry around the rose window. Photos taken prior to the window restoration indicate its presence. These bricks should continue to be monitored and replaced if significant deterioration occurs.

FIG. Div.4. 3 – Rose Window Masonry Surrounding

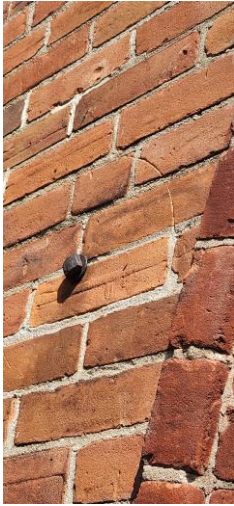
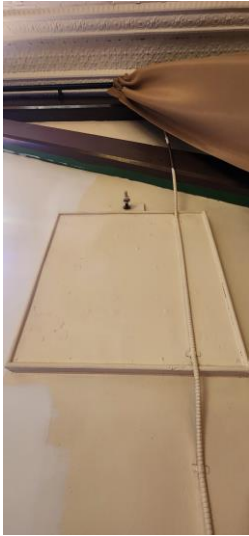
Metals refer to miscellaneous metal items such as fire escapes and railings. Fig.'s Div. 5.1 and 5.2 indicate a vestigial iron through-bolt in the front wall of the upper balcony. One suspects that it once supported something hung in the space or on the exterior that no longer exists. Fig. Div. 5.3 indicates the front exterior balcony railing to be in good shape although it will require annual monitoring to check for corrosion. Periodic painting with rust resistant paint is recommended.

FIG. Div.5. 1 – Anomalous Iron Through Bolt at Front Wall

FIG. Div.5. 2 – Interior View of Anomalous Iron Through Bolt

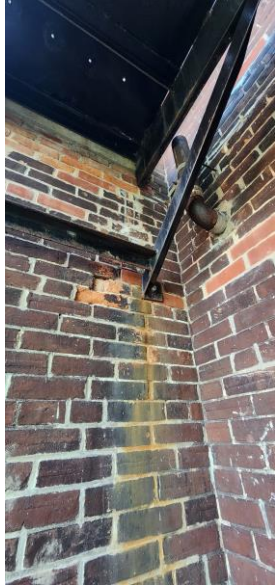
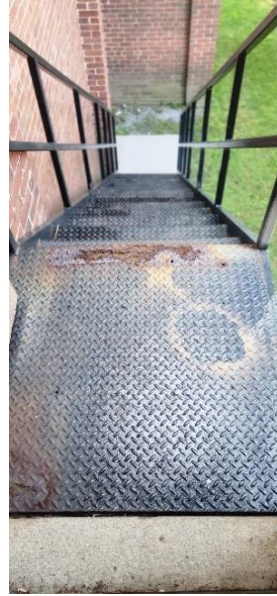
Fig.'s Div. 5.5 and 5.6 reference the west fire escape and corrosion on the landing and its anchorage which is causing damage to the surrounding masonry. As the fire escapes represent a means of egress, repairs to ensure a safe path of exit are paramount. Fig.'s Div. 5.7 and 5.8 reference the east fire escape which passes by windows on the first floor thereby exposing the path of egress to potential fire should it occur on that level when the upper floor is occupied. This could result in an order to comply from the fire department at any time. Possible solutions would be to provide fire shutters on the interior side of the offending windows or applying a hollow metal frame with fire rated glass on the exterior although the available masonry depth appears to be insufficient to add exterior protection. A similar situation occurs at the west fire escape. Refer to Fig. Div. 8.15. Fig. Div. 5.9 illustrates corrosion on the landing of the east fire escape which represents a priority repair to ensure a safe means of egress from the auditorium. Fig. Div. 5.10 illustrates a steel column supporting the auditorium balcony faux painted to look like stained wood. Fig. Div. 5.11 illustrates the auditorium balcony decorative wrought iron railing with add pipe above at 36" AFF to serve as a code compliant guard. Unfortunately, the new steel railing allegedly blocks sightlines to the stage.

FIG. Div.5. 5- West Fire Escape Anchorage

FIG. Div.5. 6- West Balcony Fire Escape Landing

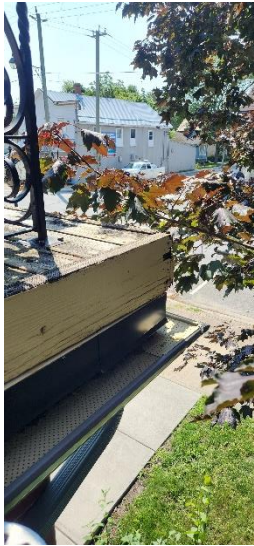
Generally, the exterior wood elements of the building are in good condition. However, the protective coatings appear to be deteriorating and should be prepped and re-finished soon to avoid deterioration. (Refer to Fig.'s Div. 6.4 to 6.7). Fig. Div. 6.1 and 6.2 illustrate the condition

of the exterior balcony facias which are showing sufficient deterioration of the finishes and underlying wood to require replacement soon. The surface of the deck should be re-finished at the same time and the supporting structure and roof membrane (not visible) should be checked to determine its condition. Fig. Div. 6.3 indicates the balcony soffit to be in good condition with no signs of leaking from above. This work has been included in the phased building envelope restoration process as identified in the cost spreadsheet.

FIG. Div.6. 1 – Entrance Canopy Balcony Fascia

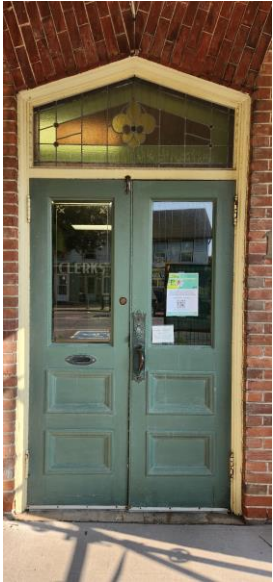
Fig.'s Div. 8.1 and 8.2 illustrate the front doors to the town hall which are typical of their time, but do not meet current code standards for exiting. Drawings to provide a compliant single door with barrier-free operator were tendered recently and LAL is awaiting direction from the Township on next steps. Fig.'s Div. 8.3 and 8.4 illustrating the exterior balcony doors were part of the same tender process. In this case, the doors have deteriorated to the point at which they require replacement, but do not require accessibility, so can be replicated.

FIG. Div.8. 1 – Front Doors (Exterior)

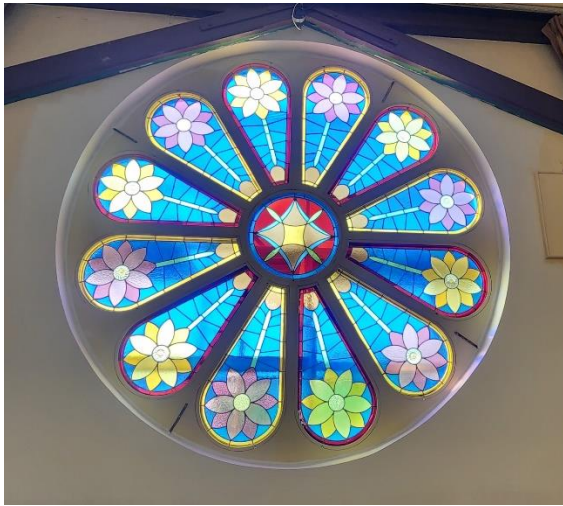
FIG. Div.8. 12 – Rose Window after Restoration.

The Rose Window has been subject to a recently completed contract to replace the deteriorated frame, clean the stained glass, install new protective exterior glazing with a ventilated interstitial space, provide exterior sill flashings, and complete repairs to the interior plaster surround. Drawings for this work are included in the appendices. (Refer also to Fig.'s Div. 8.11 and 8.12). Another project to replace the front doors with a barrier-free entrance and to replace the deteriorating balcony doors has been tendered and currently under review by the Township. (Refer to Fig.'s Div. 8.1 to 8.4 inclusive). The drawings for this project are also included in the appendices along with basic building layout drawings provided by the Township.

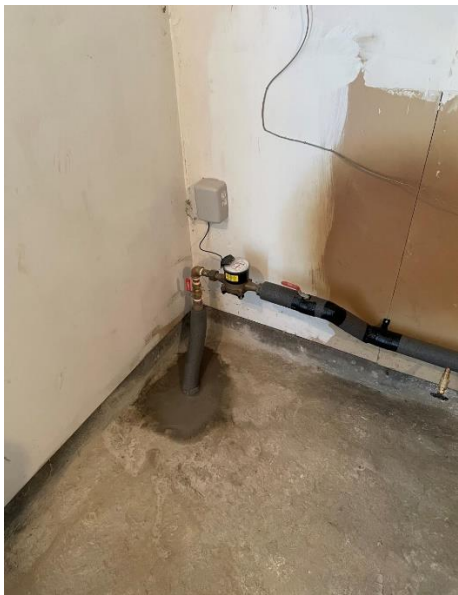
FIG. Div.15. 7 – New Water Line

Fig. Div. 15.7 indicates the new $\frac{3}{4}$ " water service that was recently installed to replace the existing service.

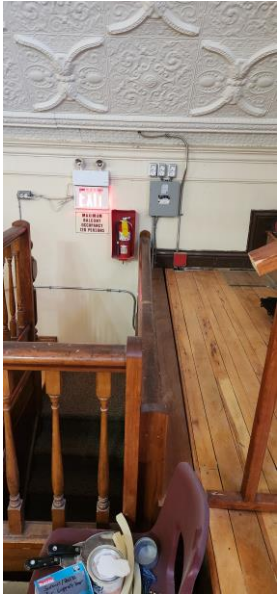
FIG. Div.16. 1 – Sub-panel at Balcony Technical Support Area

is likely not significant. A 200-amp service may be adequate for the building. A subpanel servicing several electrical outlets was noted on the auditorium balcony in the area used by the performance technical operators. (Refer to Fig. Div. 16.1) Further investigations with respect to the condition of the service main switchgear and panels may be warranted.

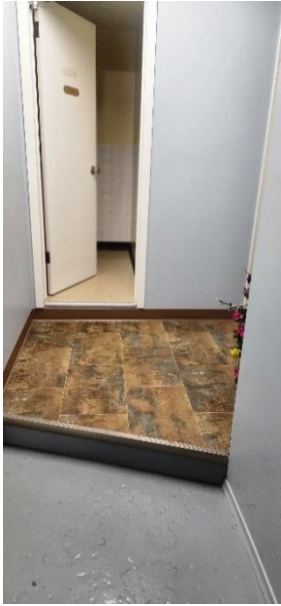
FIG. Div.17. 1 – Step in Rear Exit Corridor

It was observed that the rear exit corridor serving the banquet hall and associated washrooms has a step that prevents a barrier-free path to the rear exit and washrooms. The front of house washrooms each have a handicap stall. However, it would be prudent to provide at least two exits that are barrier-free from the first floor.
